MNMM Fatal 2004-15

- Powered Haulage
- August 18, 2004 (Missouri)
- Cement Operation
- Deck Hand Helper
- 50 years old
- 9 years experience

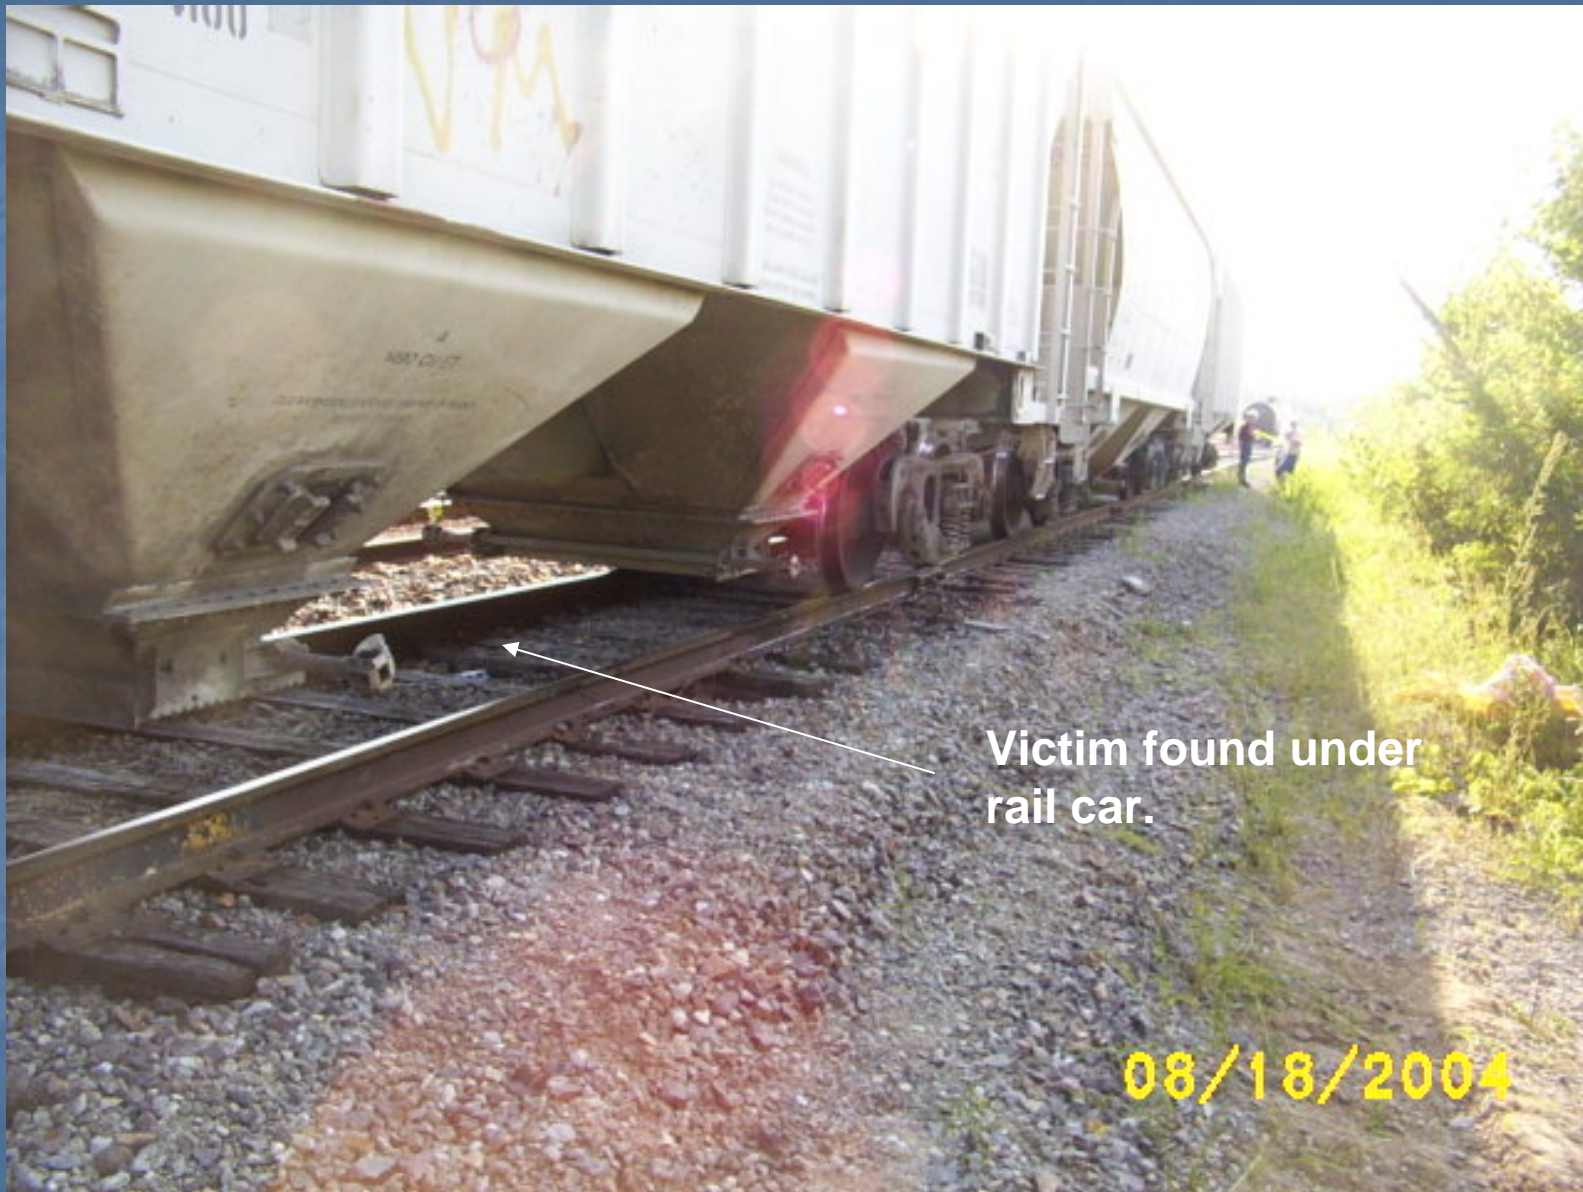
- The victim was helping the locomotive operator reposition rail cars in the plant rail yard when he was struck by moving railcars.

Victim found under
rail car.

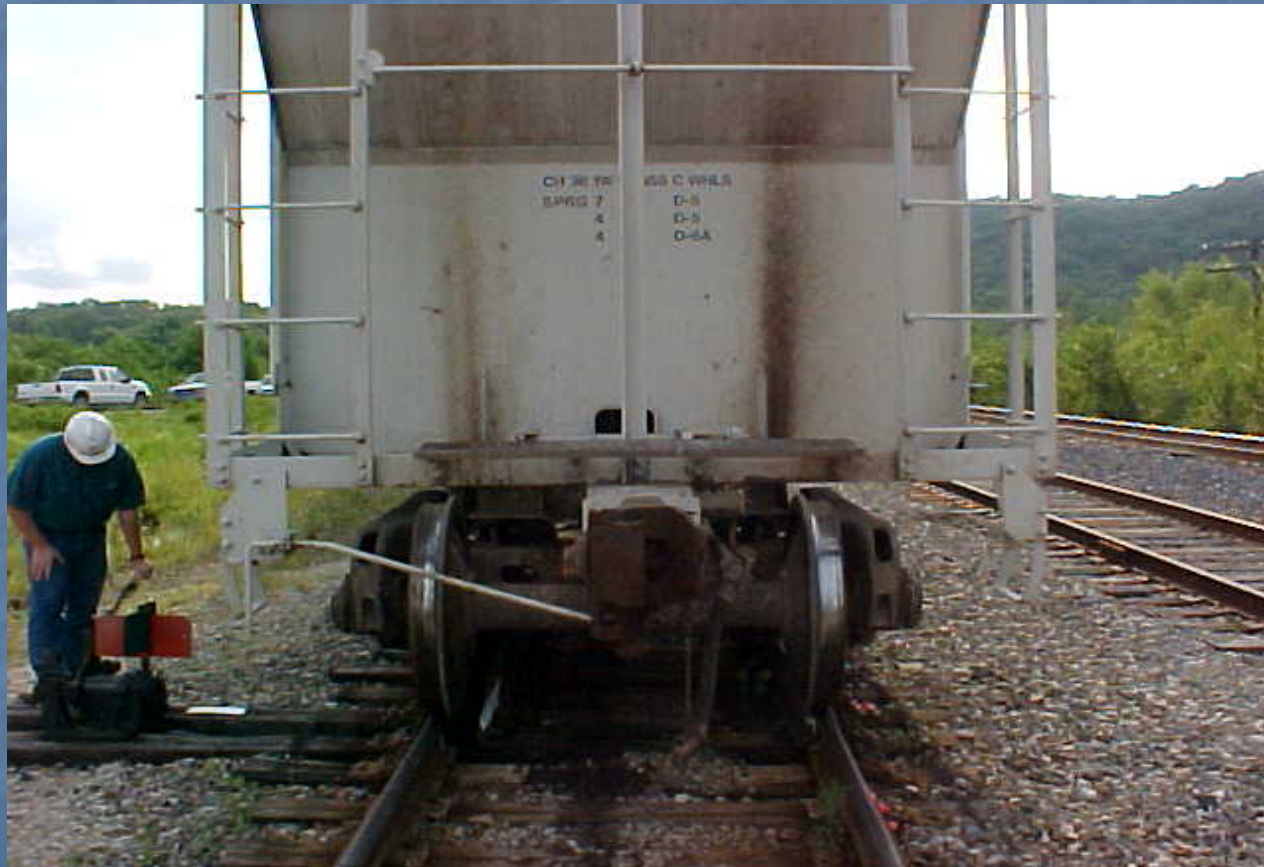
Front view of rail car involved in the accident

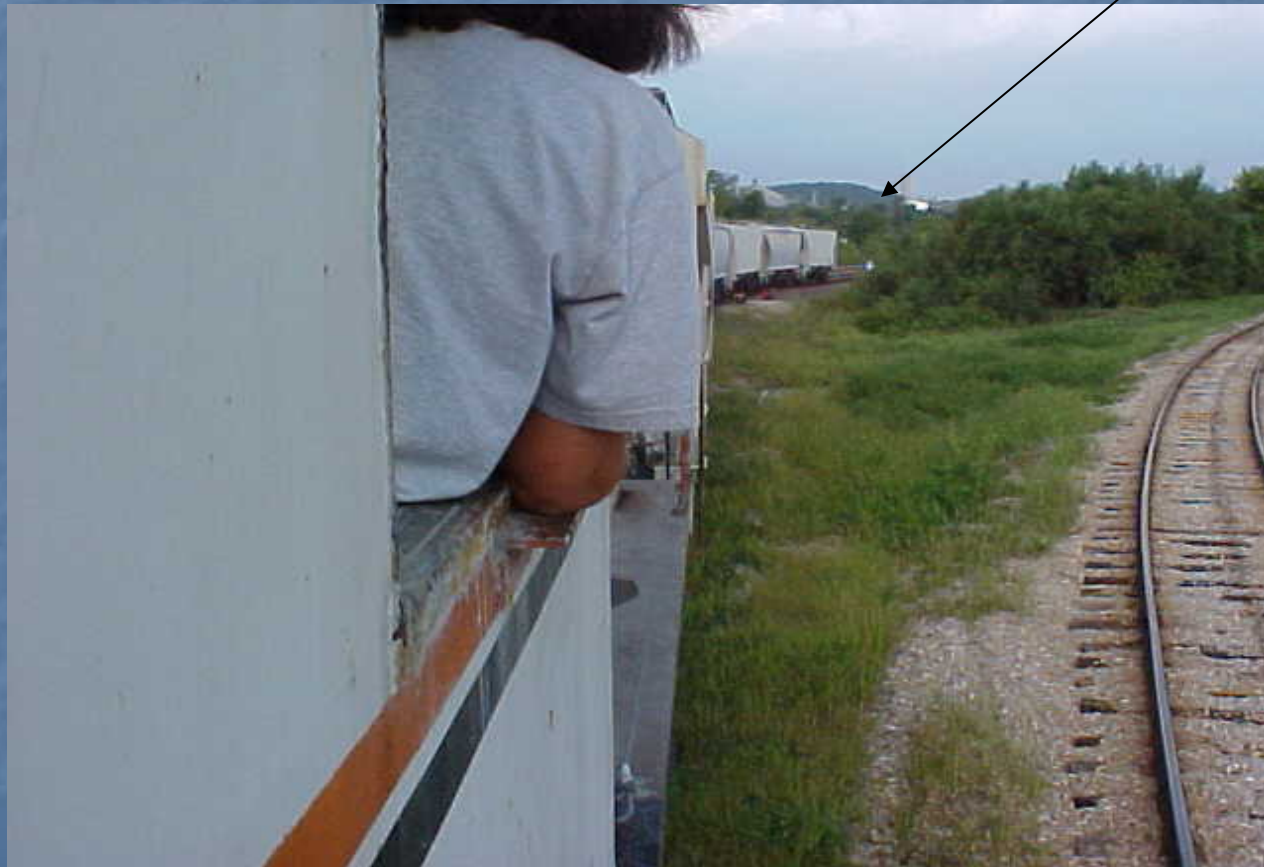
View from operator's compartment

Point of impact

- Neither visual contact nor communication was maintained between employees who were moving railcars. The locomotive operator continued to push the railcars onto the inbound track even though the victim was no longer in view.

- Position yourself in a safe location where you are not exposed to hazards.
- Utilize radios to communicate when visual contact can not be maintained.
- Monitor personnel routinely to determine that safe work procedures are followed.
