Coal Mine Fatal Accident 2005-13

Operator:	Thomas J. Smith Inc.
Mine:	Smith No. 1 Mine
Accident Date:	August 18, 2005
Classification:	Machinery
Location:	Dist. 2, Armstrong County, PA
Mine Type:	Surface Coal Mine
Employment:	24

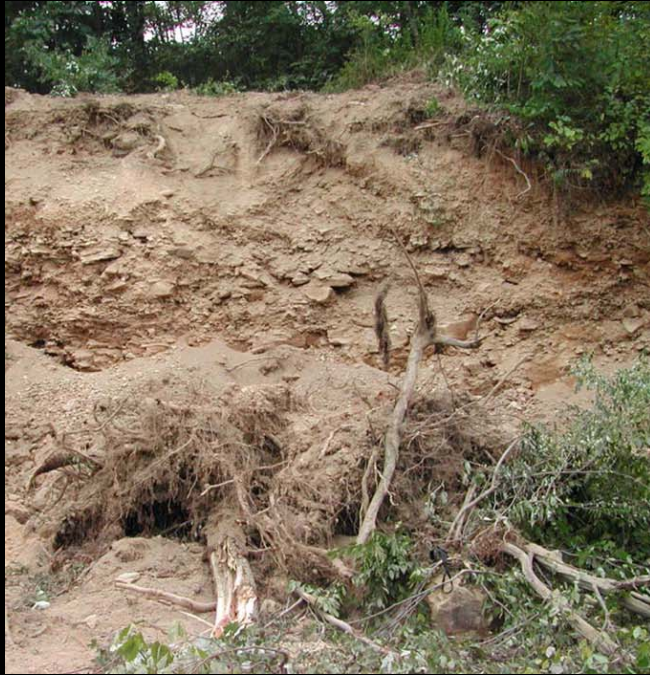
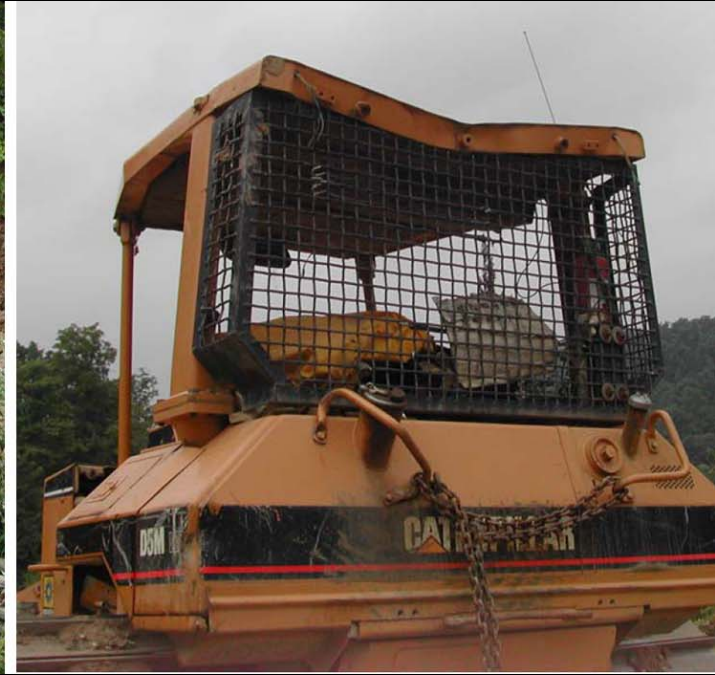
At ~12:00 p.m. on Thursday, August 18, 2005, a 50-year old Pit Foreman/Machine Operator, with 26 years of mining experience was fatally injured while operating a Caterpillar D5M-LGP bulldozer to construct a haul road to a pit. The victim was pushing trees over the top of a 24' high embankment adjacent to the haul road construction site. As the trees fell, the failing root systems loosened the soil near the crest and the dozer traveled over the embankment and came to rest on its left side. The victim was not wearing a seat belt and was thrown from the cab of the dozer.

The accident occurred because the machine used to complete the task of pushing over the large trees was inappropriate for the task being conducted near the top edge of an embankment. The severity of the accident was increased due to the fact that the victim was not wearing a seat belt.

Corrective Action: Management adopted safety policy to ensure compliance with safe work procedures. Management should monitor and strictly enforce the established policy regarding the use of seat belts.

Corrective Action: Management should evaluate the current safety, work and operational procedures in use at the mine. Management should encourage all employees to do a risk analysis any time a task is started.
