# MNMM Fatal 2006-20

- Powered Haulage
- August 29, 2006 (Pennsylvania)
- Crushed Stone Operation
- Contract Blacktop Paving Supervisor
- 61 years old
- 31 years experience

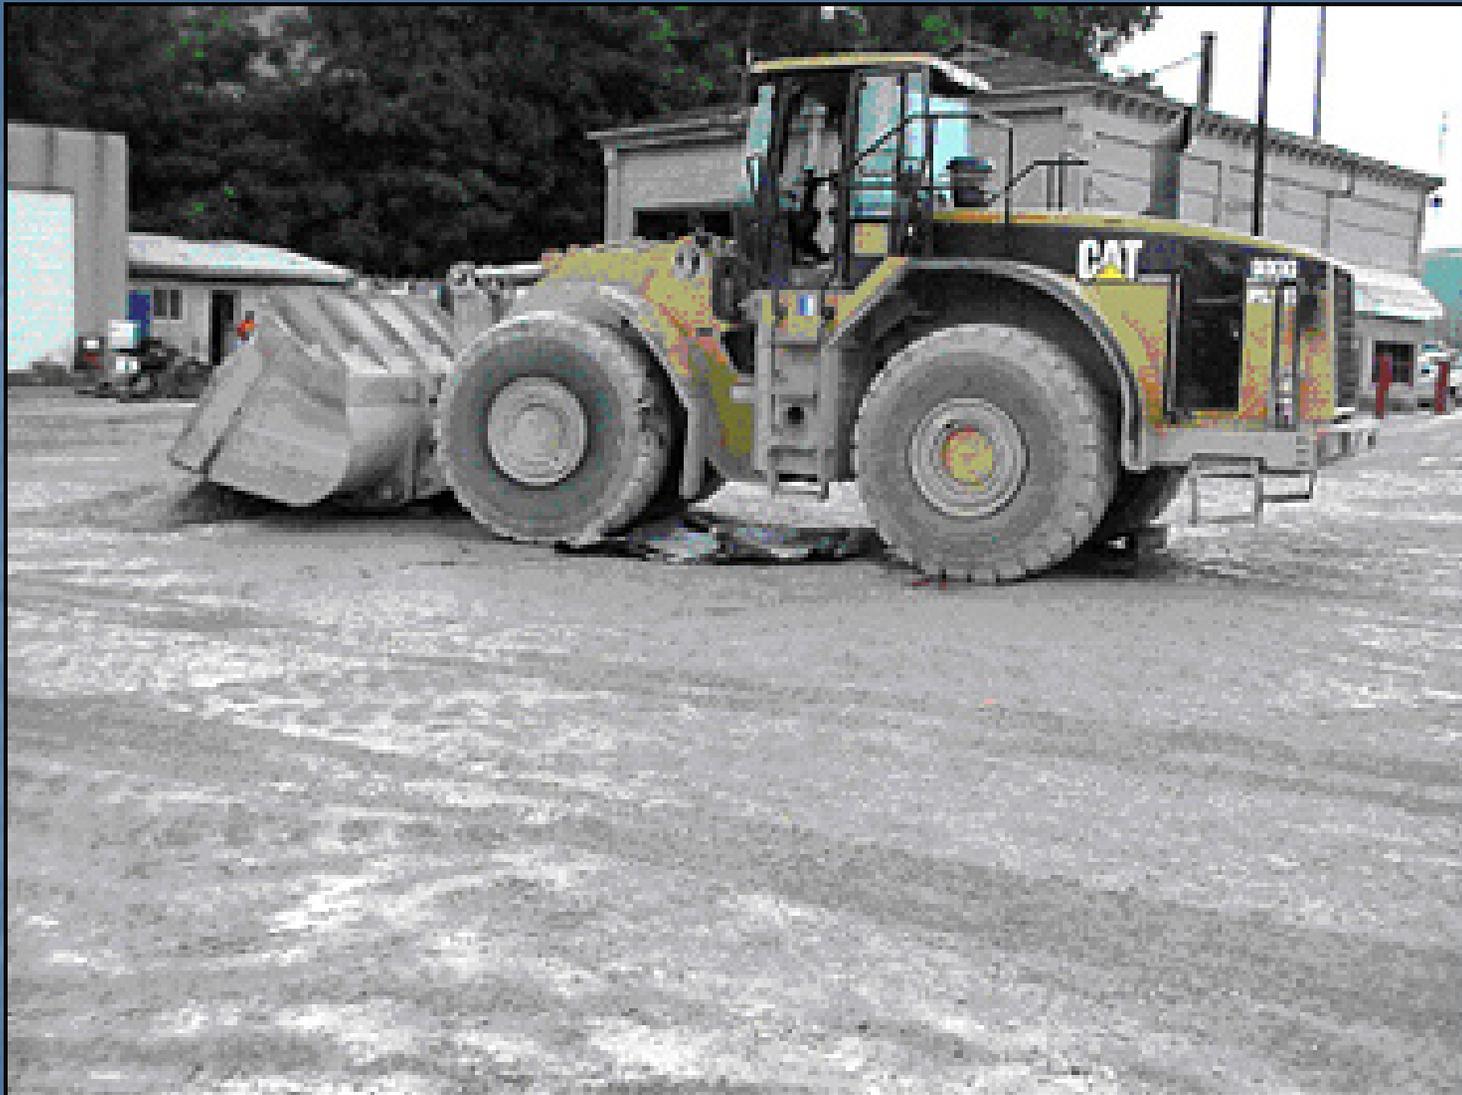
The victim was fatally injured while walking from the mine's main shop toward the plant when he was struck by a front-end loader. The front-end loader bucket, loaded with rock and positioned several feet off the ground, blocked the operator's view of the victim. The six-person crew he supervised was preparing to pave an area south of the mine's main shop.

- A risk assessment to determine all possible hazards and to establish safe work procedures was not conducted prior to paving near the mine shop. The area was congested with moving mine equipment, asphalt equipment, and paving personnel.
- Management policies and controls were inadequate in that a front-end loader traveled through a congested work area with its bucket raised, blocking the operator's vision.

- At locations where pedestrians and mobile equipment are both performing tasks, rules should be established and signs or signals warning of hazards should be utilized.
- Initiate action to protect yourself when performing every task ( SLAM ). Train all miners to recognize the hazards associated with mobile equipment traveling nearby when they are on foot.
- When tramming a front-end loader from one location to another, position the loader bucket as low to the ground as possible.
