MNMM Fatal 2007-12

- Falling Material Accident
- June 12, 2007 (California)
- Granite Operation
- Grade Setter
- 45 years old
- 10 years experience

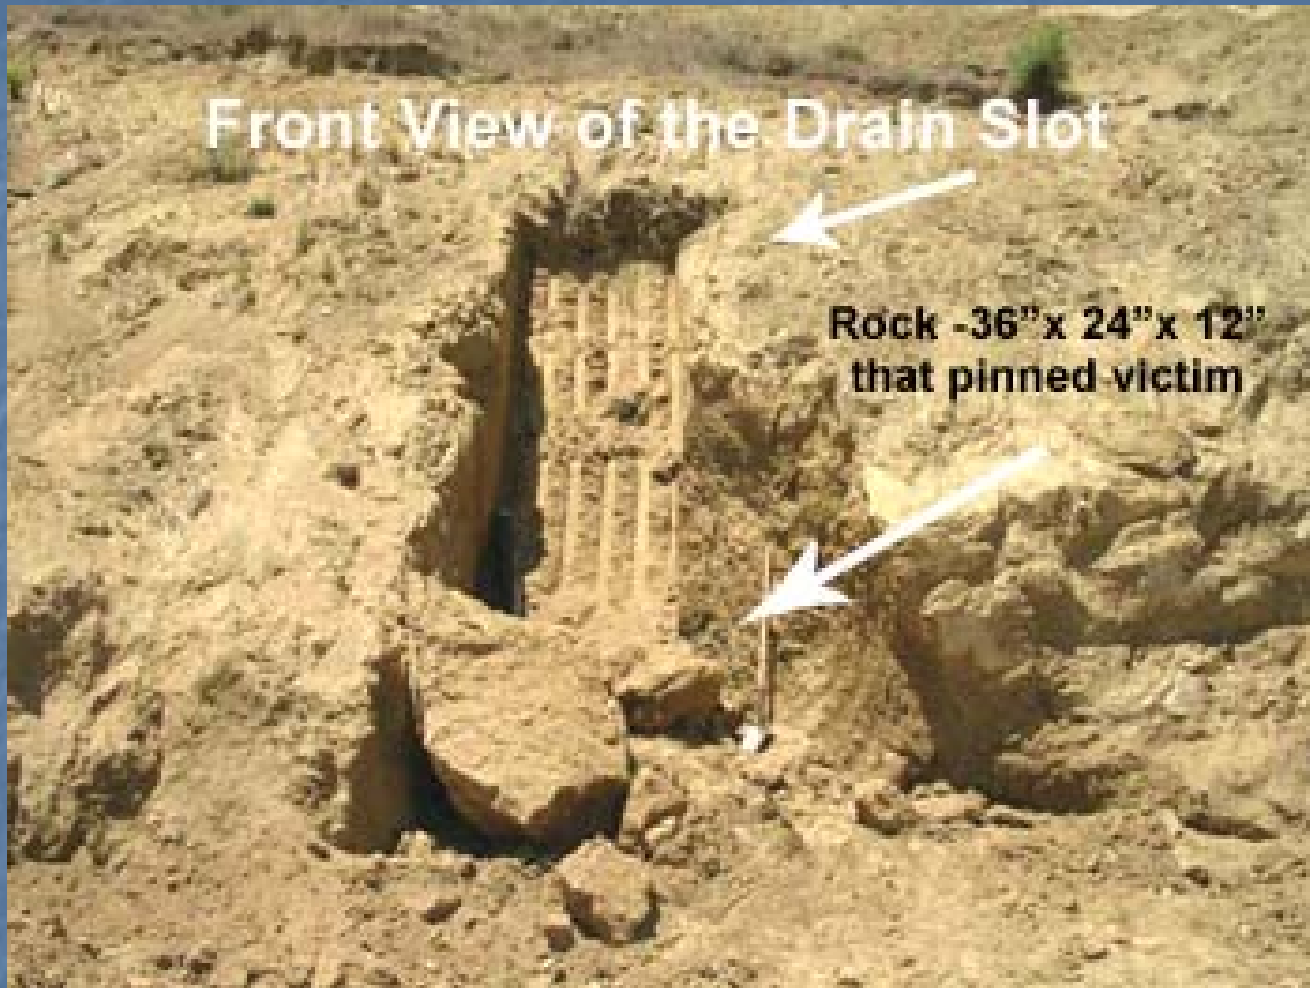
Front View of the Drain Slot

The victim was fatally injured while working on a reclamation project at a waste dump. He stepped into a trench excavated into the side of the slope when a vertical wall collapsed, pinning him between two large pieces of clay.

Rock -36"x 24"x 12"
that pinned victim

Management policies and procedures were inadequate and failed to ensure that persons could work safely at the reclamation site. Ground conditions which created a hazard were not taken down or supported before work or travel was permitted.

- Carefully examine ground conditions prior to performing tasks near excavated embankments, trenches or ditches.
- Identify hazards associated with the task to be performed, review those hazards with all personnel involved, and implement measures to ensure persons are properly protected.
- Support trench walls or slope the walls to a safe angle.
