AMENDED
REPORT OF INVESTIGATION

Surface of an Underground Coal Mine

Slip and Fall of Person
December 4, 2007
(Victim Died December 14, 2007)

No. 130 Mine
Mammoth Coal Company
Mammoth, Kanawha County, West Virginia
MSHA I. D. 46-06051

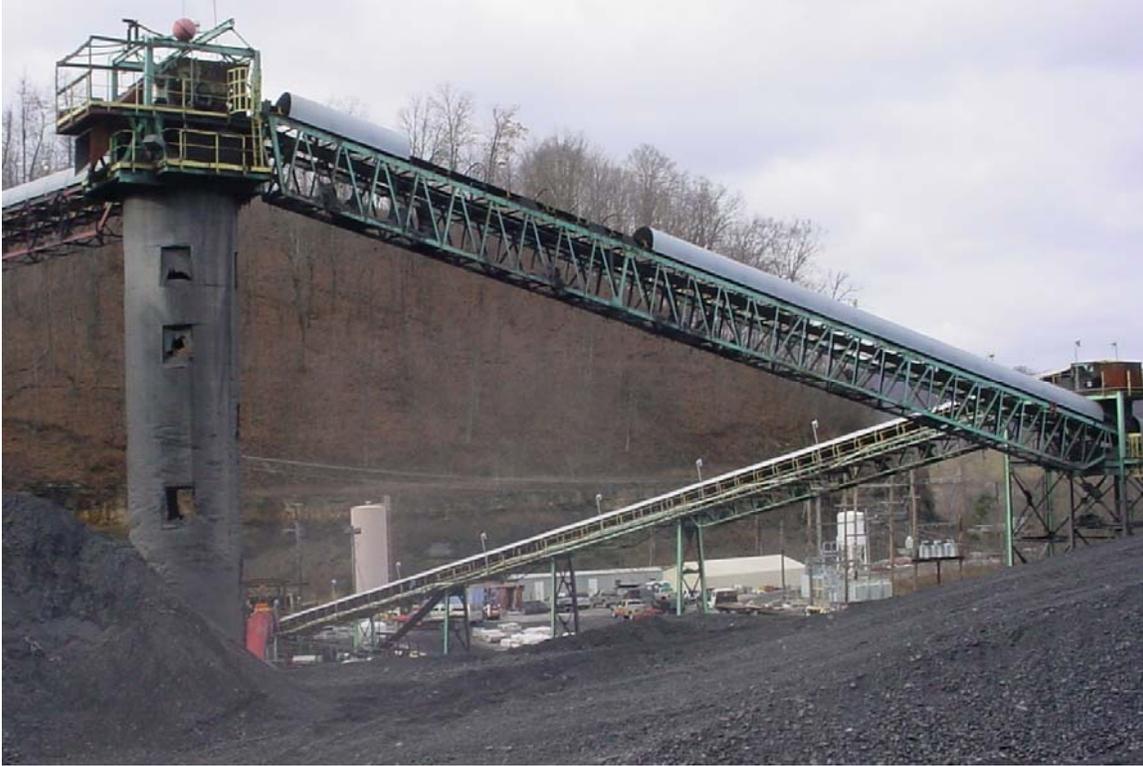
PHOTOGRAPH OF ACCIDENT SCENE1

The Stacker conveyor belt dumps the raw coal onto the Cross Hollow belt at approximately the midway point of the inclined Cross Hollow conveyor belt. A walkway is located adjacent to the conveyor. The walkway is provided with a standard height handrail (of 42 inches is on the right hand side of the belt looking up the belt), including a top rail, middle rail, and toe board is installed along the entire length of the Cross Hollow conveyor belt. A photograph of the walkway is contained in Appendix C, of this report. The location in which the bottom idler was being replaced on the Cross Hollow conveyor belt was approximately 240 feet from the conveyor belt tailpiece and approximately 52 feet above the surface of the raw coal storage area.

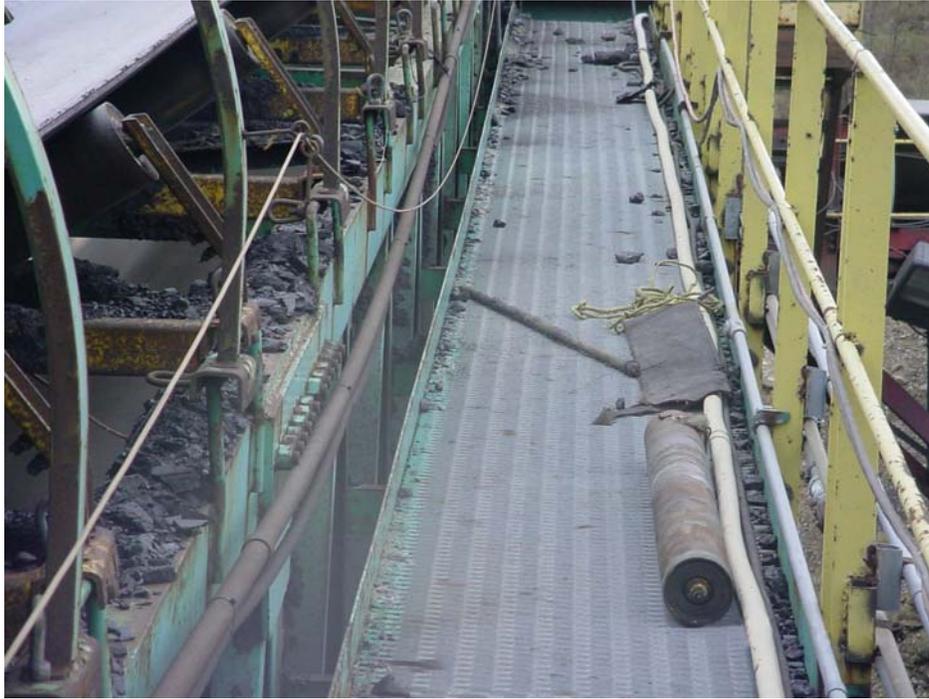
Cross Hollow Conveyor Belt Walkway at the Location of the Accident

Corrective Action: The Training Plan was revised requiring that a supervisor must ensure that proper fall protection procedures are followed before any repairs are performed on the structure. The use of a harness and lanyard while working in elevated areas is required when working above 6 feet in height.

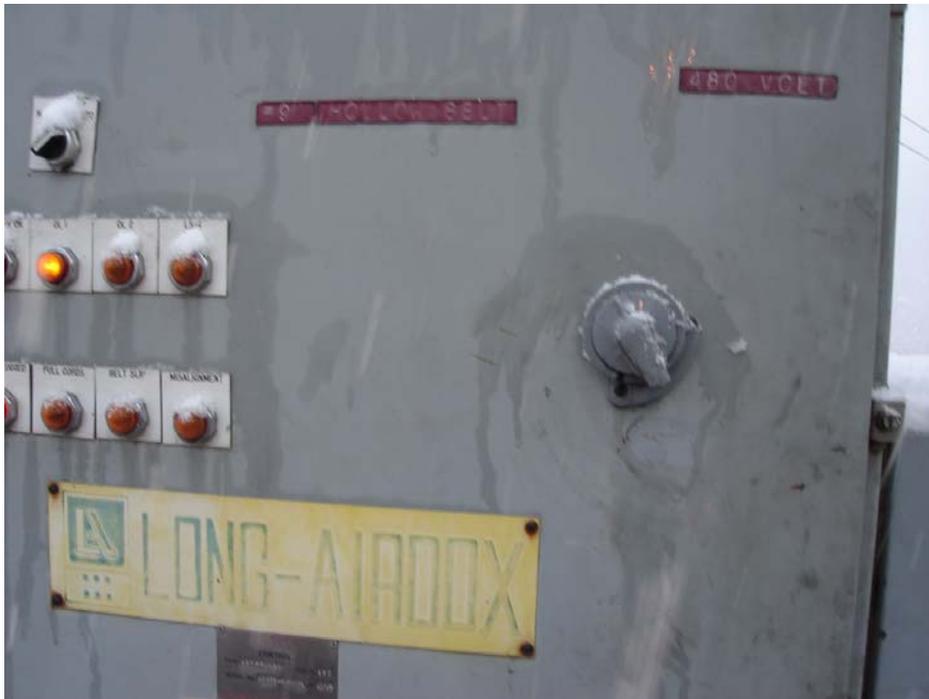
The Cross Hollow conveyor belt is provided with a mechanical means to disconnect power at a 480 volt controller box located at the motor platform. The controller box has a grey handle which can be turned to open the circuit breaker, disconnecting electrical power. The handle is constructed to facilitate a lock to physically keep the system deenergized during mechanical or electrical repairs. The circuit breaker handle for the Cross Hollow conveyor belt was broken, rendering it useless for its intended purpose. A photograph of the controller and the handle are contained in Appendix C, of this report.

Root Cause: The circuit breaker supplying electrical power to the Cross Hollow conveyor belt was not deenergized prior to installing the bottom belt idlers. The circuit breaker handle located at the motor platform for the Cross Hollow conveyor belt was broken and therefore could not be used to properly deenergize and lock the conveyor motor circuit. Proper procedures were not followed before working on the conveyor belt.

- 1) A 103(k) Order, No. 7281413, was issued to ensure the safety of the miners until the investigation could be completed.
- 2) A 104(a) Citation, No. 7281417, was issued for violation of 30 CFR 77.502 stating that the Cross Hollow conveyor belt circuit breaker disconnecting device, located on the motor platform, was not maintained to assure safe operating condition. The handle of the device was broken which prohibited the turning motion necessary to deenergize electrical power.

Broken Conveyor Handle at the Cross Hollow Conveyor Belt Controller Located at the Conveyor Belt Platform

Corrective Action: The Training Plan was revised requiring that a supervisor must lock and tag out the Cross Hollow conveyor belt and ensure that proper fall

protection procedures are followed before any repairs are performed on the structure.
