REPORT OF INVESTIGATION

**Surface Nonmetal Mine
(Lime)**

**Fatal Fall of Person Accident
December 14, 2007**

**Natividad Plant
Chemical Lime Company of Arizona
Salinas, Monterey County, California
Mine I.D. No. 04-00156**

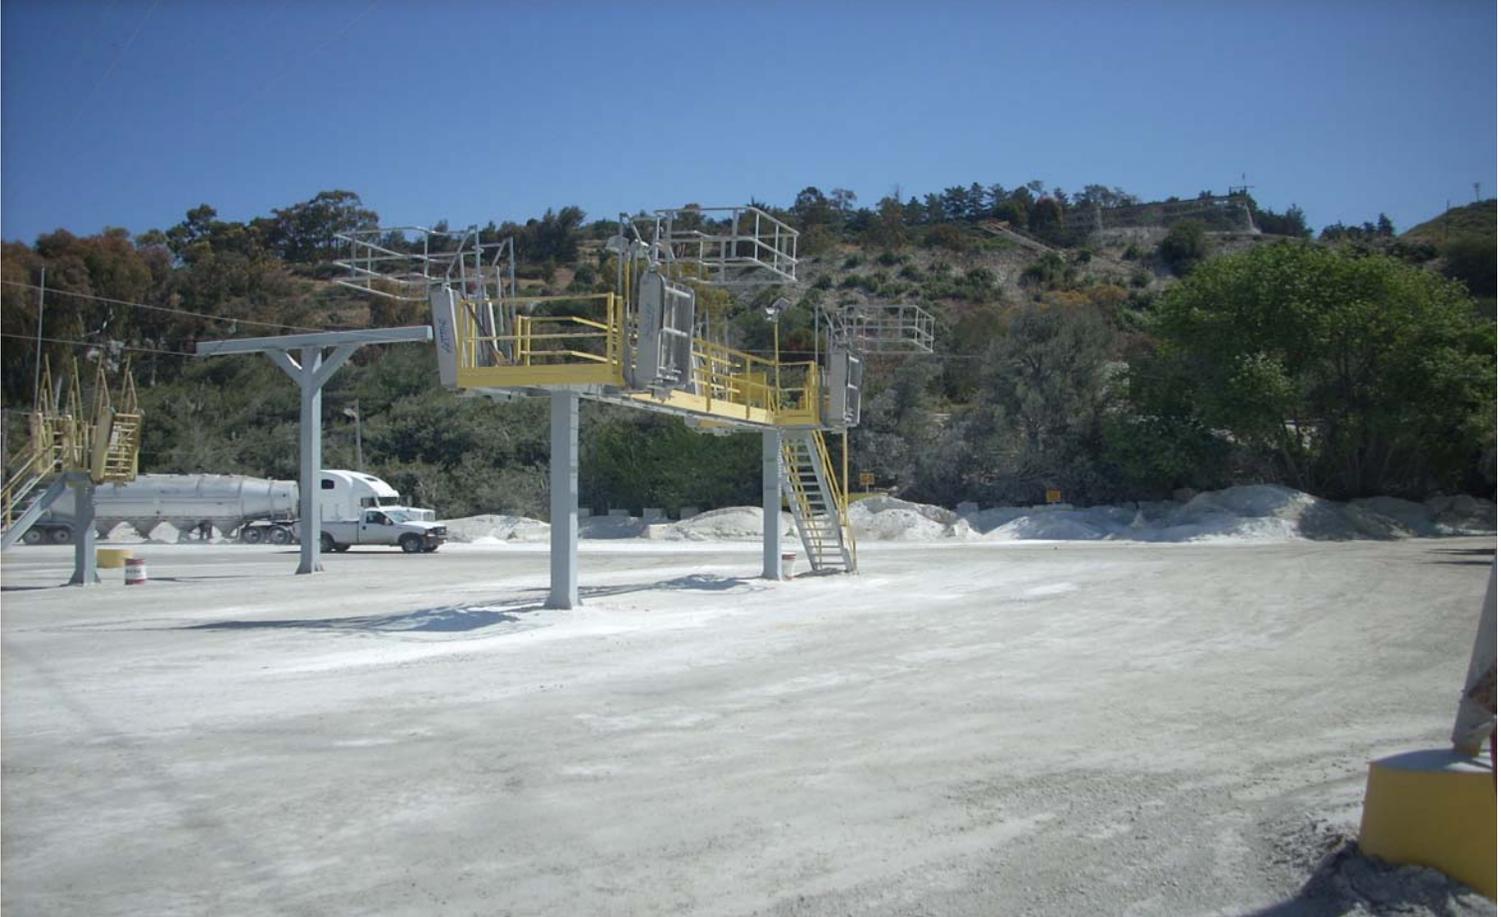
Appendix B

The truck rack was a model RTC 35A, fabricated by Graff Access Equipment in 2003. The access walkway was 66 inches long and 38 inches wide. The hand rail basket measured 69 inches wide 46 inches long and 28 inches high.

Truck rack

Root Cause: Management did not establish policies, procedures, or controls to ensure that truck drivers could safely access the lids on their bulk trailers. The truck rack used by the drivers would not remain in position to provide a safe means of access to the trailer top and lid. The truck rack was not maintained as recommended by the manufacturer.

Corrective Action: Management should establish policies, procedures, and controls to ensure that truck drivers can safely access the lids on top of their trucks. A safe means of access shall be provided and maintained as recommended by the manufacturer.

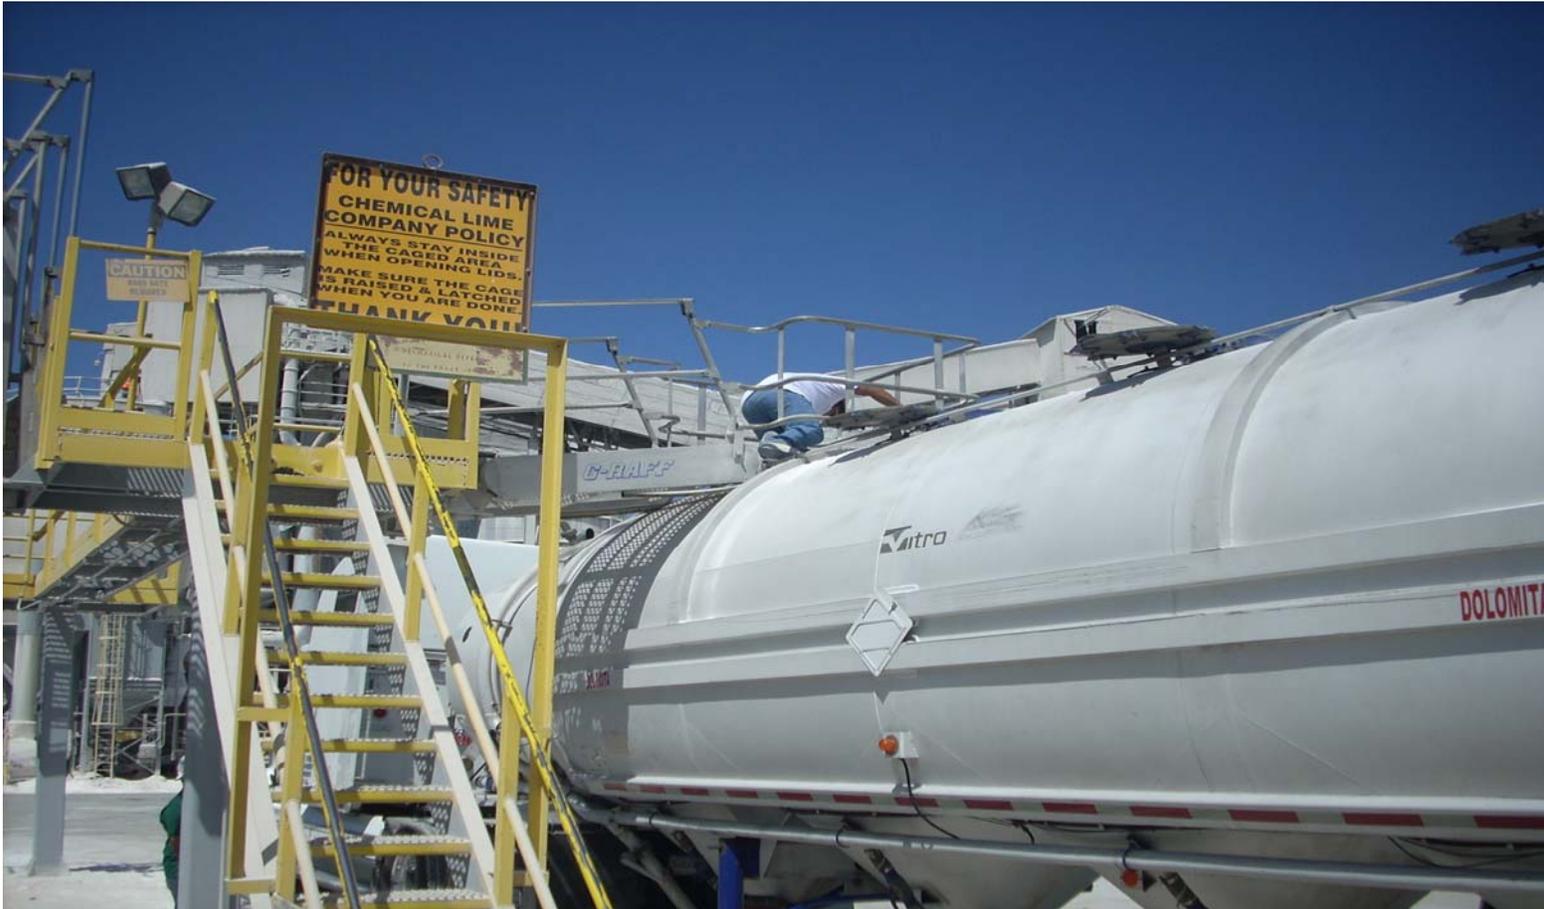
Appendix C

The access walkway and its attached handrail basket could be moved to a fixed position. The access walkway pivoted at the connection points to the main structure. This allowed the access walkway to move as needed to contact bulk trailers of various heights. As the access walkway pivoted, the handrail basket also pivoted and remained perpendicular to the ground. When properly tensioned as recommended by the manufacturer, the handrail basket maintained a constant distance from the trailer top relative to the angle of the access walkway.

The access walkway was spring tensioned which aided the truck drivers to bring it and the handrail basket to the upright fixed position when not in use. However, the access walkway involved in the accident was not properly tensioned. The tension was too tight causing the access walkway to rise when the victim stepped off it and onto the truck. The spring tension was not checked on a regular basis as recommended by the manufacturer.

Truck rack showing access walkway and handrail basket

This citation was terminated on August 26, 2008. The spring tensioning system was adjusted to provide for proper operation of the access walkway and the operator is performing inspections to ensure the access walkway is being properly maintained.
