Fatality #3 - March 27, 2013

**Explosives and Breaking Agents – Missouri – Crushed, Broken Limestone NEC
Fred Weber Inc – North Stone**

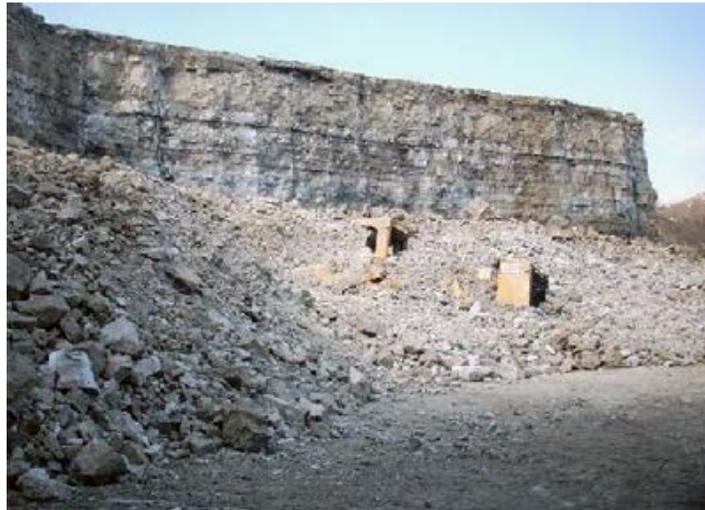
METAL/NONMETAL MINE FATALITY - On March 27, 2013, a 61-year old loader operator with 24 years of experience was killed at a crushed stone operation. The victim was in a front-end loader about 50 feet from the base of a highwall when a blast was initiated. Broken rock struck the front-end loader and covered it. The rock was removed from the front-end loader and the victim was recovered about 10 hours after the blast occurred.

- Do not initiate a blast until it has been determined that all persons have been evacuated from the blast area.
- Establish and discuss safe work procedures. Identify and control all hazards associated with the work to be performed along with the methods to properly protect persons.

- Task train all persons to recognize all potential hazardous conditions, to ensure all persons have left the blast area, and to understand safe job procedures for elimination of the hazards before beginning work.

- Maintain and use all available methods of communication, such as sirens and radios, to warn persons of an impending blast. Establish methods to ensure that all persons are out of the blast area.

- Before firing a blast give ample warning to allow all persons to be evacuated.
- Guard or barricade all access routes to the blast area to prevent the passage of persons or vehicles.

- Verify that the blasting procedures are effective and being followed at all times.
