**UNITED STATES DEPARTMENT OF LABOR
Mine Safety and Health Administration**

**Report on Issues Related To High Temperature Disposable
Diesel Particulate Filters Including Laboratory Results on
Kindling Temperatures**

October 2004

**Approval and Certification Center
Mechanical and Engineering Safety Division**

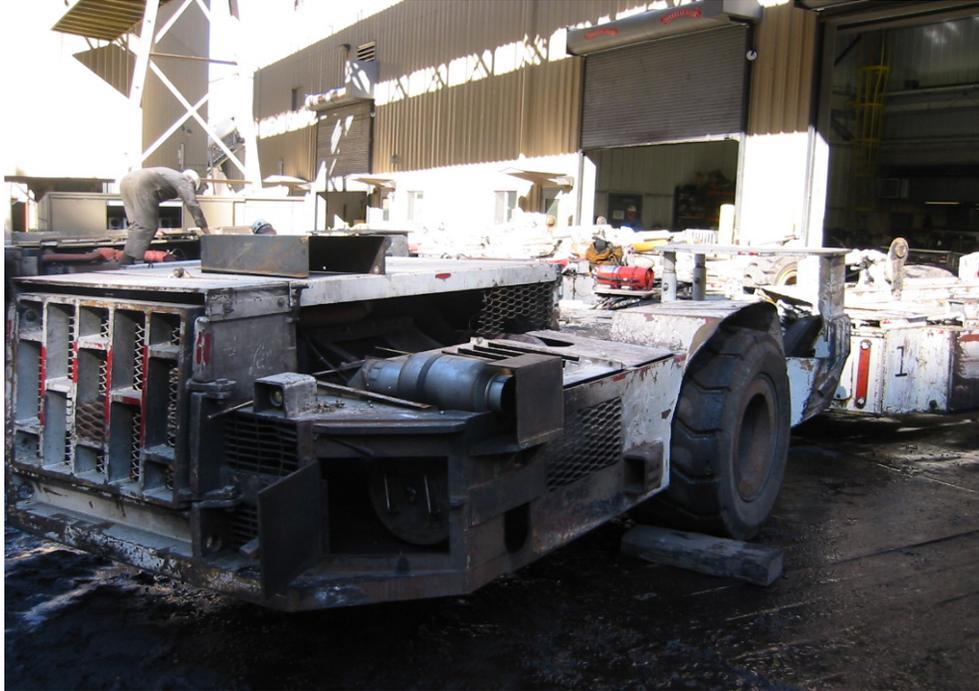
FIGURE ONE: No. 1 WAGNER 20X SHIELD HAULER EQUIPPED WITH SPARK ARRESTOR ASSEMBLY

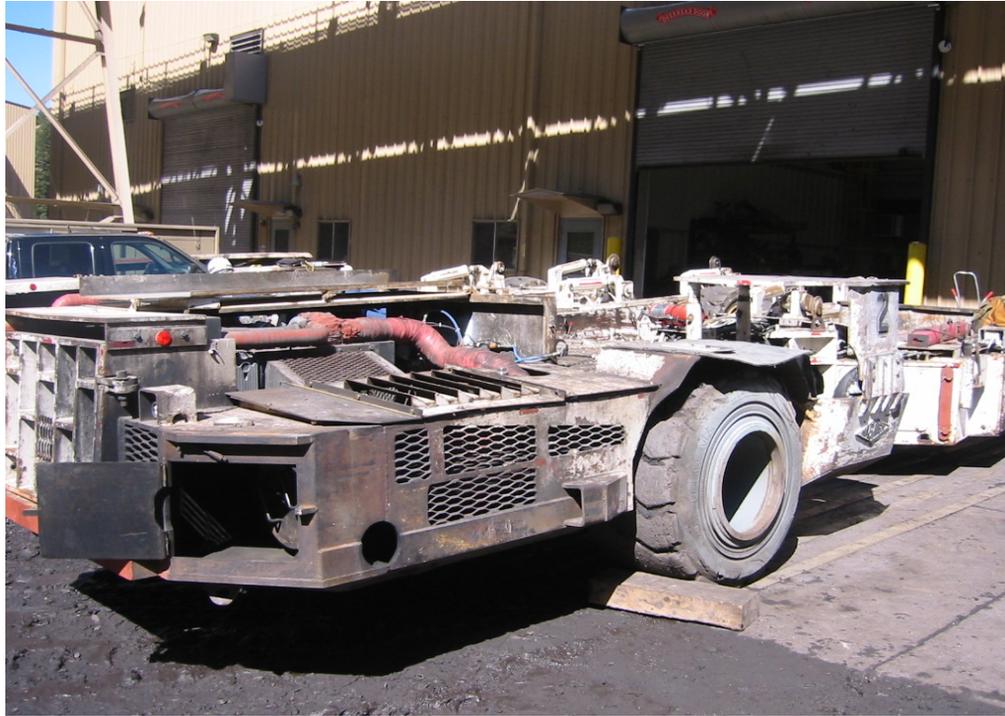
FIGURE THREE: No. 2 WAGNER 20X SHIELD HAULER EQUIPPED WITH WATER INJECTION SYSTEM

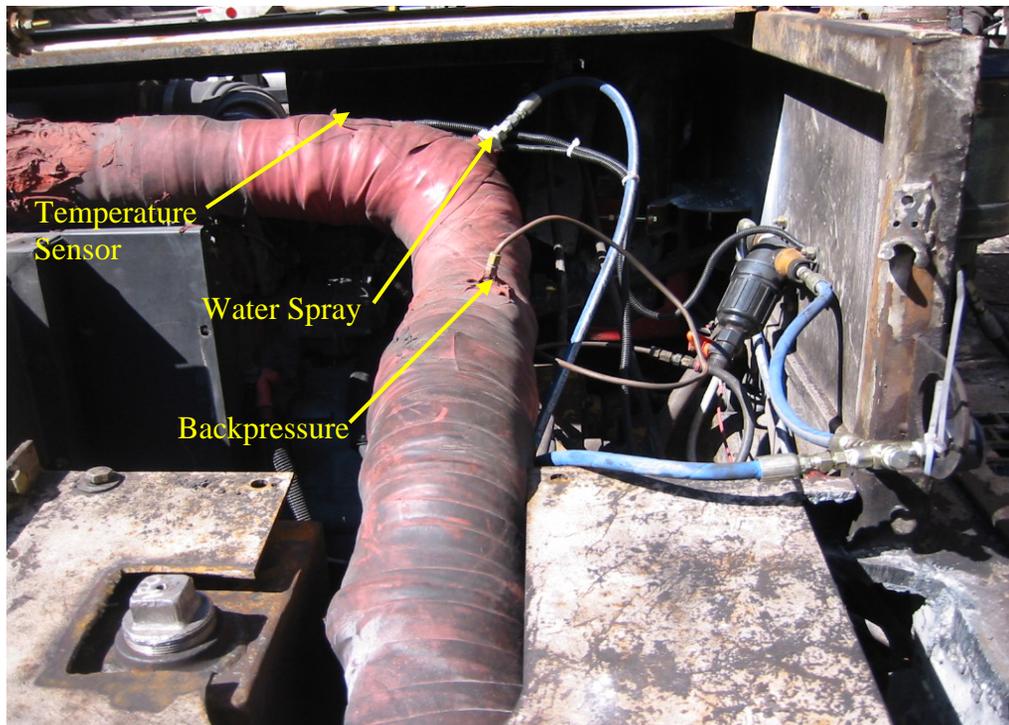
FIGURE FOUR: WATER INJECTION SYSTEM

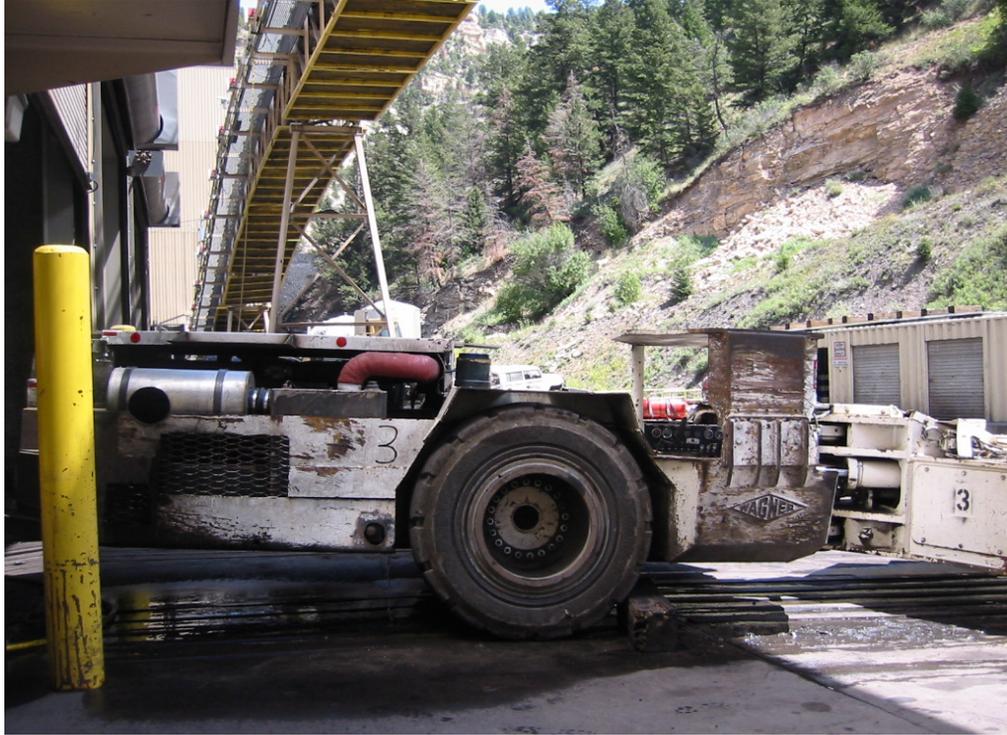
FIGURE FIVE: No. 3 WAGNER 20X SHIELD HAULER EQUIPPED WITH WATER SCURBBER SYSTEM

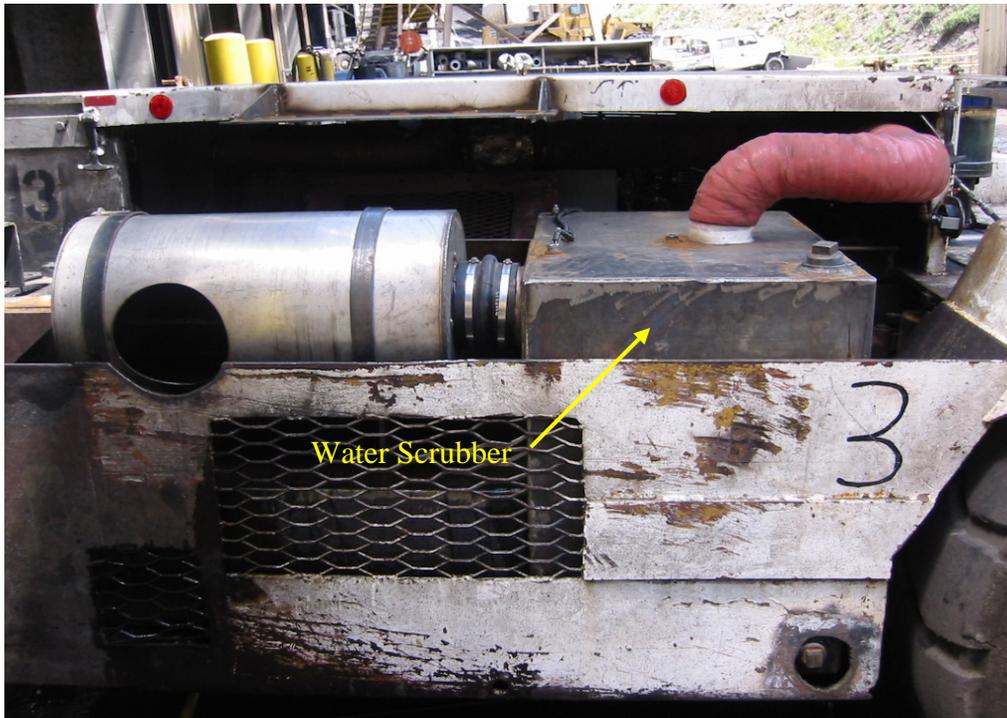
FIGURE SIX: WATER SCRUBBER SYSTEM

The scrubber system displayed the most cooling ability in the limited tests performed at the mine. In terms of fire hazards of high temperature filters being exposed to high exhaust gas temperatures, the scrubber system would be the most affective option of the three systems evaluated. After receiving and reviewing the temperature logging data, the scrubber system seemed to cool the exhaust gases most effectively.

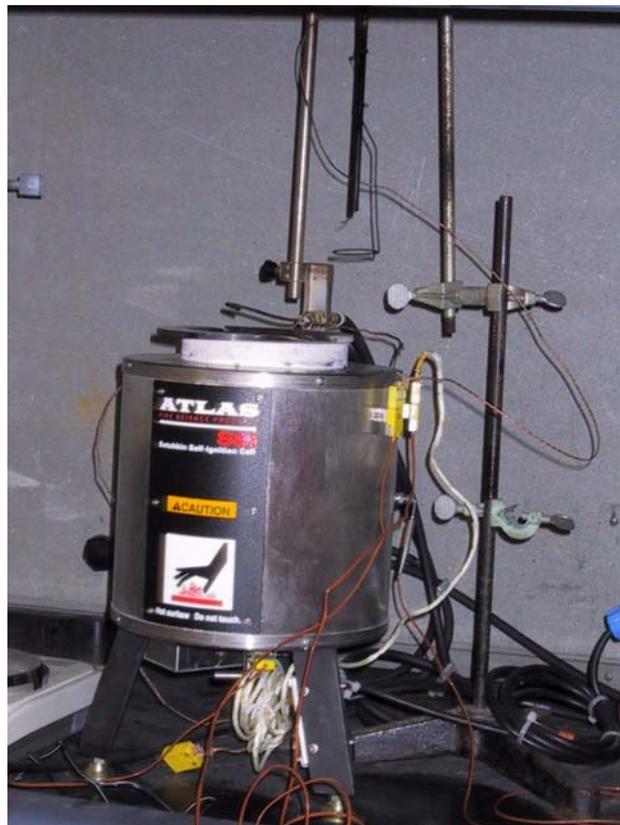
Figure 1. Setchkin furnace
The furnace is 9.5 inches high. During a test, the sample hangs in the center of a 4-inch wide, vertical tube. Hot air flows upward past the sample.

SIT determinations are made without a pilot light. The sample is placed in the furnace for 10 minutes during which time it was exposed to heated air. The heated air has a velocity of 5 ft. /min. as per ASTM D 1929-96, Standard Test Method for Determining Ignition Temperature of Plastics (Procedure 8.2). In the first nine tests (*i.e.* Tests of Burned-over Donaldson Filter Media with Supplementary DPM), we placed the samples in pans. In subsequent tests, we placed the filters directly in the hot air flow with the folds running vertically.

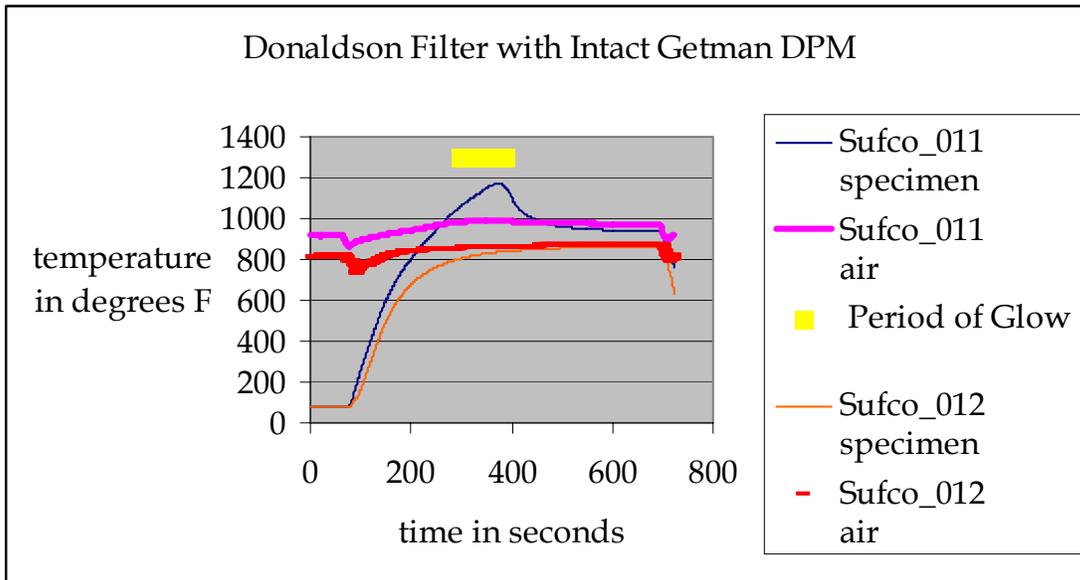
Graph 2. The Sufco_011 sample began to glow at an air temperature of 982°F. The sample temperature had started to rise prior to ignition.

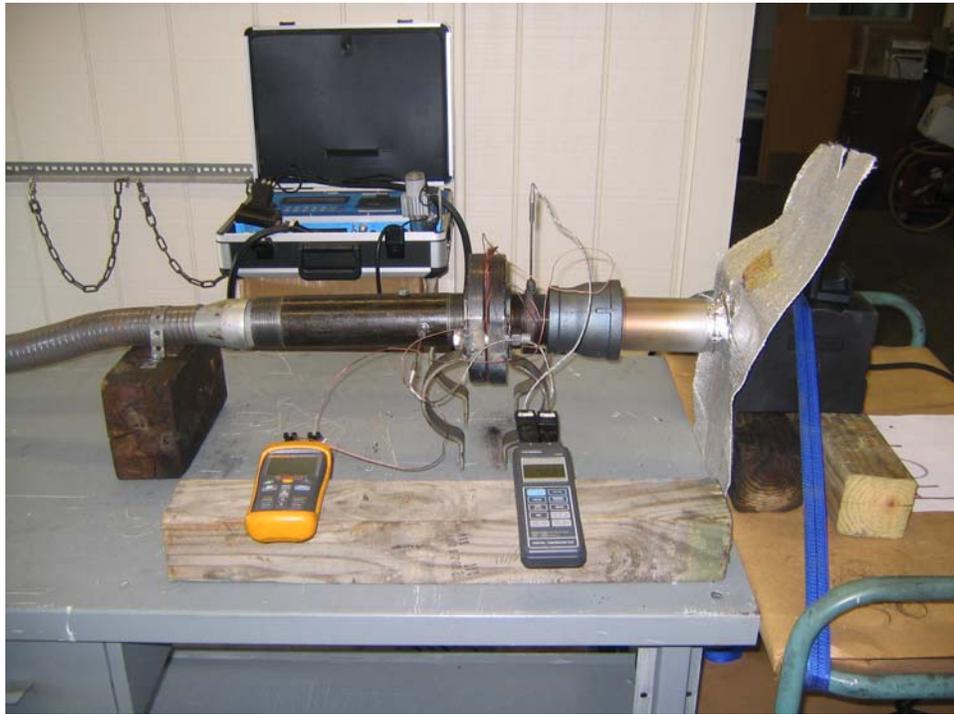
Figure 1: Original Heat Gun Test Setup.

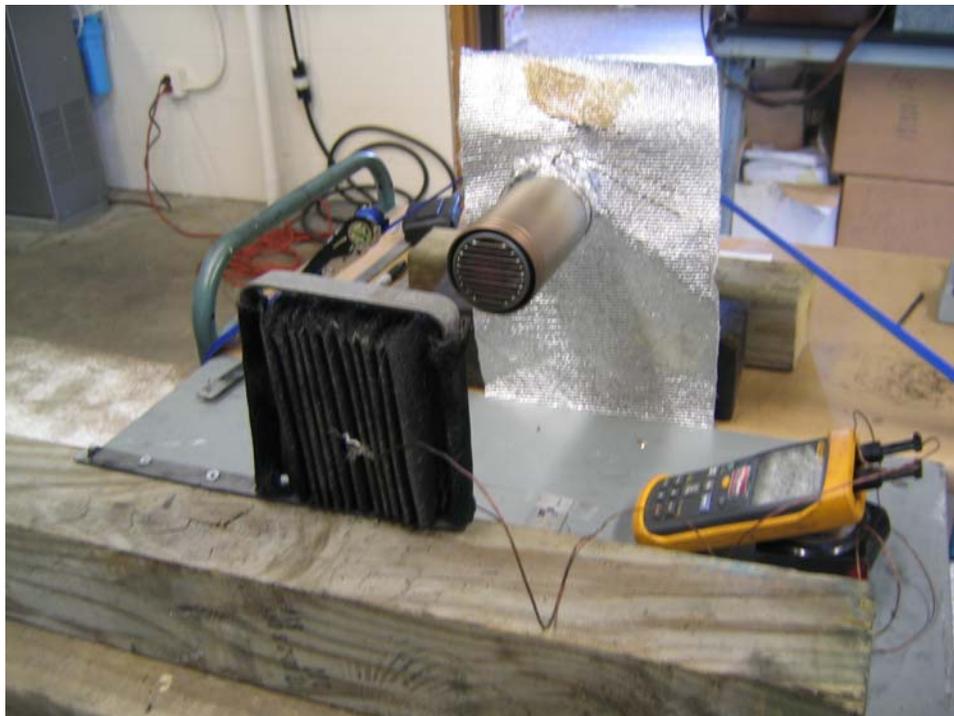
Figure 2: Modified Heat Gun Test Setup.

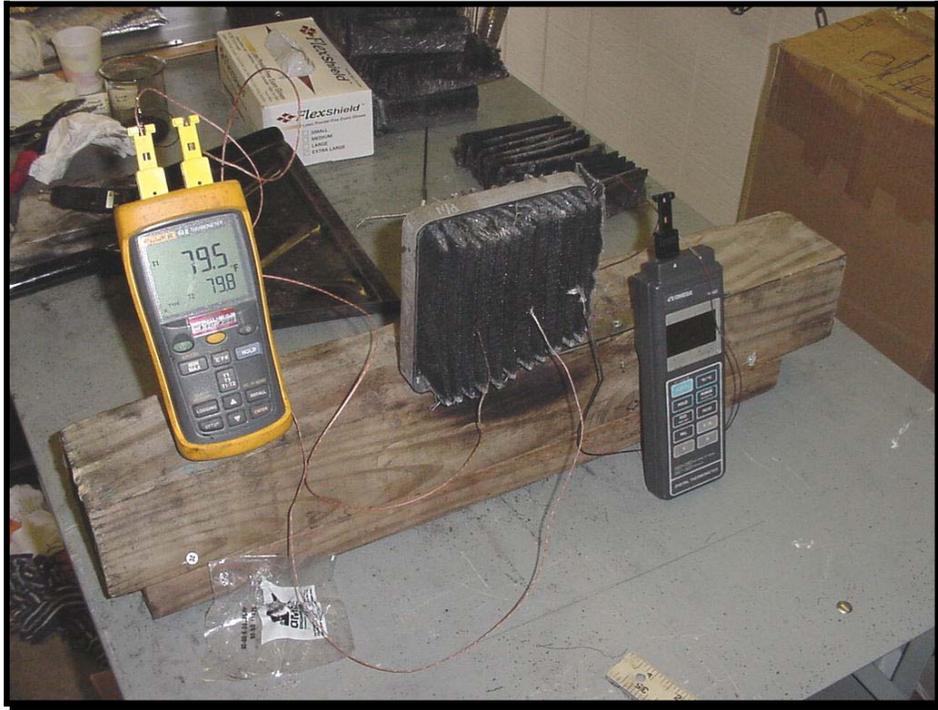
Figure 1: Filter Sample placed on rack for testing, with thermocouples applied.

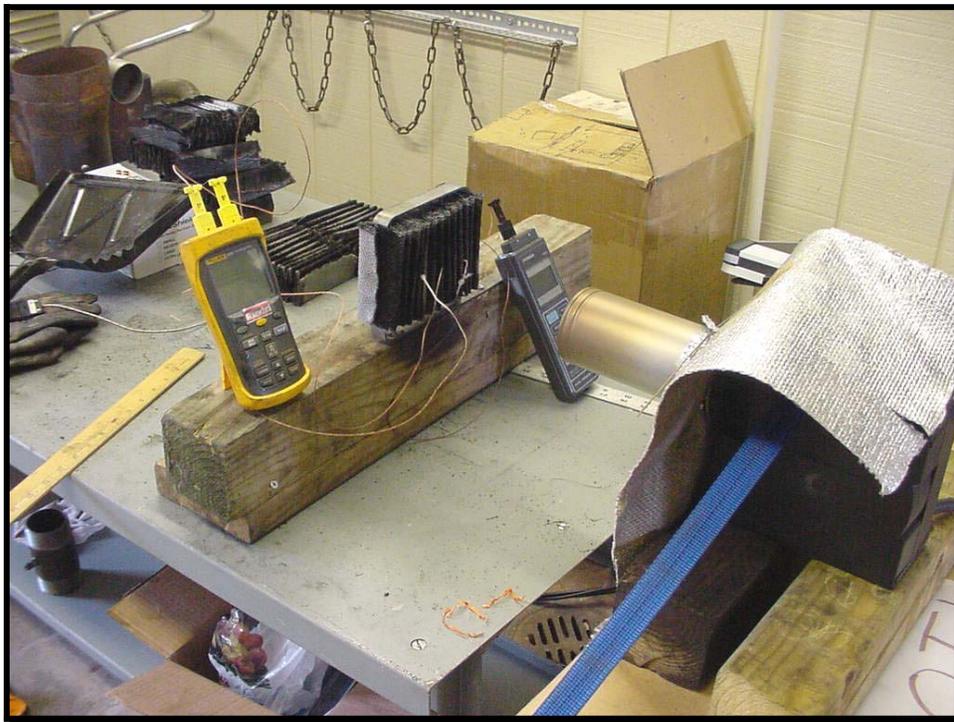
Figure 2: Sample ready for testing showing heat gun in position.

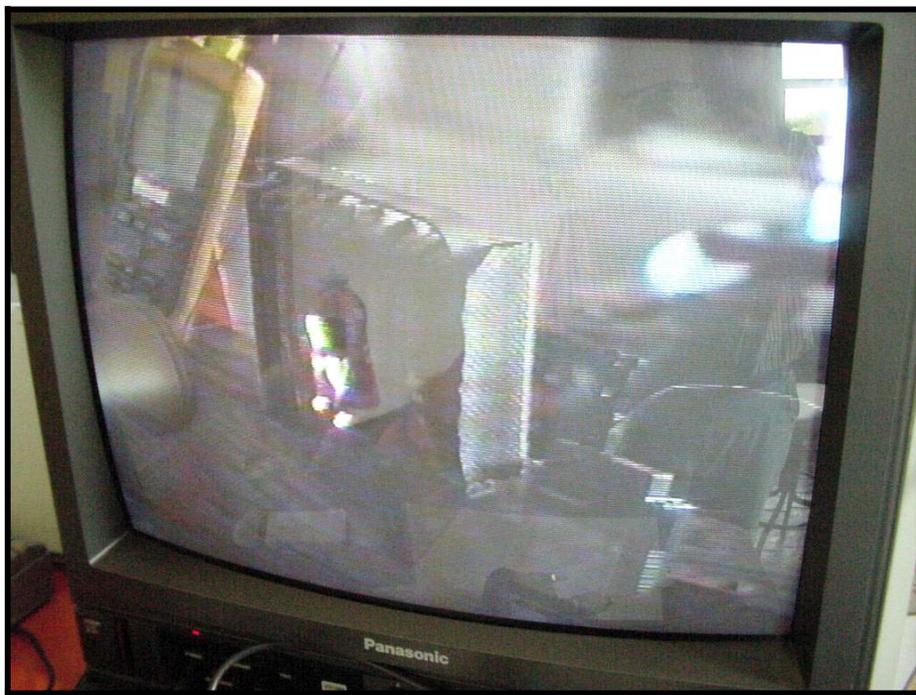
Figure 4: Image of Continuous DPM burning from Test 2 (from video).

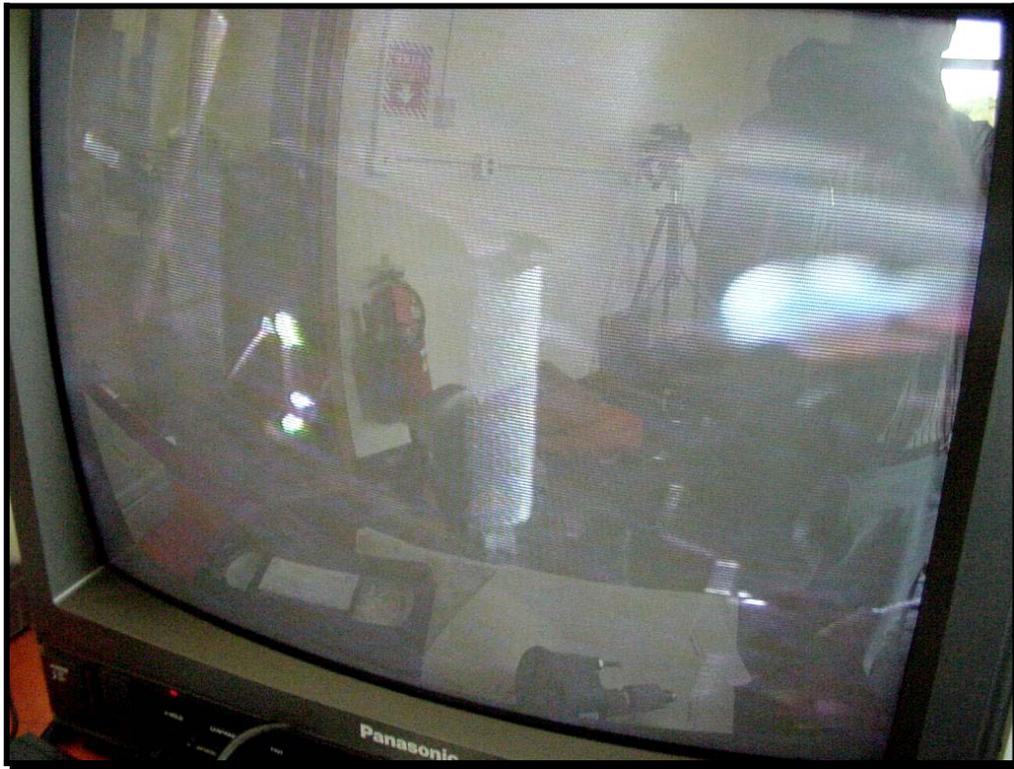
Figure 5: Image of Continuous DPM burning from Test 3 (from video).

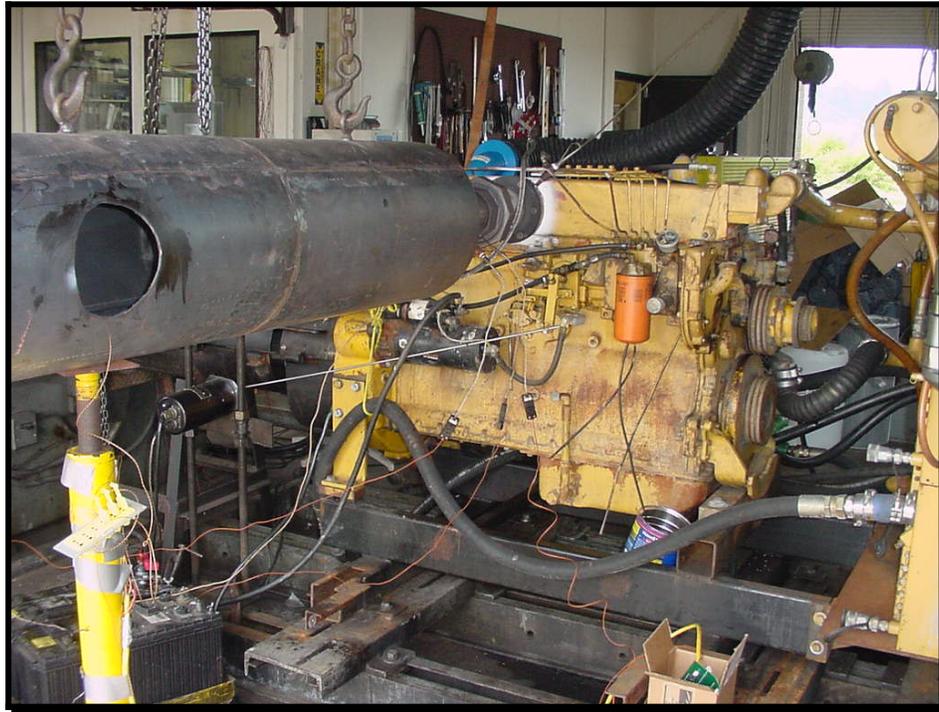
Figure 1. Filter ignition test setup.

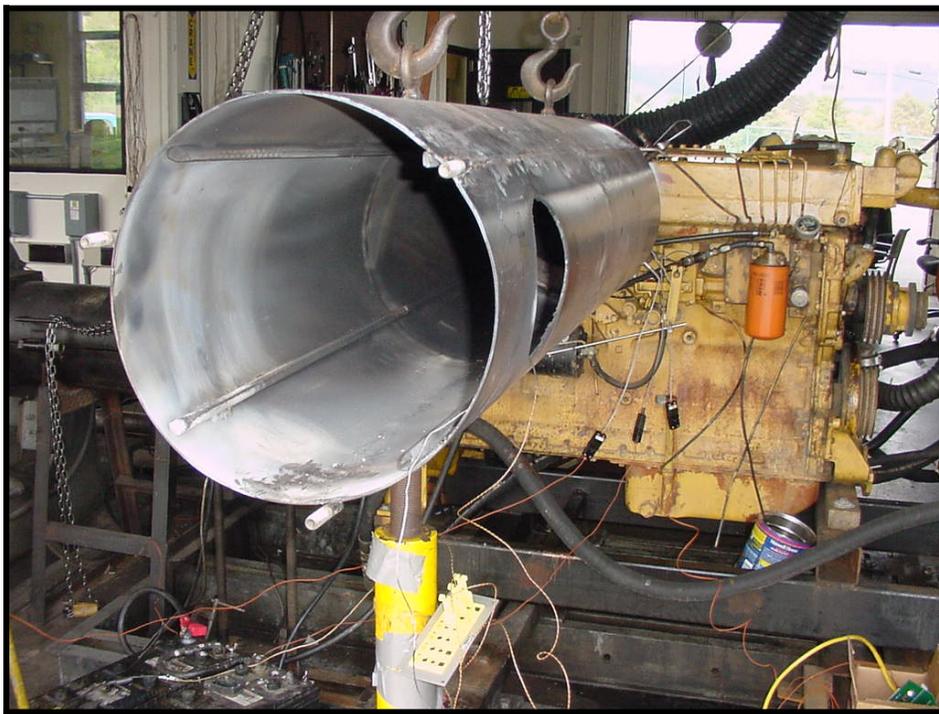
Figure 2. Filter Ignition Test Setup showing inside of filter canister.

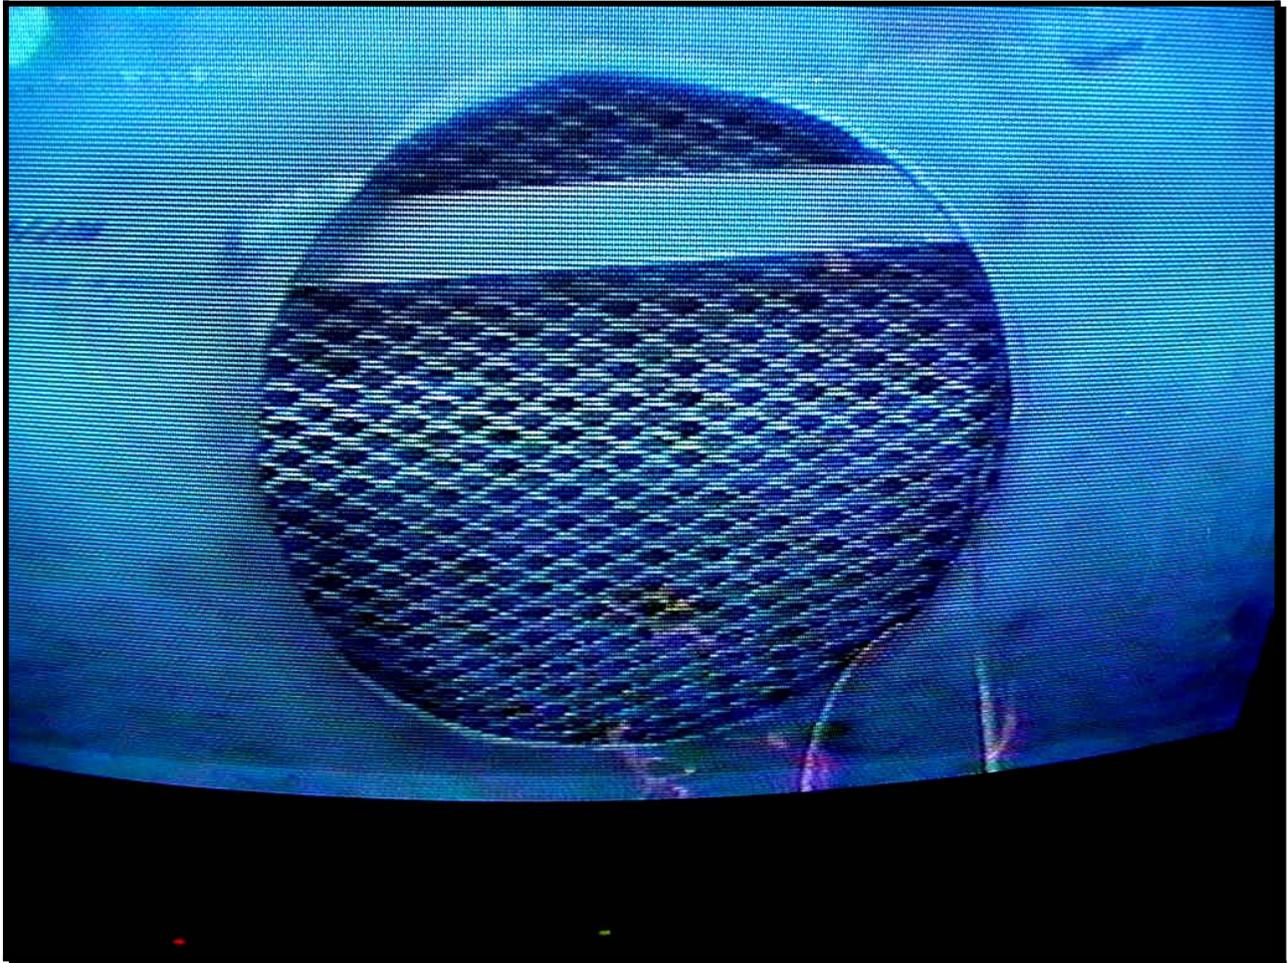
Figure 5. Example of filters emitting Sparks.

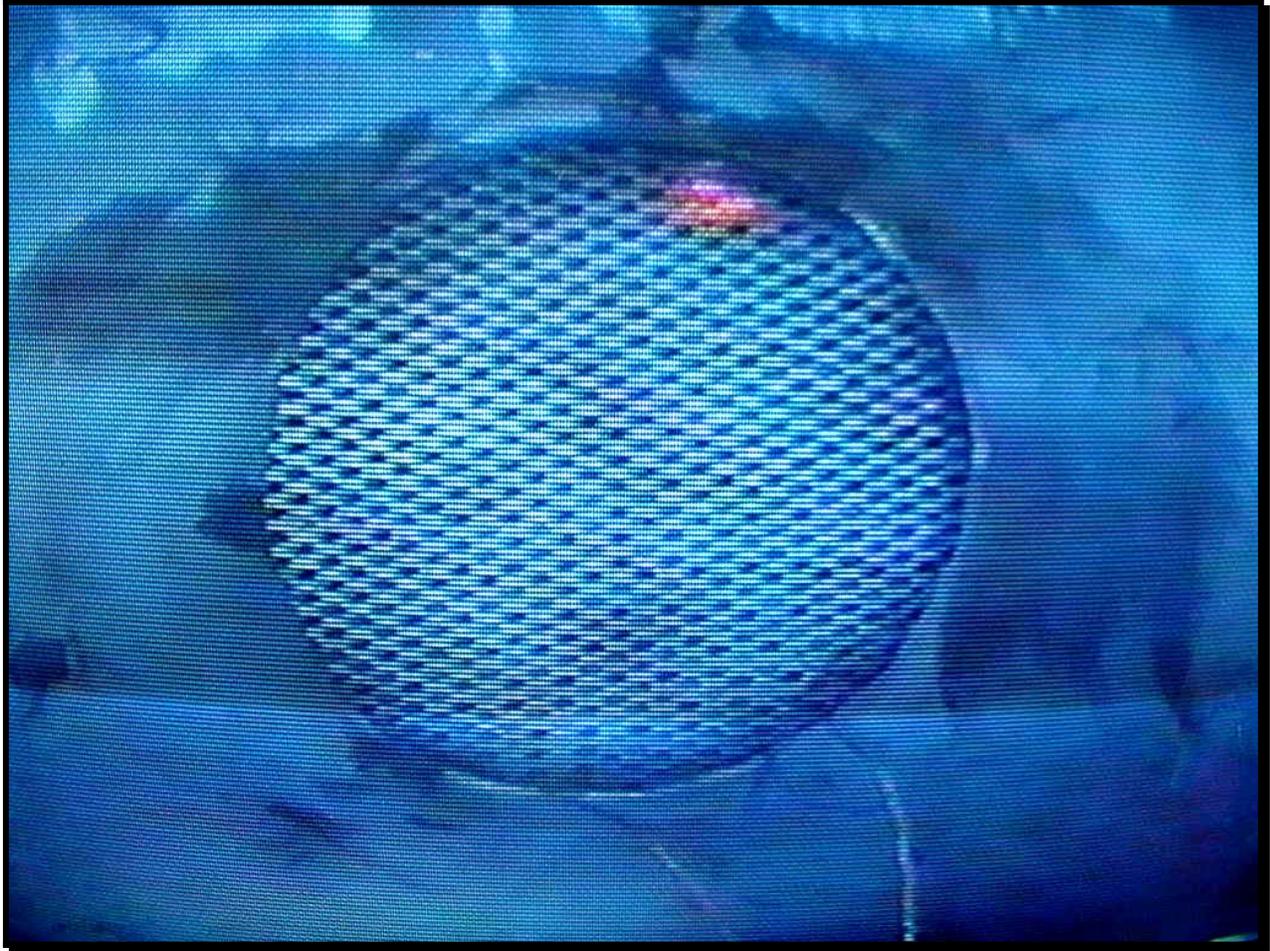
Figure 6. Example of filter Glowing.

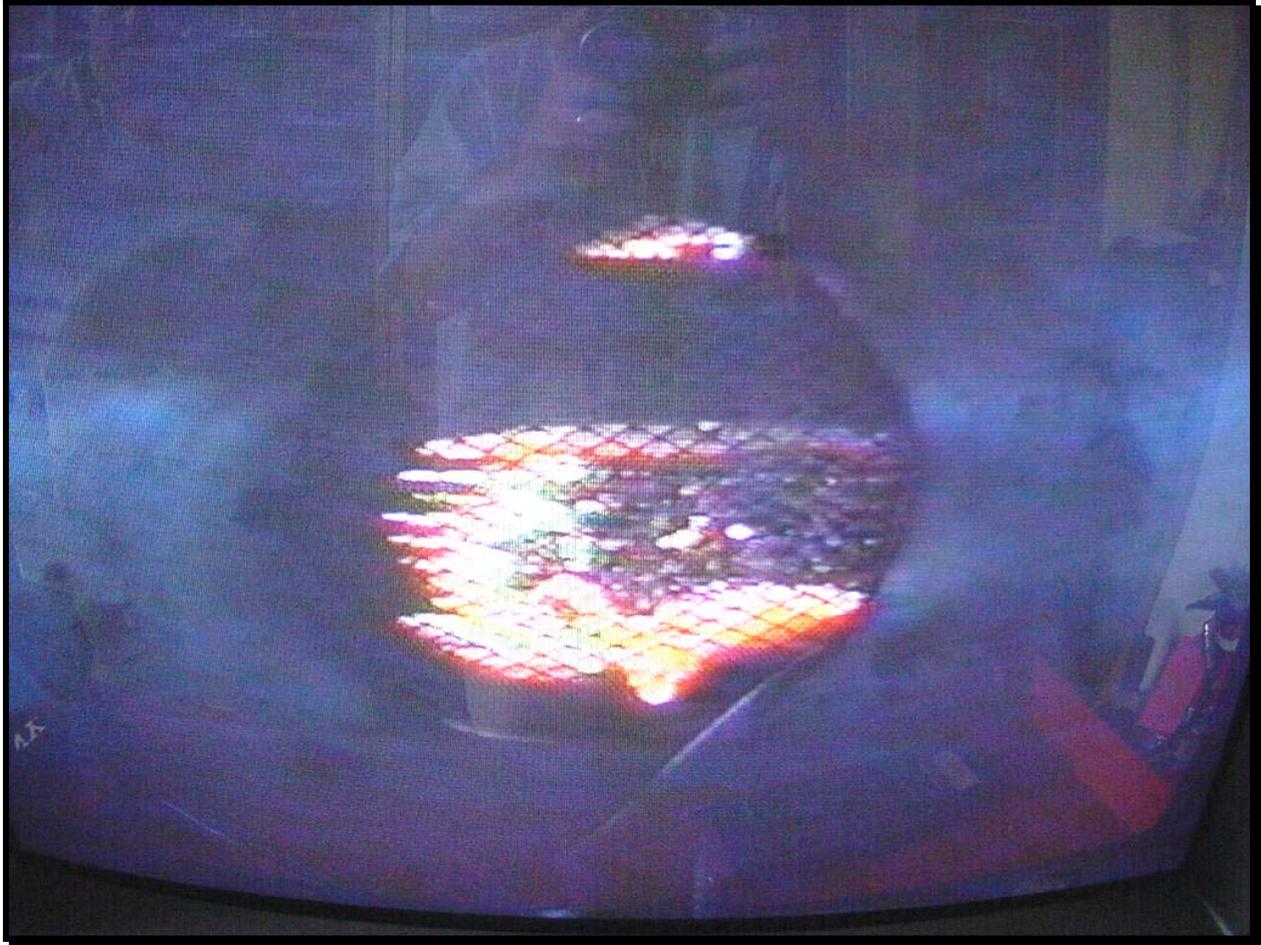
Figure 7. Example of filter Burning.

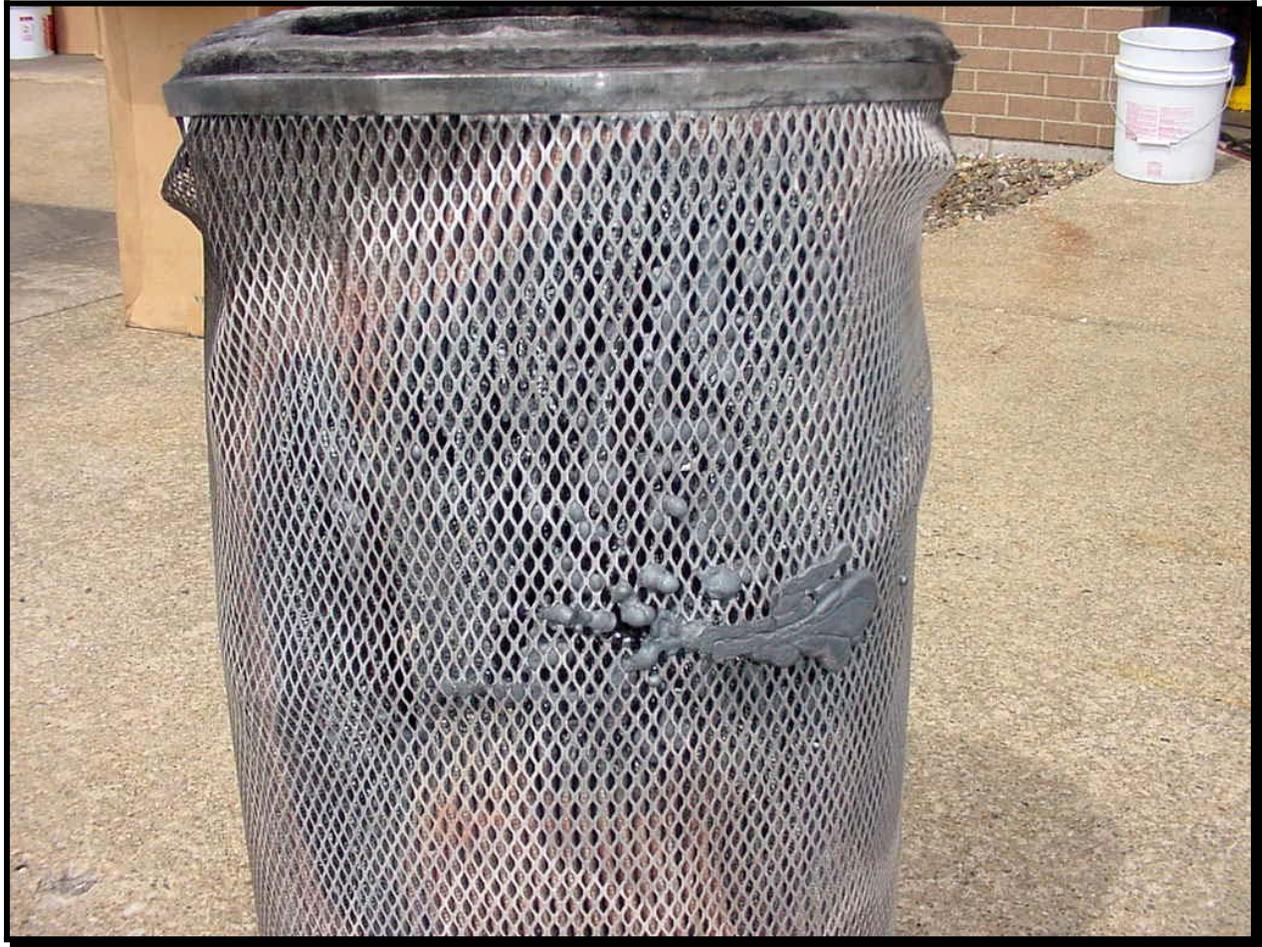
Figure 8. Typical result of a filter ignition. Globules adhering to filter are melted glass media and steel screen.

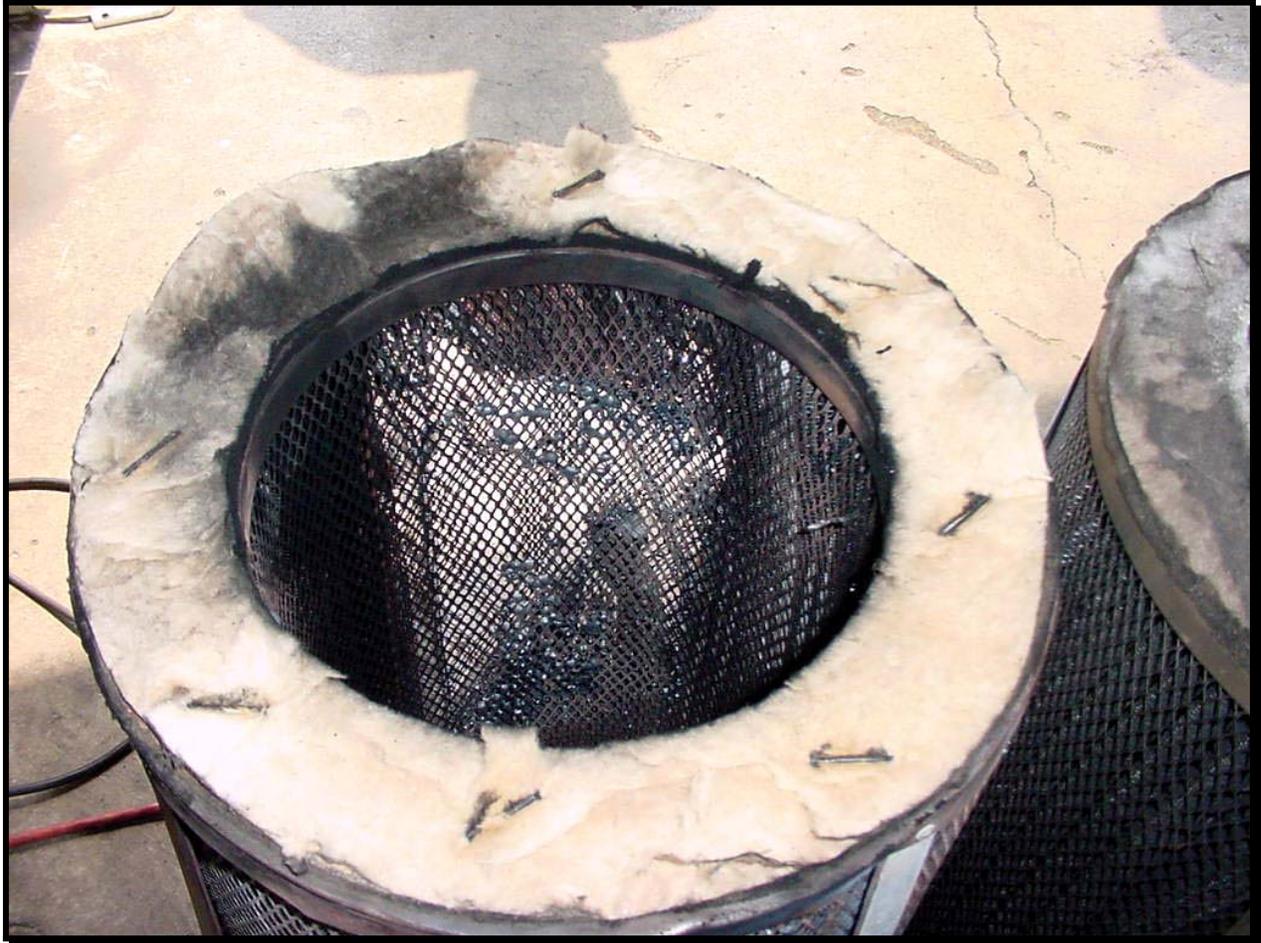
Figure 9. An inside view of a burned-through filter after an ignition.

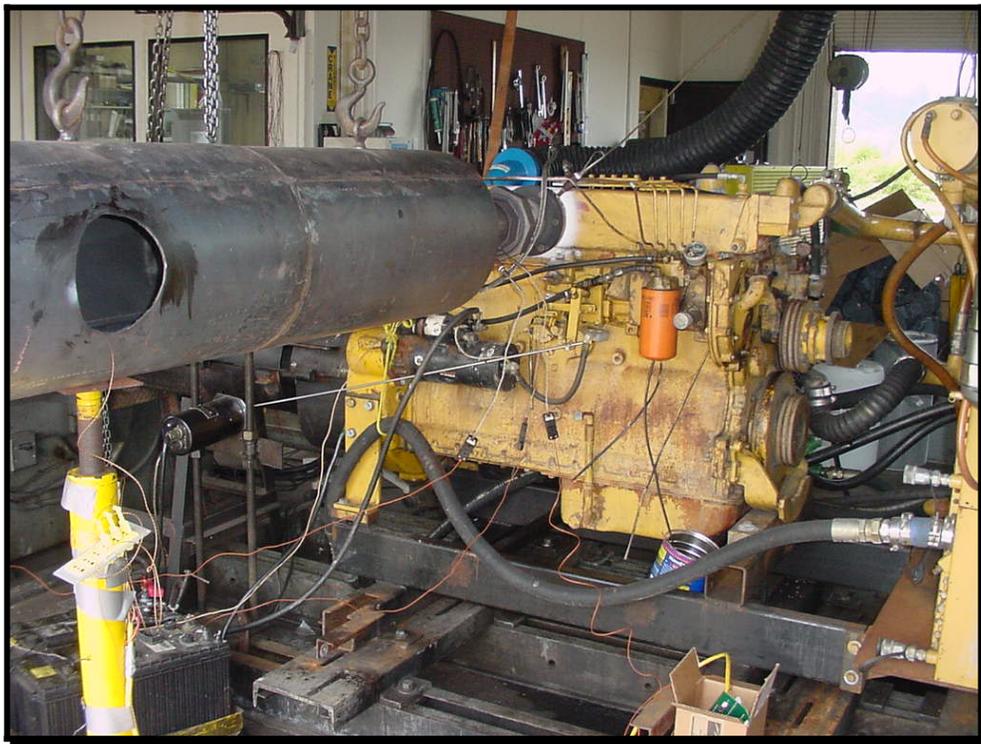
The filter canister used in the tests is a dual element, inline filter canister. This installation is typical of that used in mines for larger 6 cylinder power plants. The canister has a 4 inch diameter input, which was connected to the exhaust of the CAT 3306 engine. The canister has a 6 5/8 inch diameter exit hole aligned with the second filter in the canister (Filter #2). The filters are loaded by removing an end cap on the canister which is held in place by 3 bolts (Figure B.3). The canister is capable of holding high temperature filters from Donaldson and FSATC with slight compression to the filters during tightening of the end cap. The canister is constructed of steel and was built by Gary Poteet at Oxbow mine.

Figure B. 1. Test Setup

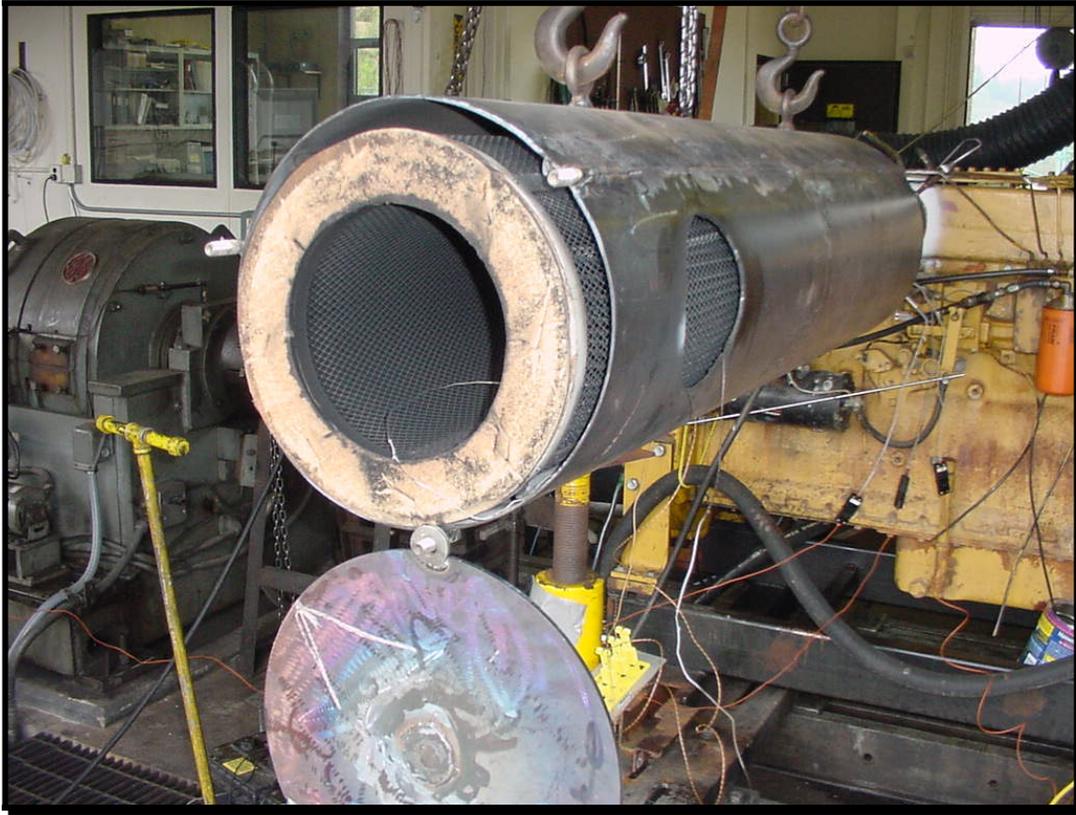
Figure B. 3. Installation of a set of test filters.

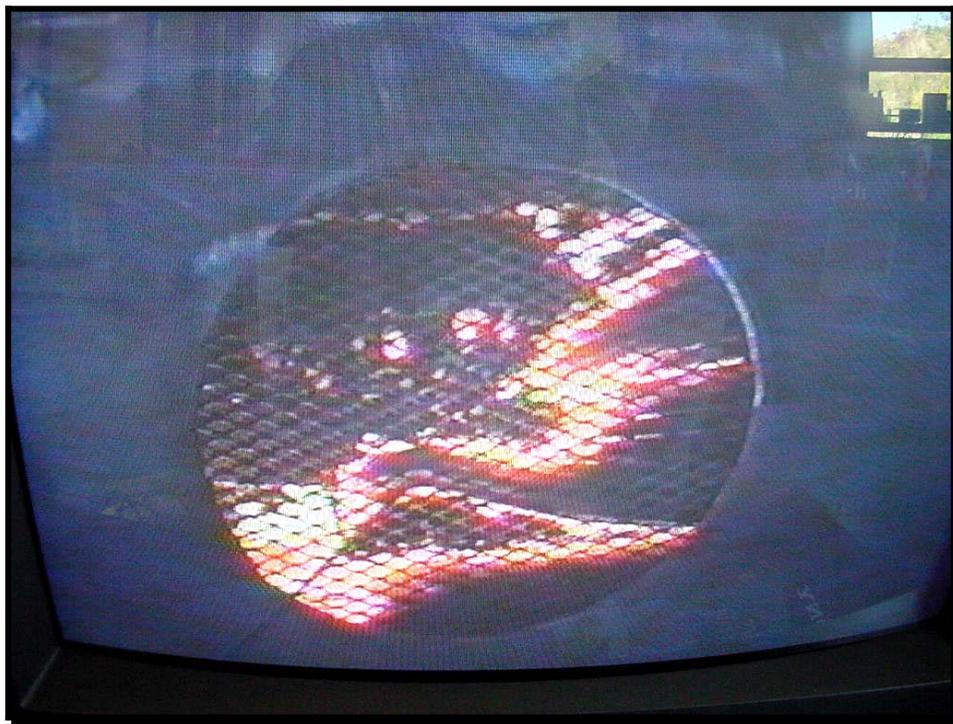
Figure B. 5. Test #5, Video view of filter burning.

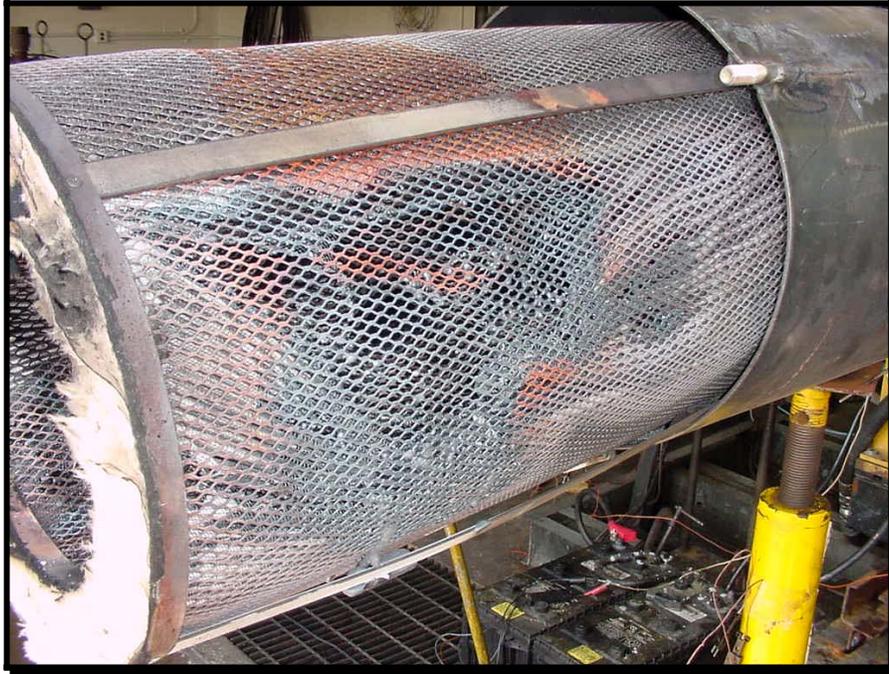
Figure B. 6. Test #5; Burn Damage to Filter #2 aligned with filter canister hole.

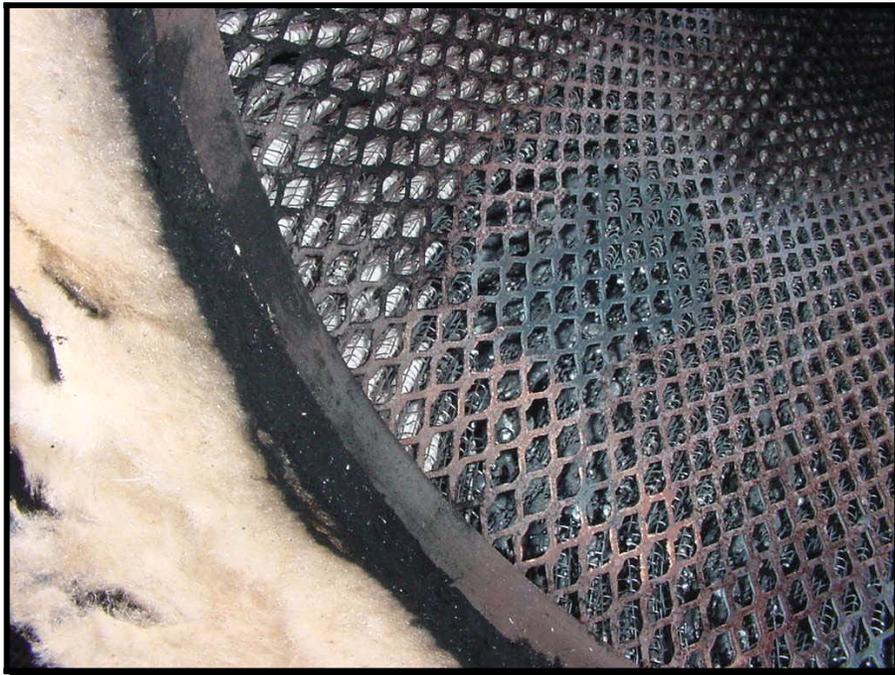
Figure B. 7. Test #5; Small burn through near end cap of Filter #2.

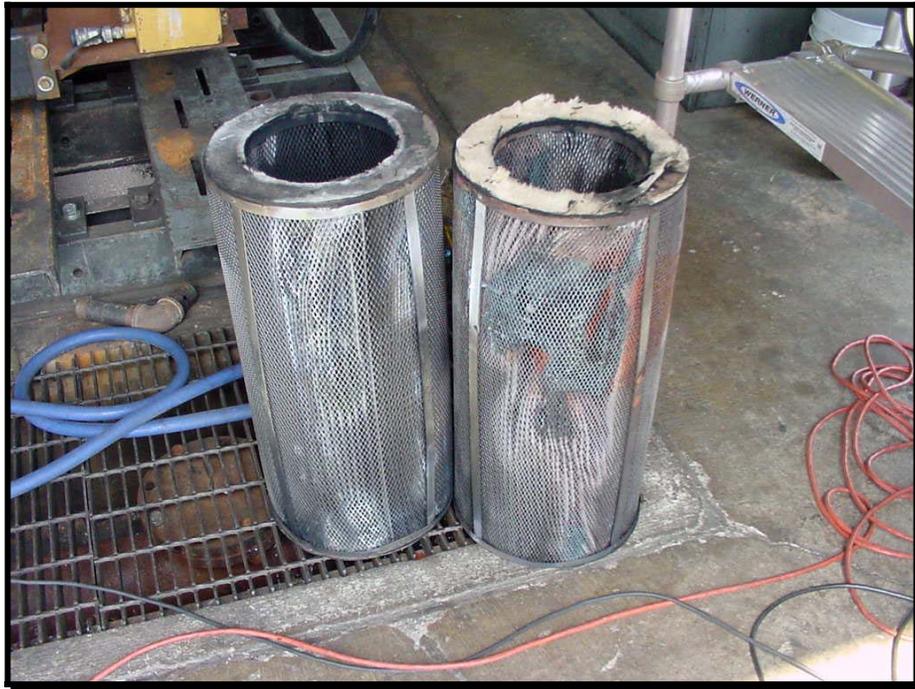
Figure B. 8. Test #5; Burn damage to both filters, Filter #1 on left.

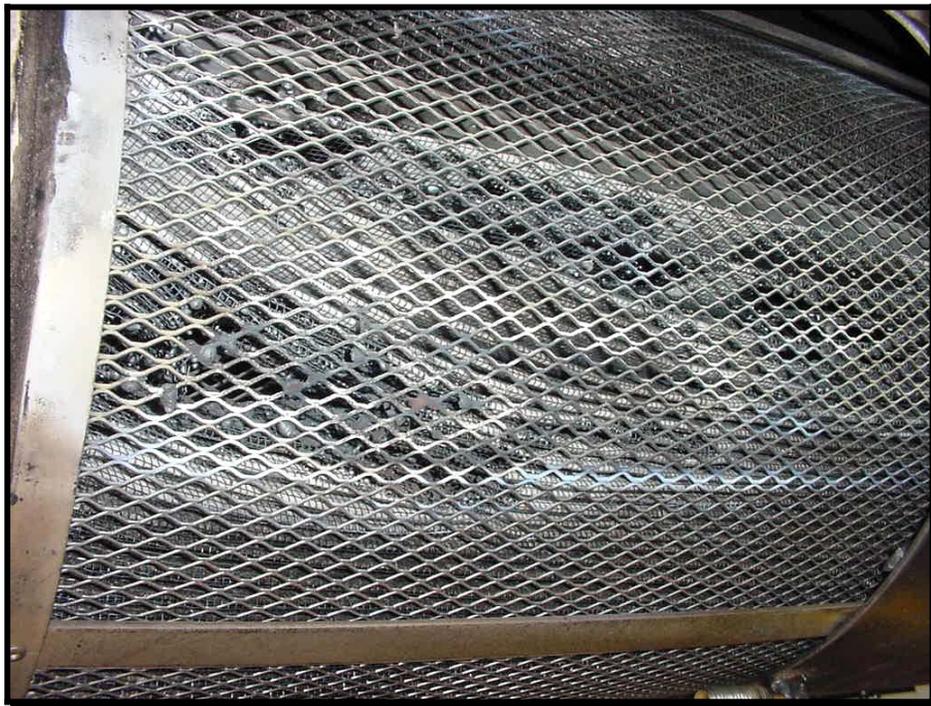
Figure B. 9. Test #5; Burn damage to Filter #1.

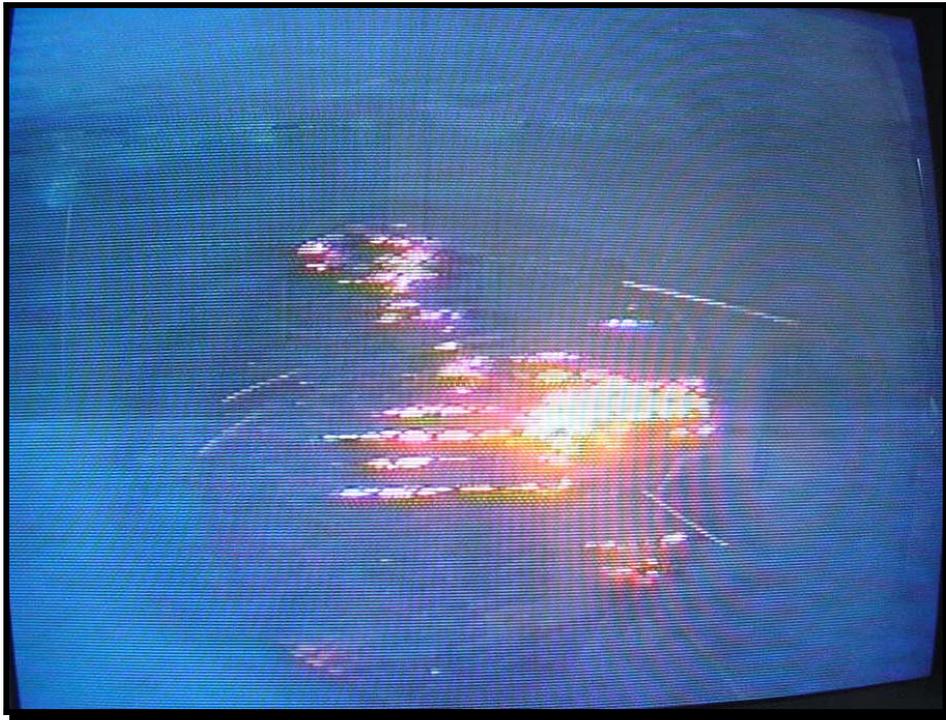
Figure B. 10. Test #7, Initiation of Fire in Filter #2, (haze is smoke from filter).
