**UNITED STATES DEPARTMENT OF LABOR
Mine Safety and Health Administration**

**Report on Issues Related To High Temperature Disposable
Diesel Particulate Filters Including Laboratory Results on
Kindling Temperatures**

October 2004

**Approval and Certification Center
Mechanical and Engineering Safety Division**

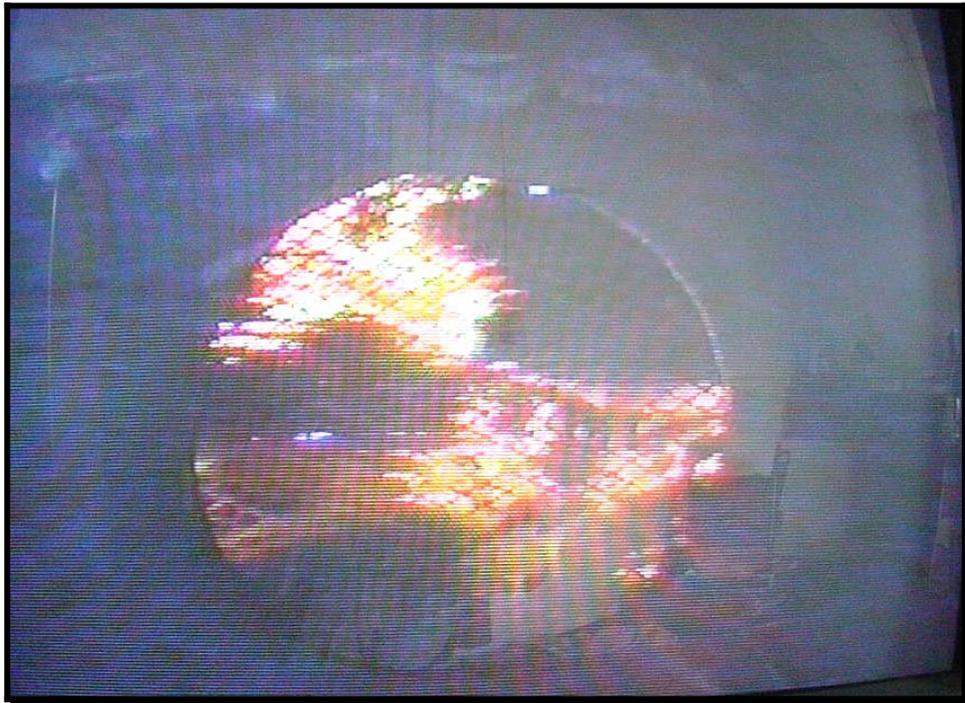
Figure B. 11. Test #7; Filter Burning.

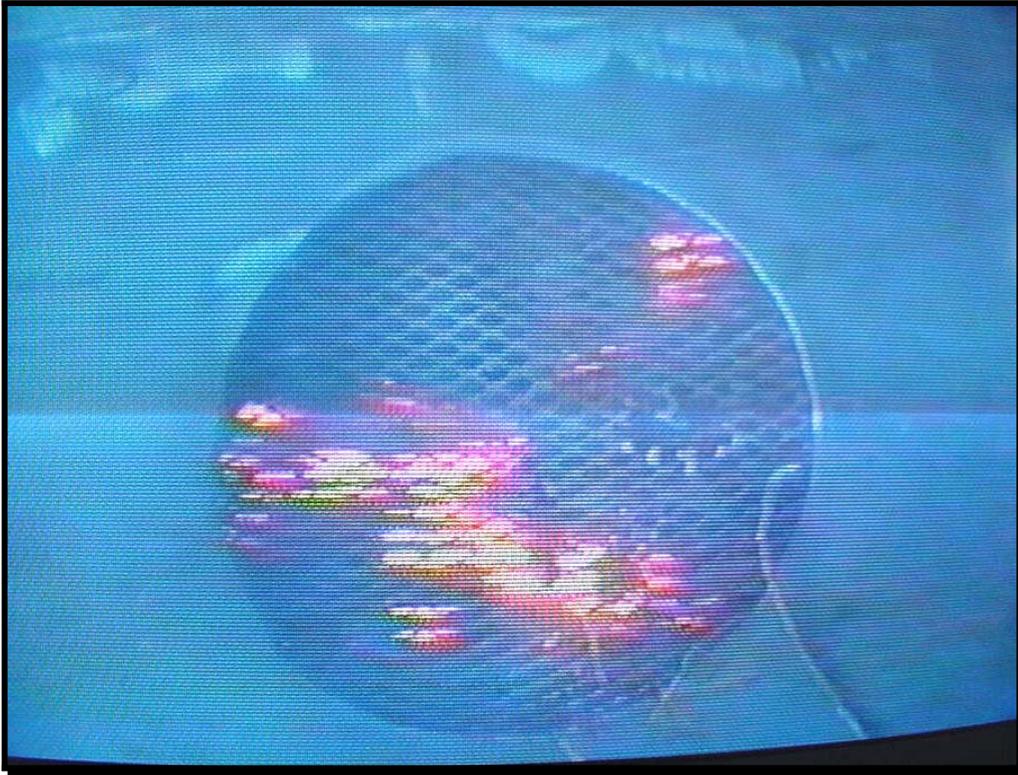
Figure B. 12. Test #7; Filter continuing to burn, hole in outer cage can be seen (3 o'clock position).

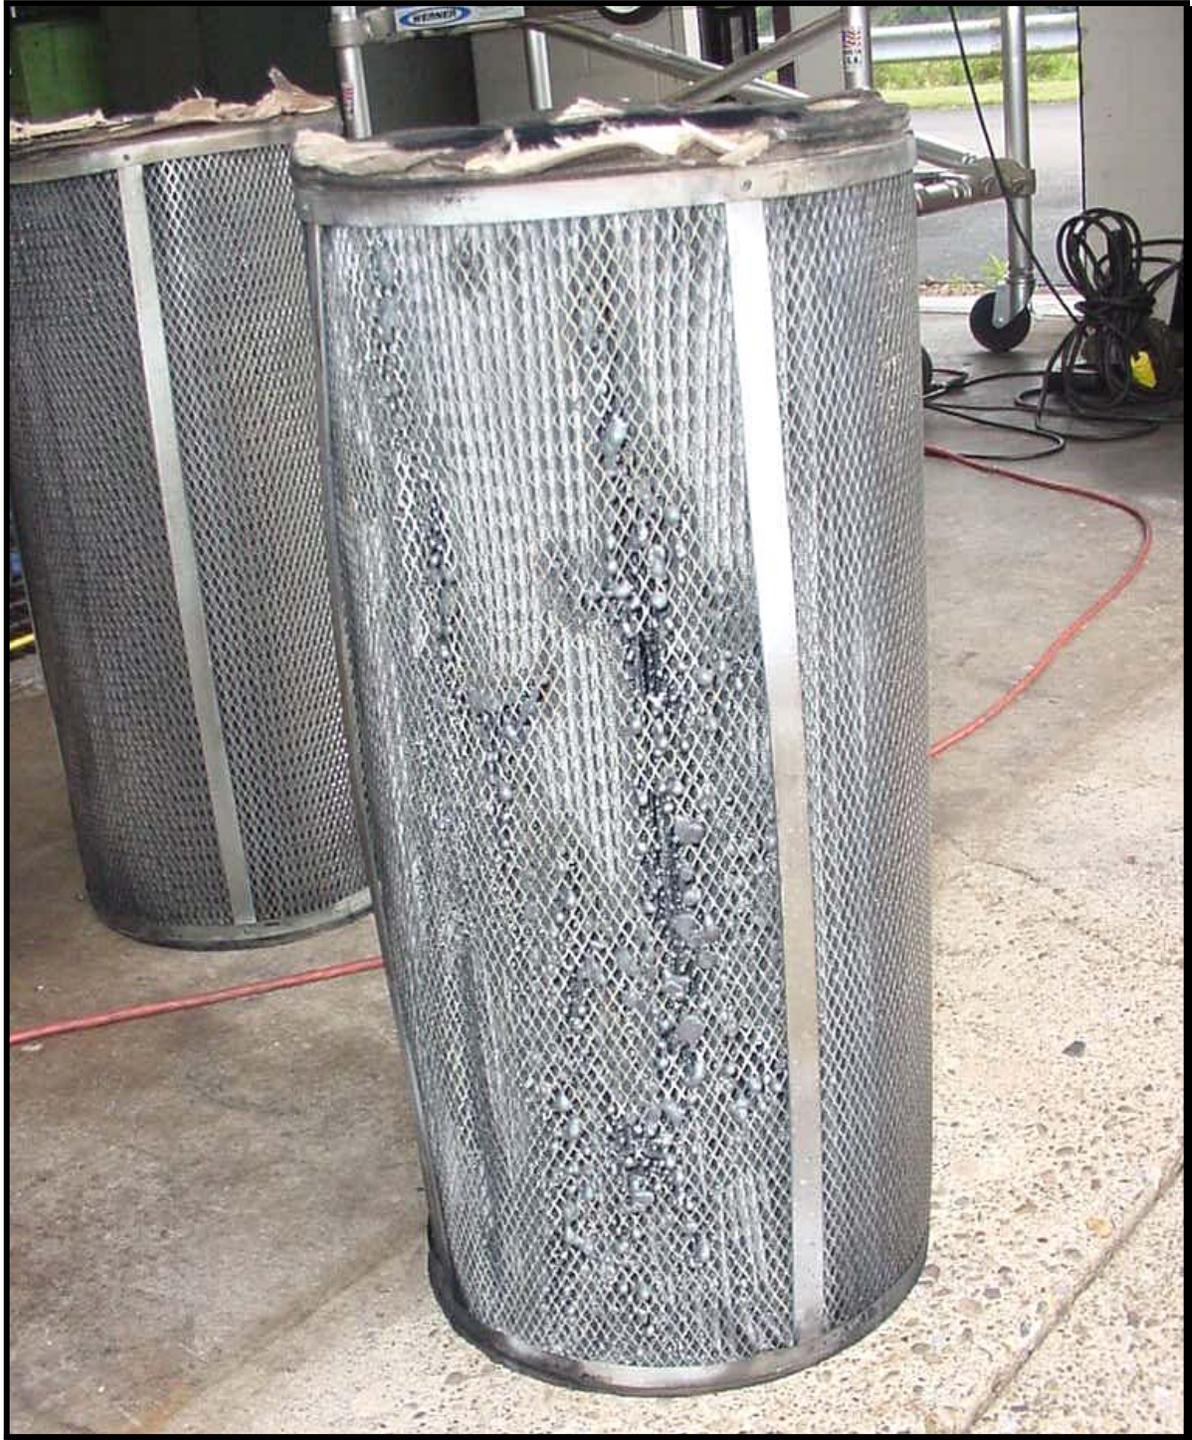
Figure B. 15. Test #10; damage to #2 filter with melted media and screen material.

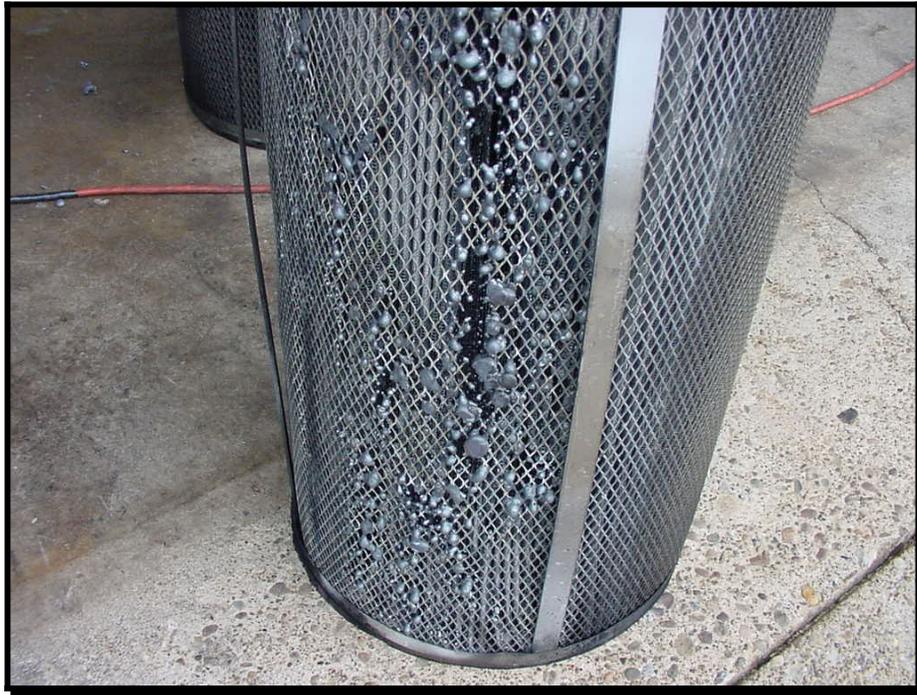
Figure B. 16. Test #10; close-up of damage to #2 filter.

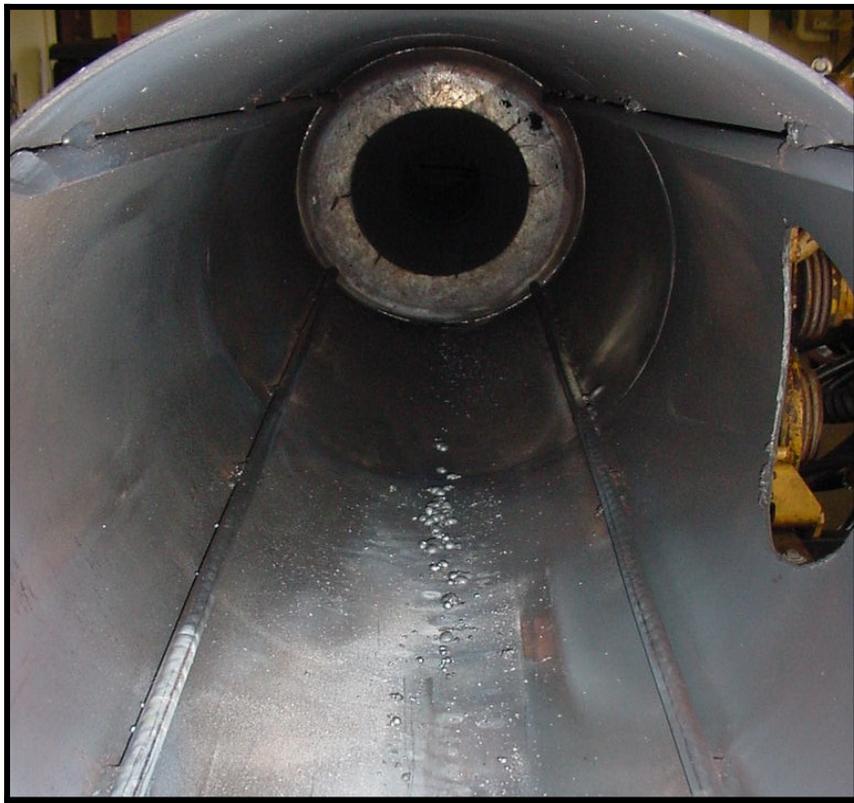
Figure B. 17. Test #10; Inside of filter canister showing burn marks and remains of burned filter.

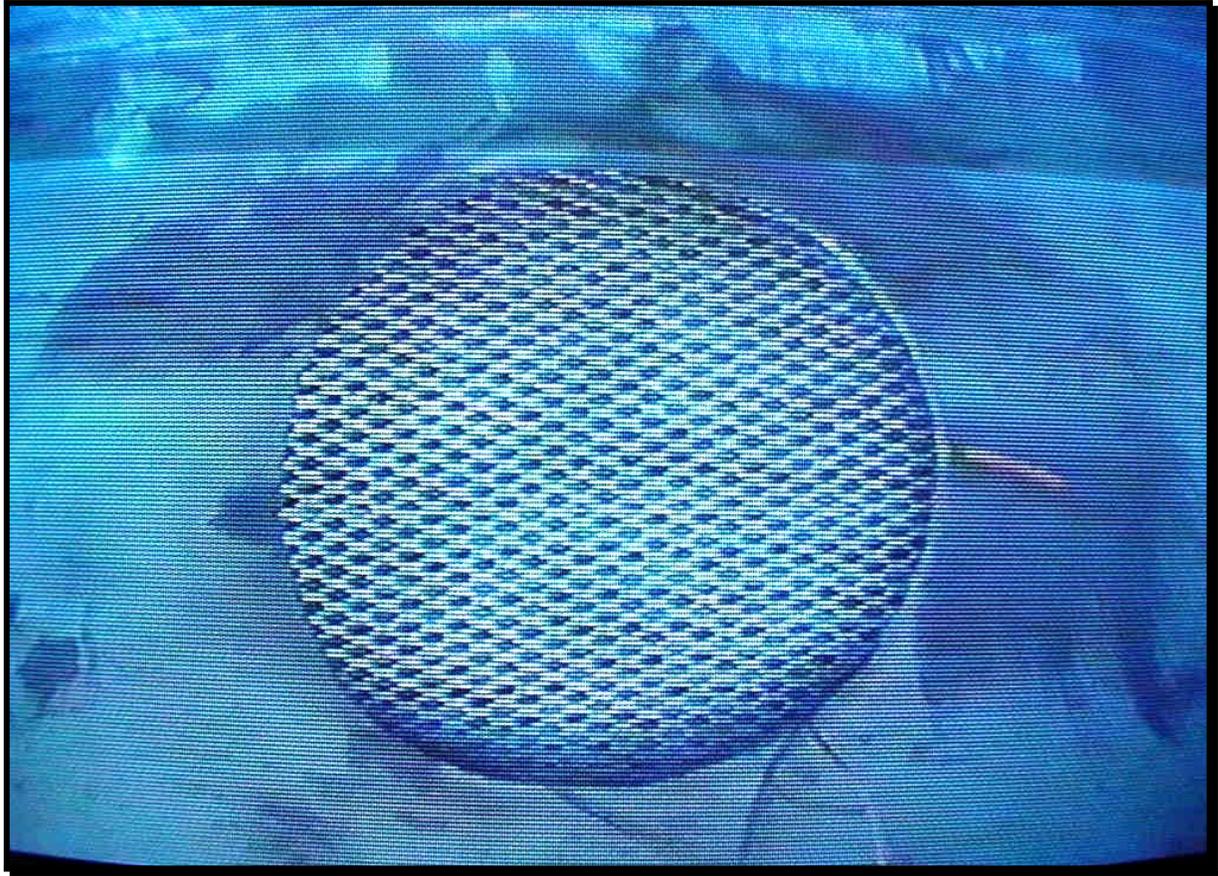
Figure B. 18. Test #14; example of spark exiting canister (right side of hole).

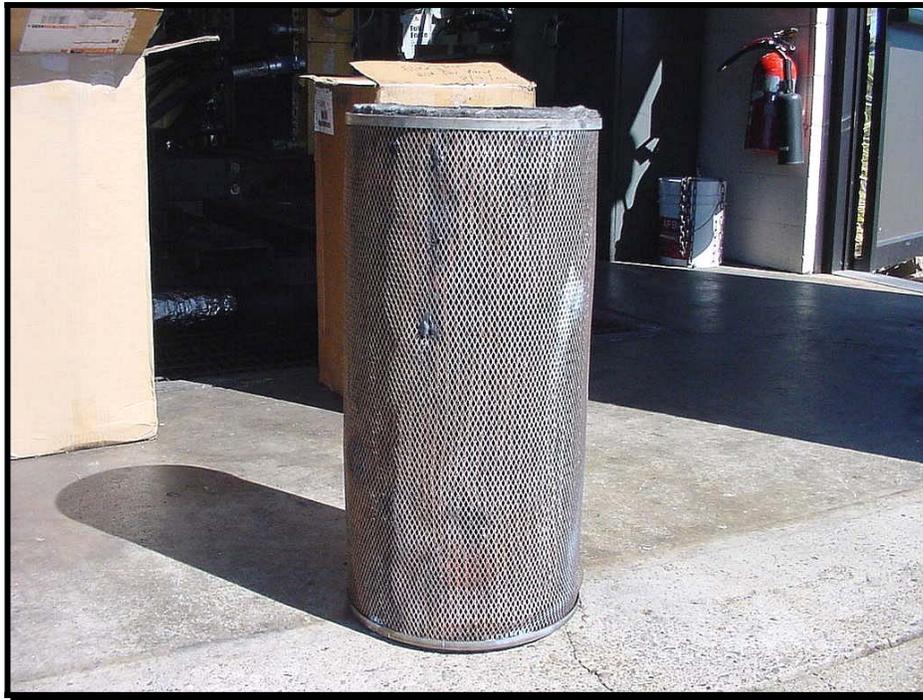
Figure B. 23. Test #16; Damage to filter #2 from ignition.

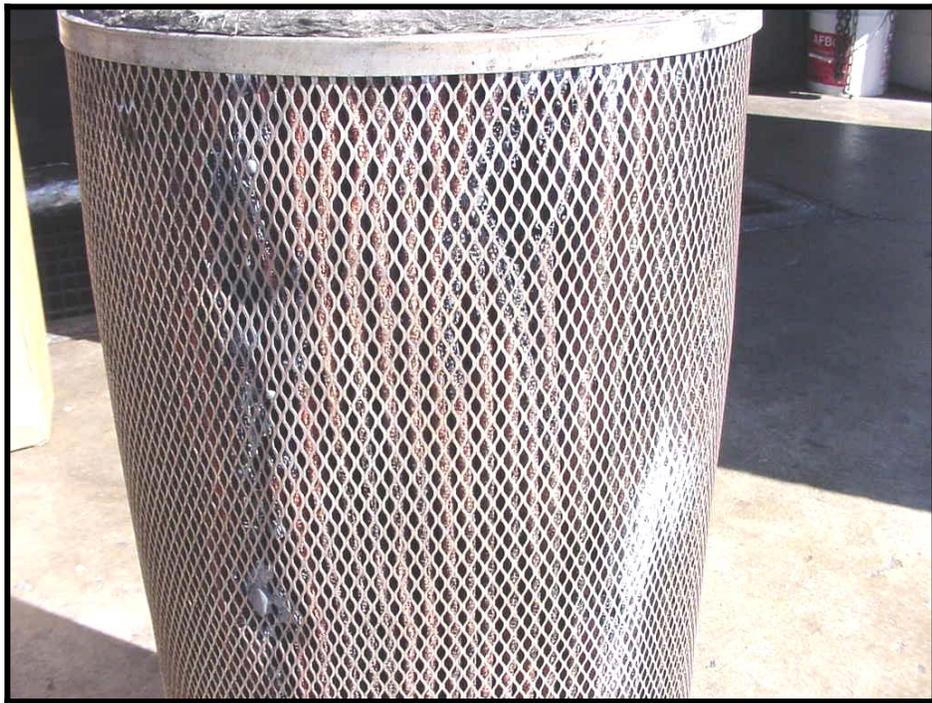
Figure B. 24. Test #16; Damage to #2 filter.

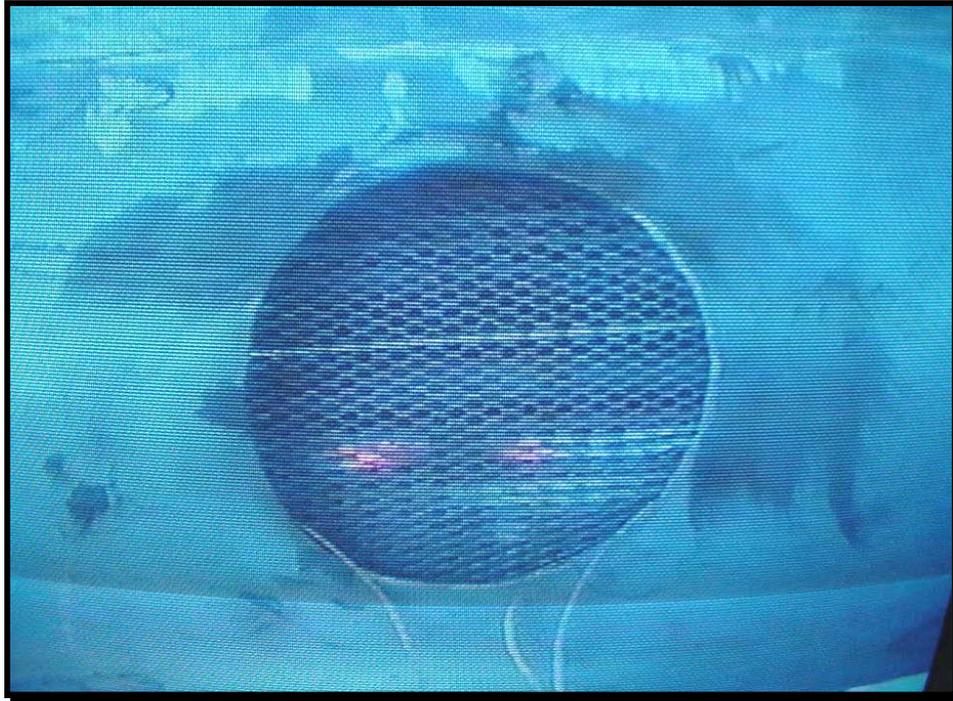
Figure B. 25. Test #17; Glowing ignition on Filter #2 at 850F.

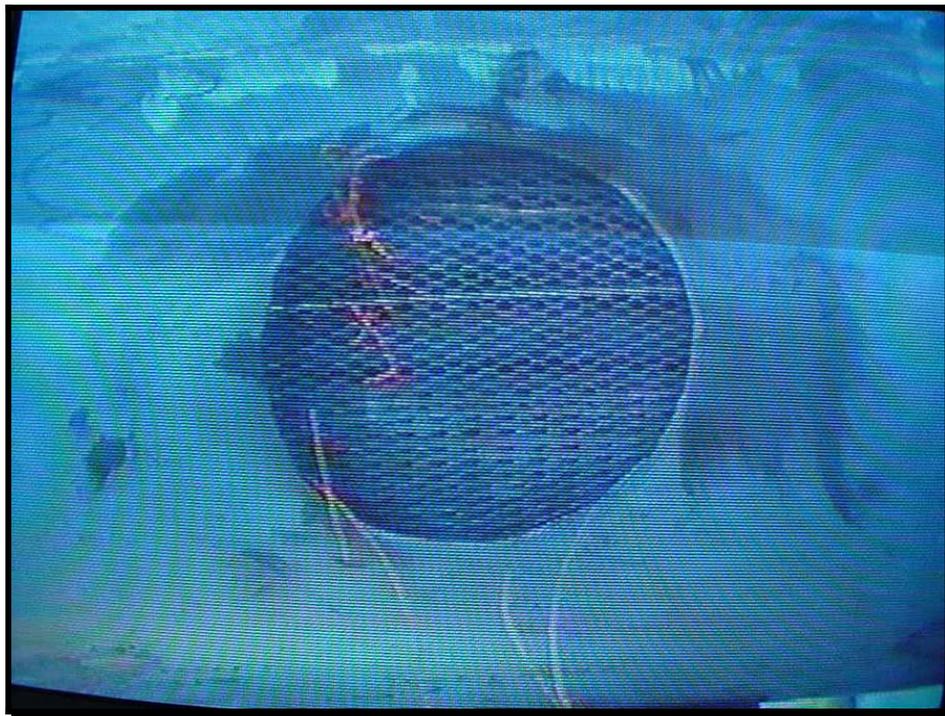
Figure B. 26. Test #17; Sparks from top of #2 filter at 1000F.

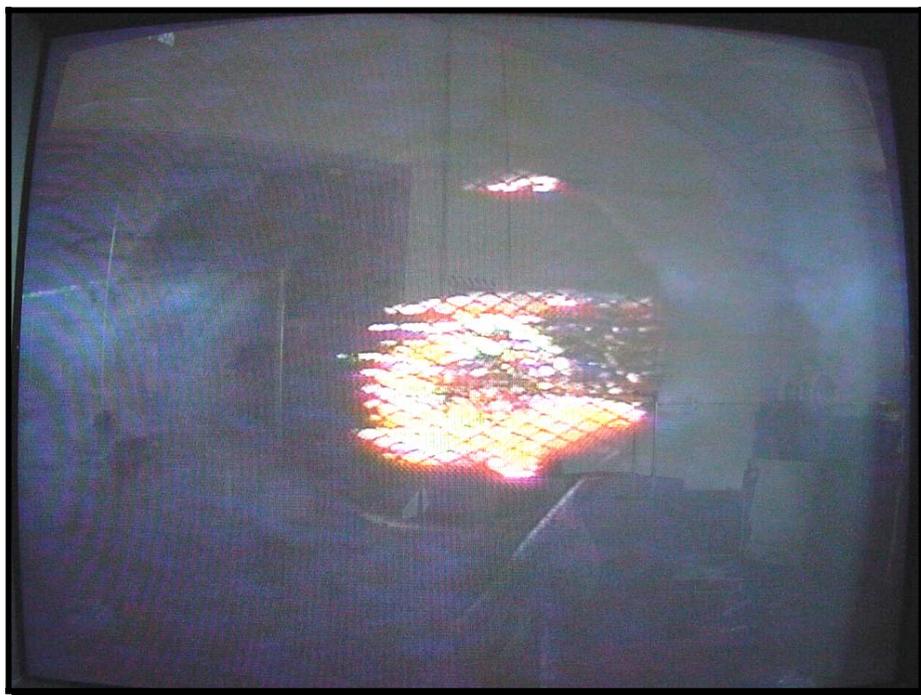
Figure B. 28. Test #18; Filter #2 burning.

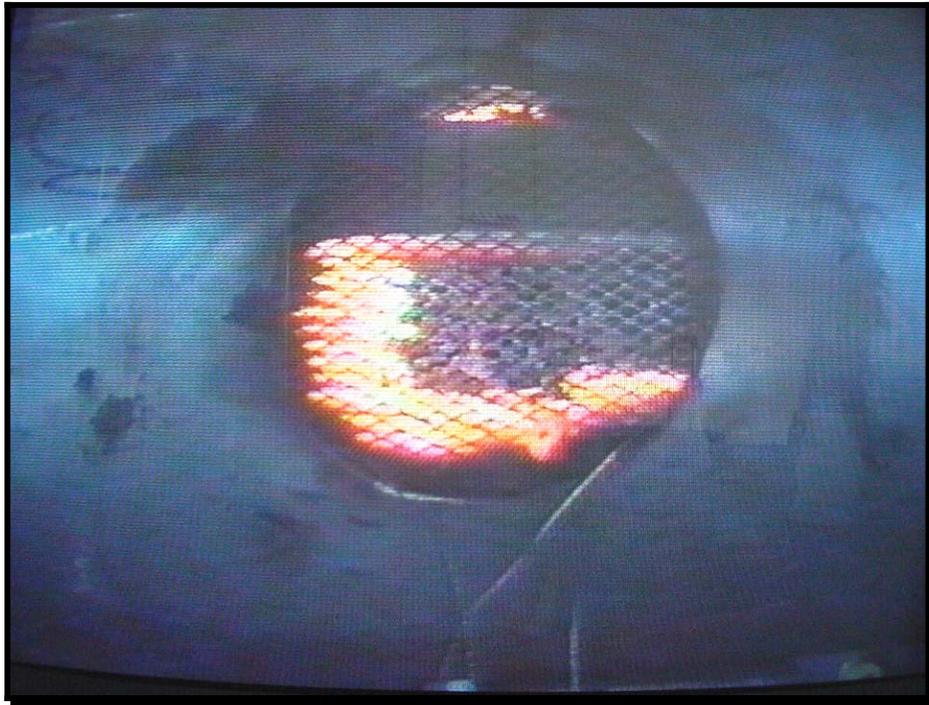
Figure B. 29. Test #18; Filter #2 burning, with hole apparent in center of burn.

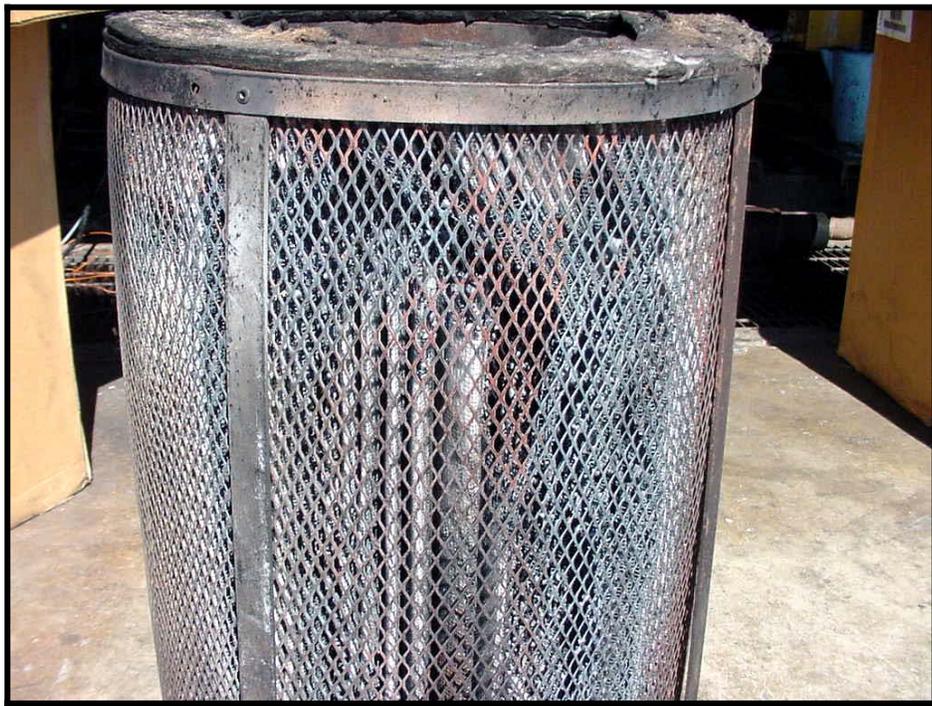
Figure B. 30. Test #18; Damage to Filter #2.

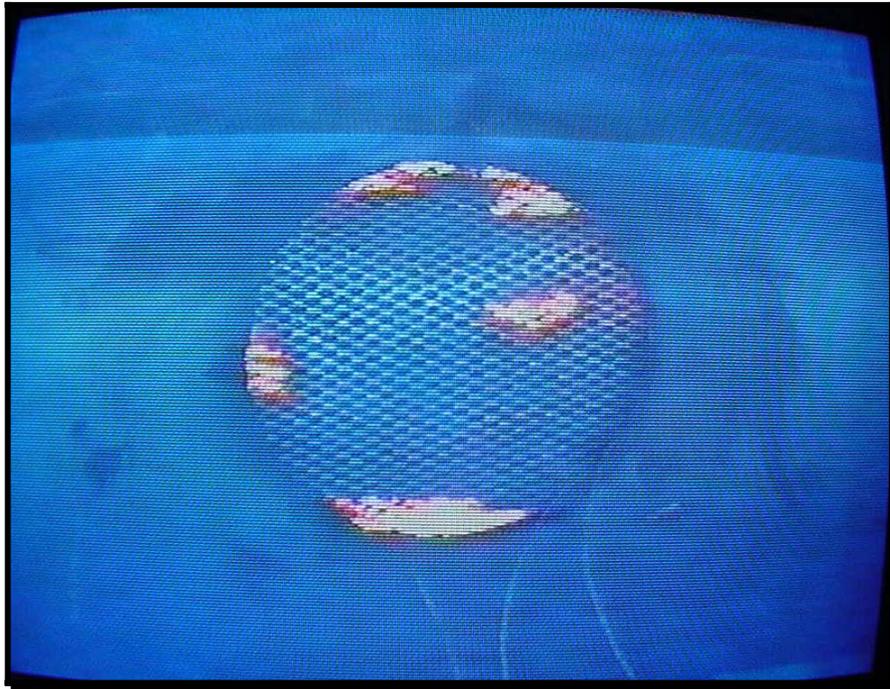
Figure B. 31. Test #19; Ignition and burning of filter #2.

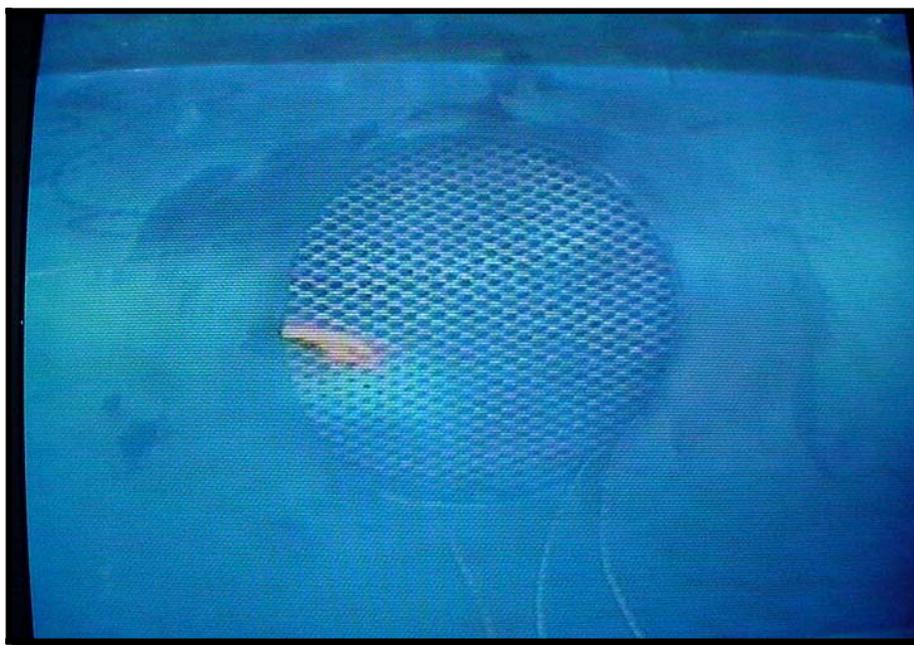
Figure B. 32. Test #19; Open flame exiting from canister hole.

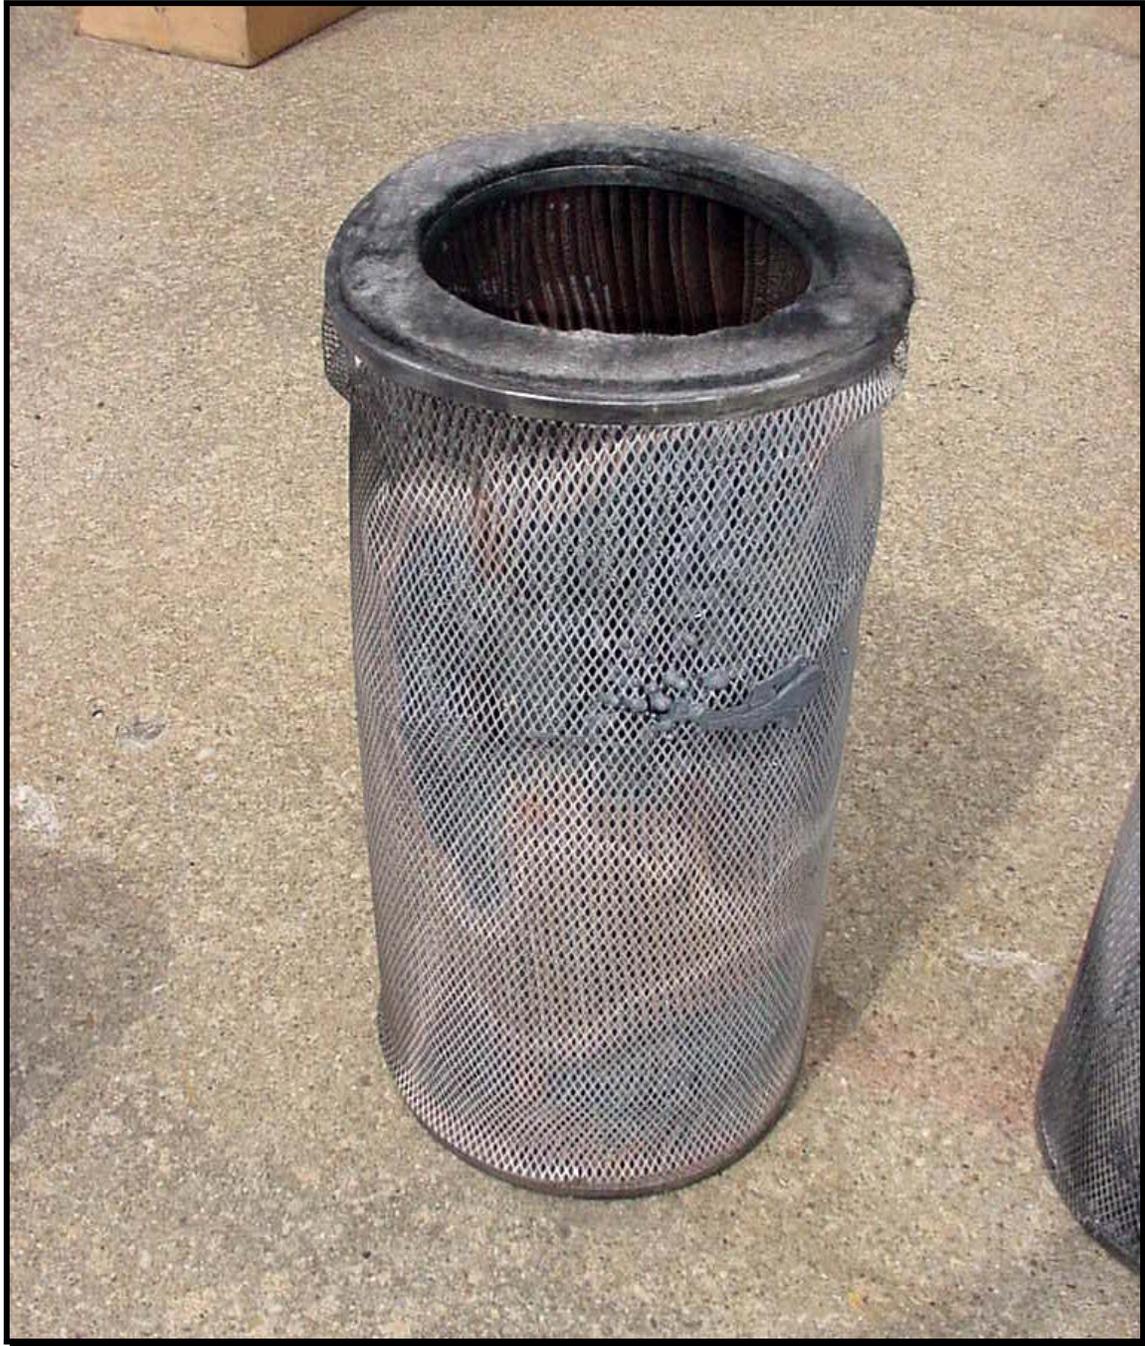
Figure B. 33. Test #23; damage to filter #2 along bottom of filter.

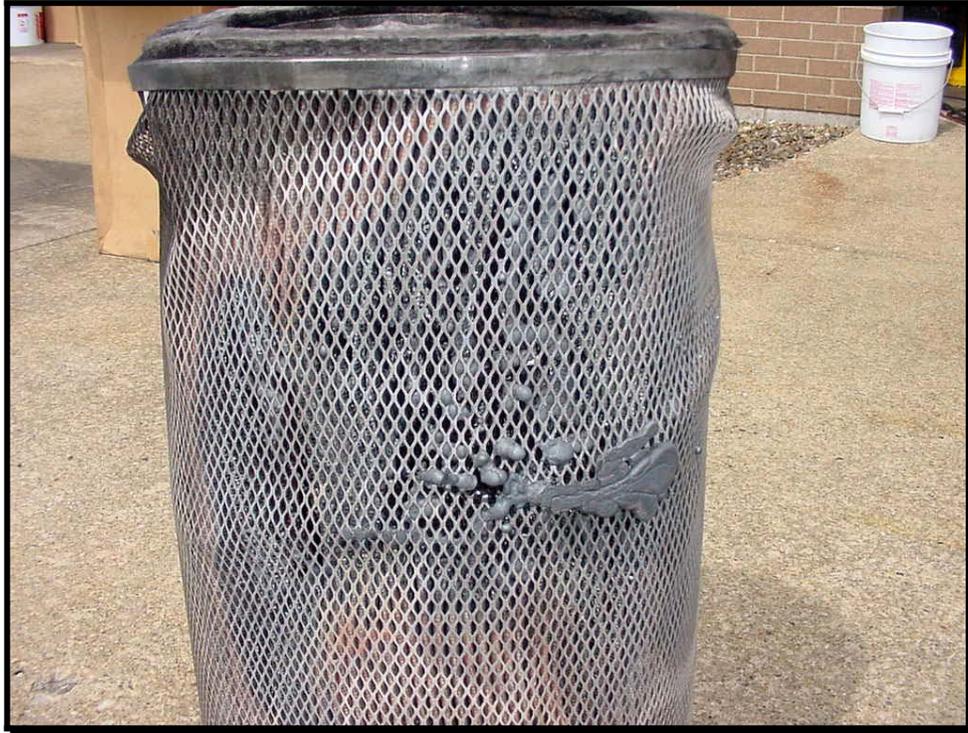
Figure B. 34. Test #23; damage to filter #2 along bottom of filter.

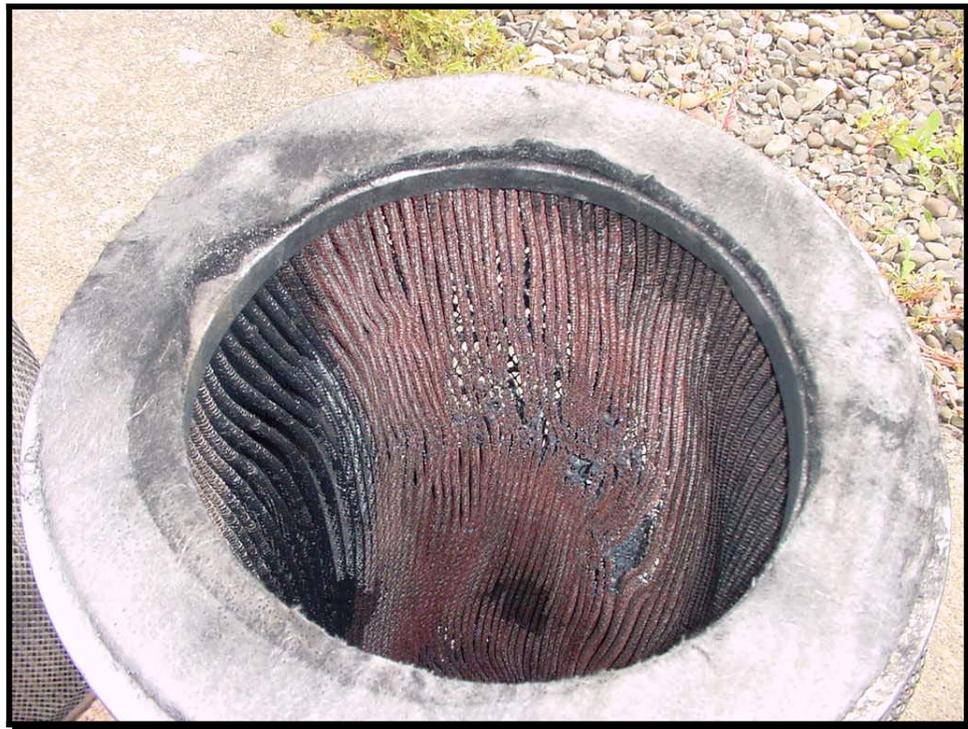
Figure B. 35. Test #23; damage to filter #2 along bottom of filter.

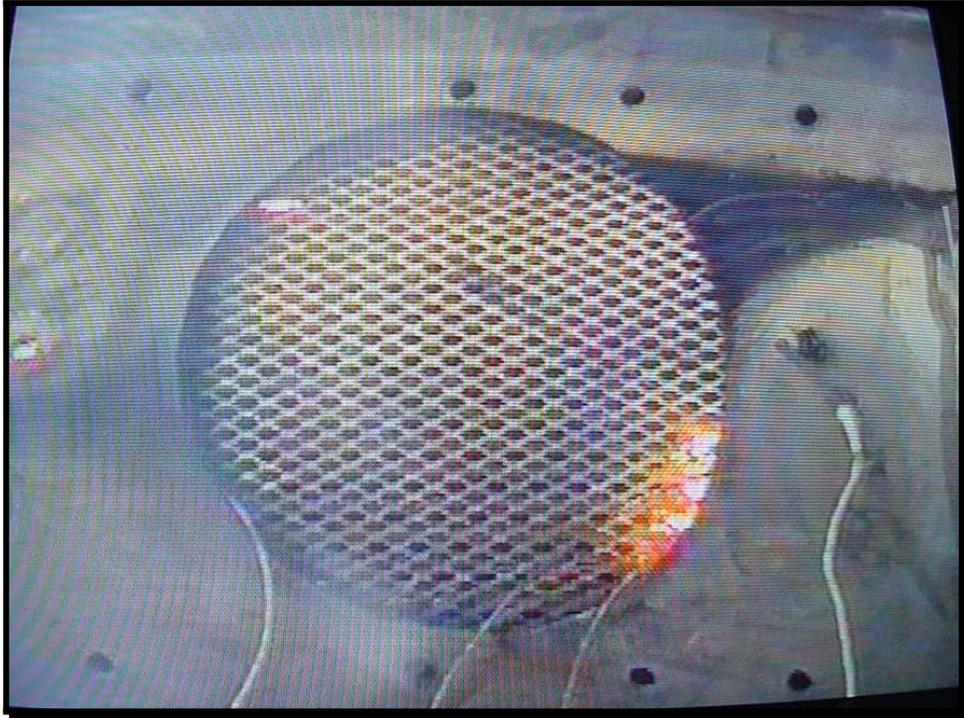
Figure B. 36. Test #24; initial #2 filter ignition.

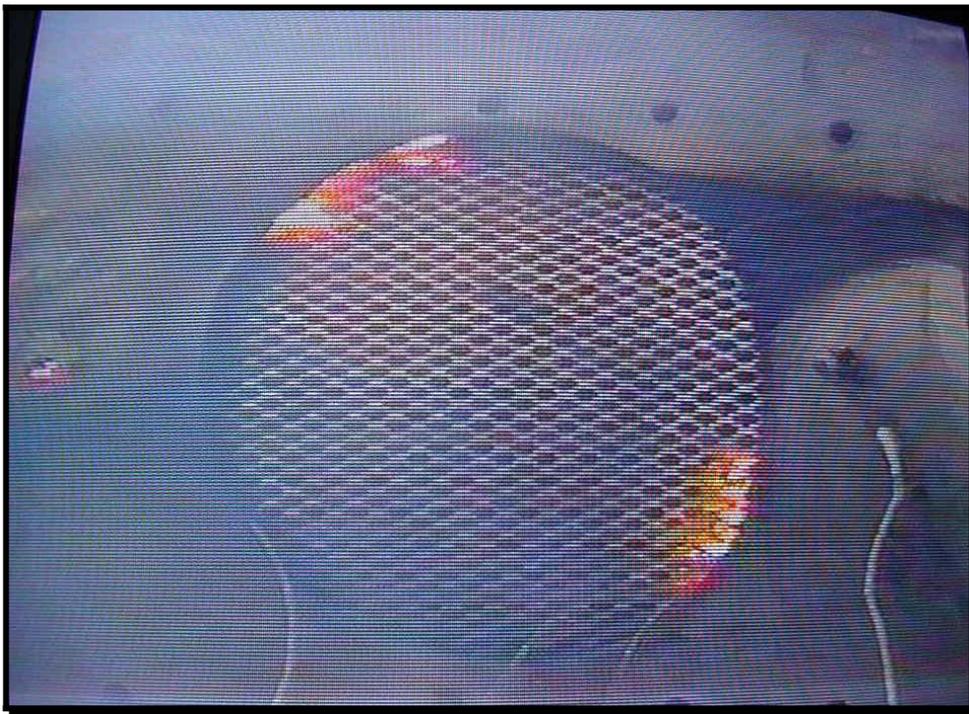
Figure B. 37. Test #24; second ignition on #2 filter.

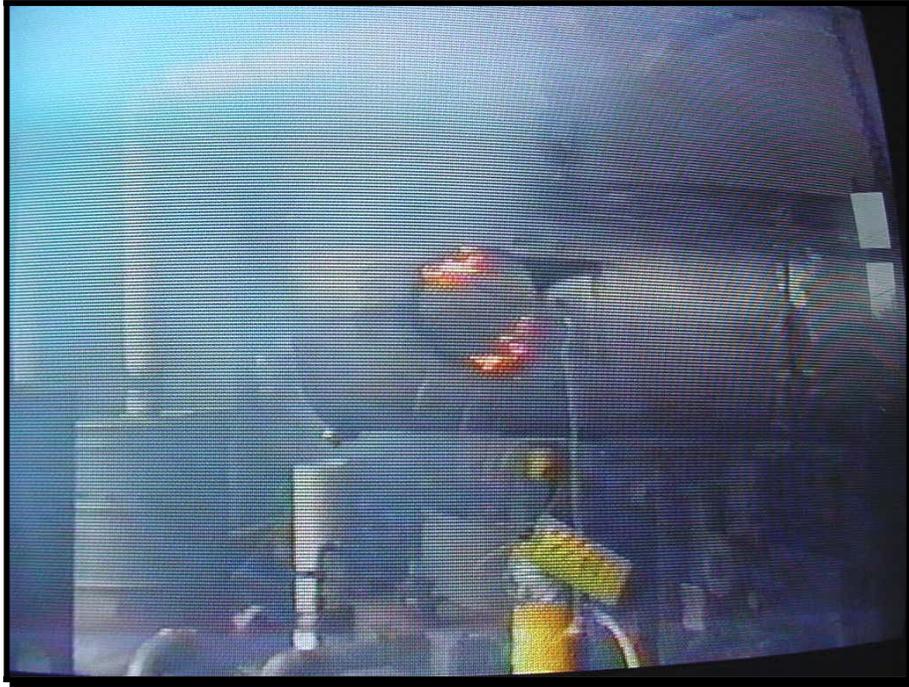
Figure B. 38. Test #24; filter burning with heavy smoke in lab.

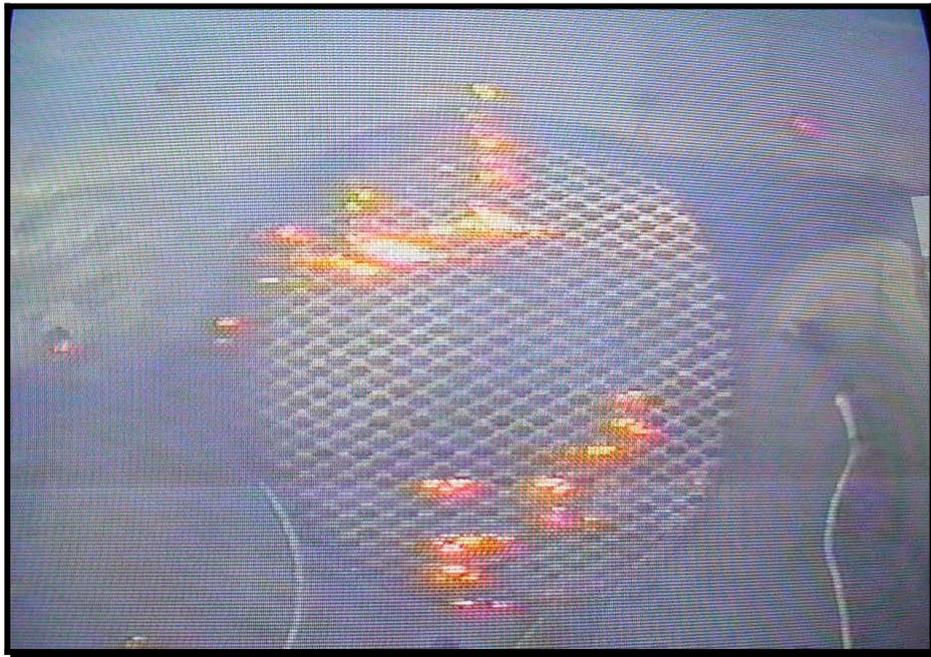
Figure B. 39. Test #24; filter #2 burning over large area of exposed surface.
