Mine Waste and Geotechnical Engineering Division

Summary of Geophysical Void Detection Demonstration
Project, In-Seam Seismic Method by Pennsylvania State
University, MSHA Account Number B2532532, RFP Number
MSHA J53R1011

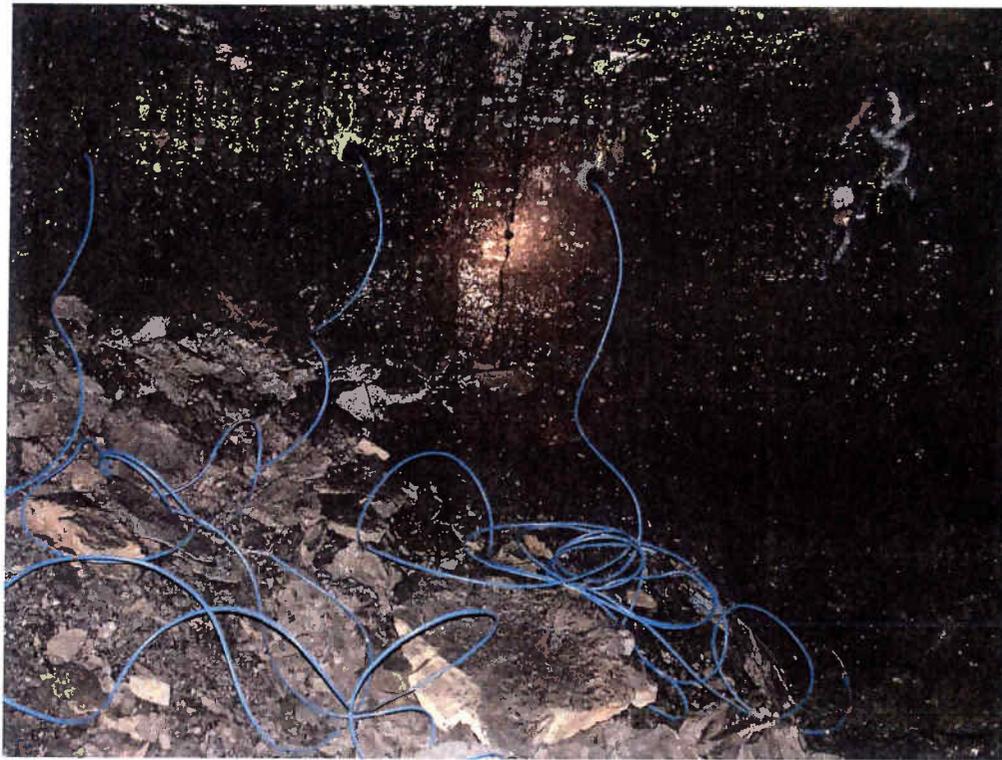
Figure 1: Sensors installed in a coal seam.

The sensors for the data acquisition system are accelerometers and geophones. These sensors are powered by 28V DC and are not permissible for use in a gassy mine environment. Thus, intrinsic safety barriers are used to limit any surge of current to the sensors. An addition of an intrinsic barrier for the 9V triggering mechanism would make the entire system permissible for a gassy environment. The sensors have been installed in a small borehole with use of epoxy resin and threaded connections and are retrieved for reuse. The sensor installation technique has been developed for this project with help of the consultants. A typical installation of sensors is shown in Figure 1. Claiming that information regarding the particle movement direction is needed for data interpretation, the PSU team has installed sensors in orthogonal pairs in close proximity at the expense of a larger coverage area.

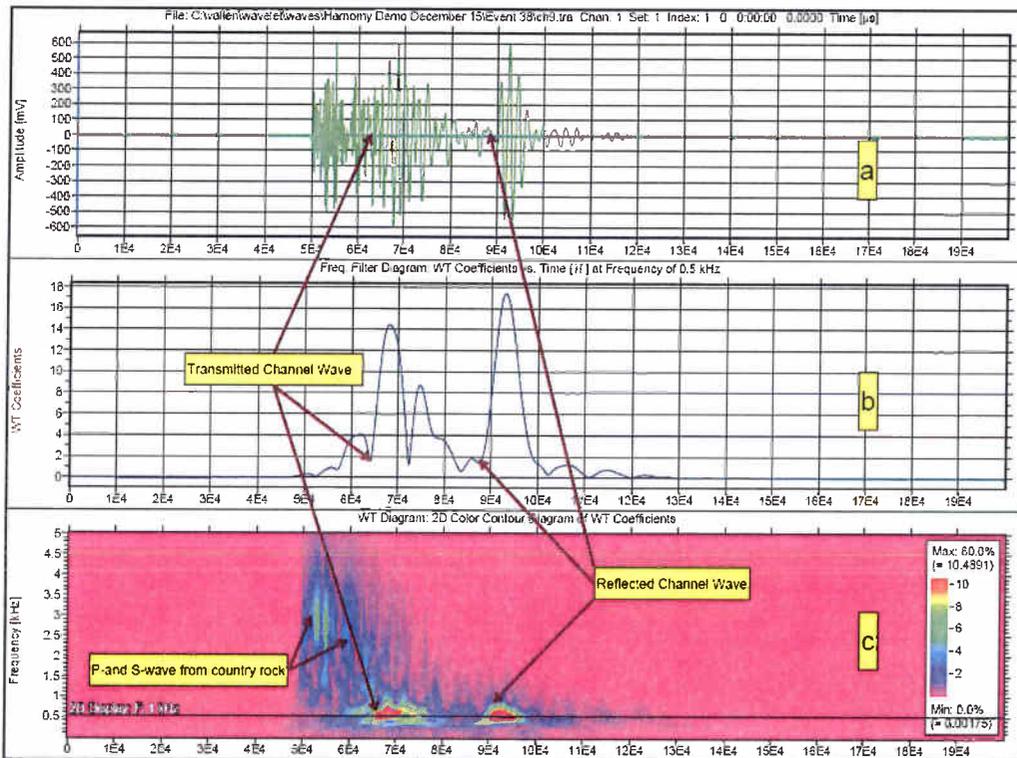
Figure 2: Garbo wavelet transform of a wave train.

The recorded signal was processed using a technique called Garbo wavelet transform. A typical result of the wave transform is shown in Figure 2. The travel distance was plotted with information from the source and sensor locations. The plotting usually results in multiple ellipses near or at the reflection boundary.

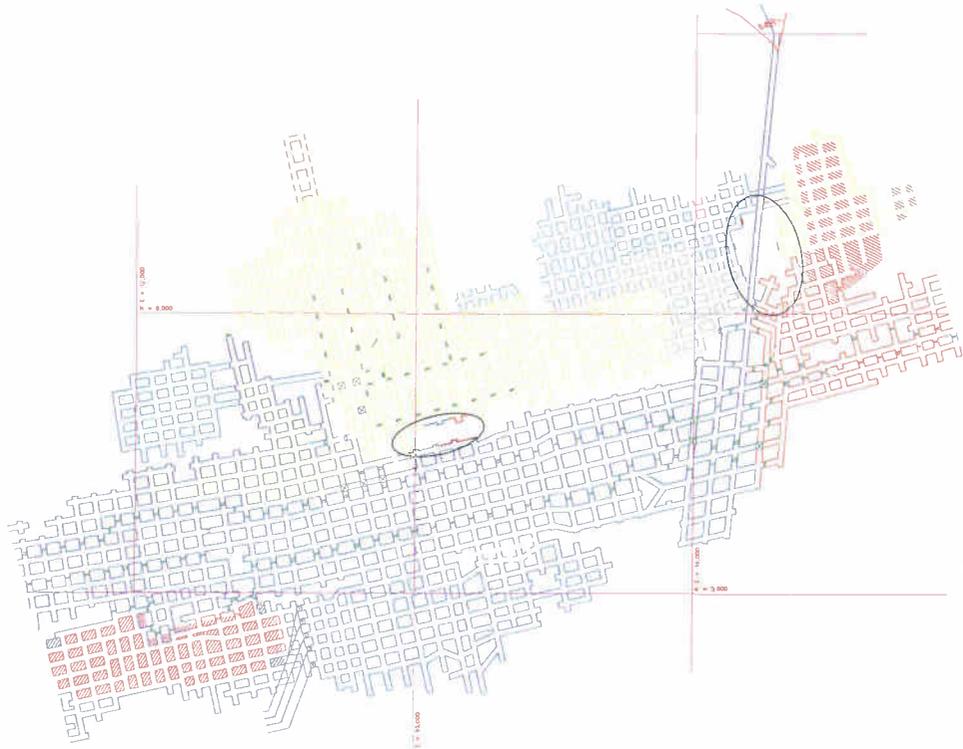
Figure 3: Test sites at the Harmony Mine.

The PSU team conducted field tests on November 15, 2005, February 7-8, 2006, and April 29, 2006. The site for the first field test was conducted along a 60-foot-wide barrier pillar, while the second and third tests were conducted along a 150-foot-wide pillar developed for the field tests. The 150-foot-wide pillar will be left to protect the main access tunnel of the mine. Figure 3 shows the location of the test sites.

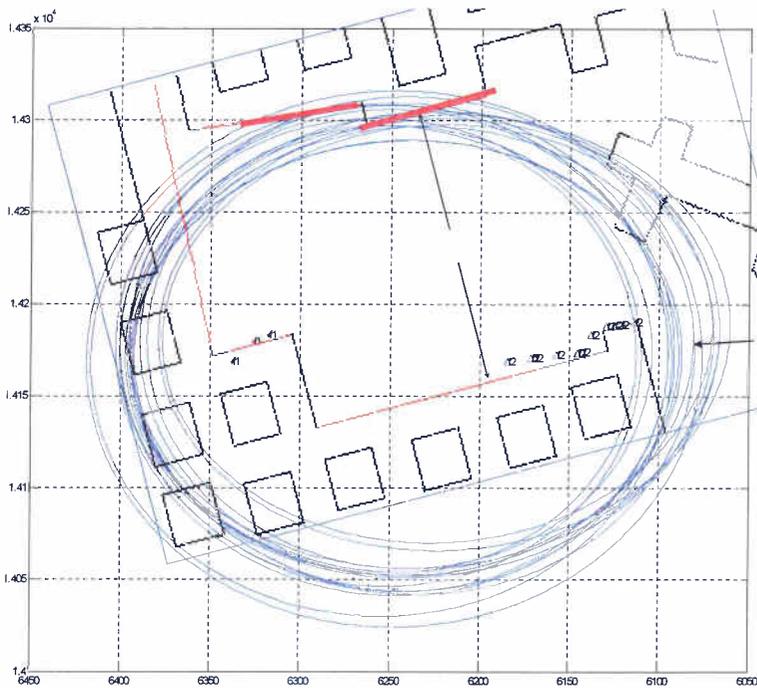
Figure 4: Void located by the ellipse method.

The PSU team determined the void location using the elliptical location method. The location is determined by plotting multiple of ellipses without applying migration correction. Because of the sensor arrangement, the recorded wave forms show the presence of a channel wave in the frequency range of 400 to 600 Hz. Because of the irregular reflection surfaces, the data interpretation was not clear-cut. In Figure 4, two groups of ellipses were calculated using a channel wave velocity of 5,200 ft/s and represent two reflection surfaces shown in red lines. The results shown in this figure were from the April 29, 2006, field test. Confirmation drilling was not necessary at this site since the test area was fully accessible and surveyed.

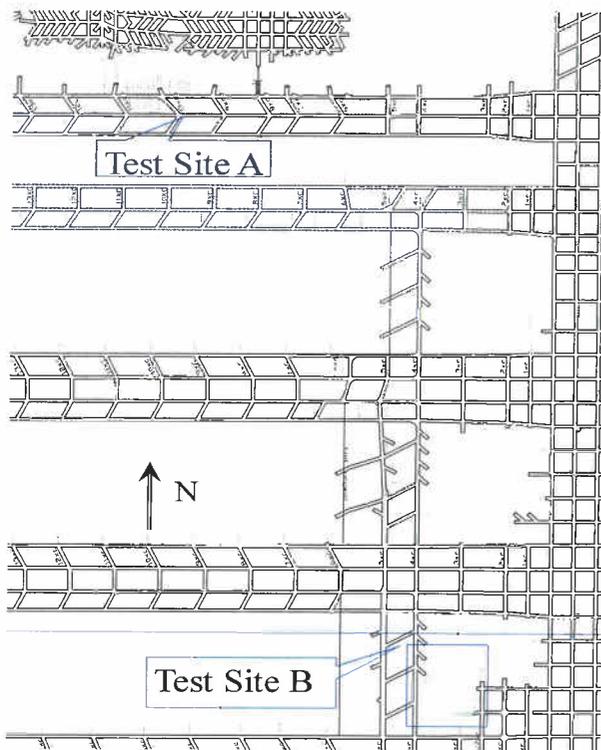
Figure 5: Location of test sites at FMC's Mine.

The next series of tests was conducted at FMC's Trona Mine on March 7-8, 2005, and August 23, 2005. Transmission tests were performed at an underground shop near an area designated as the 592 South Development. Seven sensors used for the test were installed in a room driven by a boring type continuous miner (Site B in figure 6). The source of seismic energy was located at a distance of approximately 302 to 345 feet from the sensor array. The reflection tests were conducted at the 349 West Development (Site

A in figure 5). It was separated by about 260-foot-wide flooded workings. This site was used for both field tests. Because trona is stronger than the roof and floor rock of the trona bed (Bed 17), no channel wave was generated. Void detection was achieved by determining the arrival time of reflected P- and S-waves.

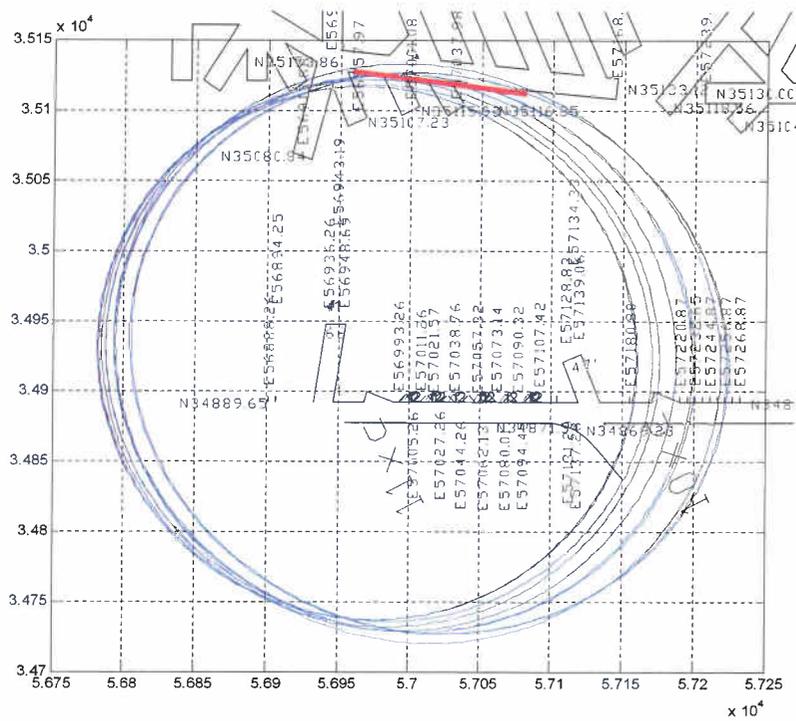
Figure 6: Void mapped using ellipses at FMC's Mine.

The signals used to detect the mine void are the reflected P- and S-wave signals. The data analysis is somewhat compounded by presence of push-ins in the development entries as well as by the flooded workings. An example of the ellipses calculated based on the travel distances is presented in Figure 6. No attempt was made to confirm the test results since the flooded workings had already been accurately mapped by the company.

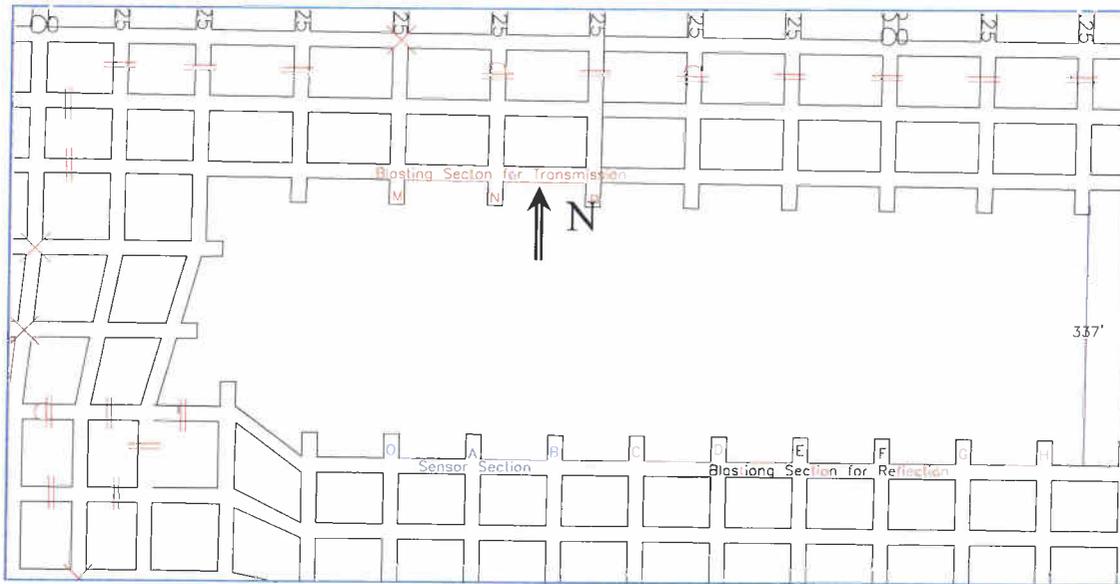
Figure 7: Test site at General Chemical's Mine.

On March 9 to 10, 2005, the project team conducted field tests at General Chemical's mine. The test site, shown in Figure 8, is one of barriers left to support the I-80 highway. The barrier pillar was approximately 340 feet wide. The sensors were installed in seven pairs. The test site has push-ins at the sensor installation site as well as the reflection site. However, the sites are parallel to each other so it was not necessary to perform a migration correction.

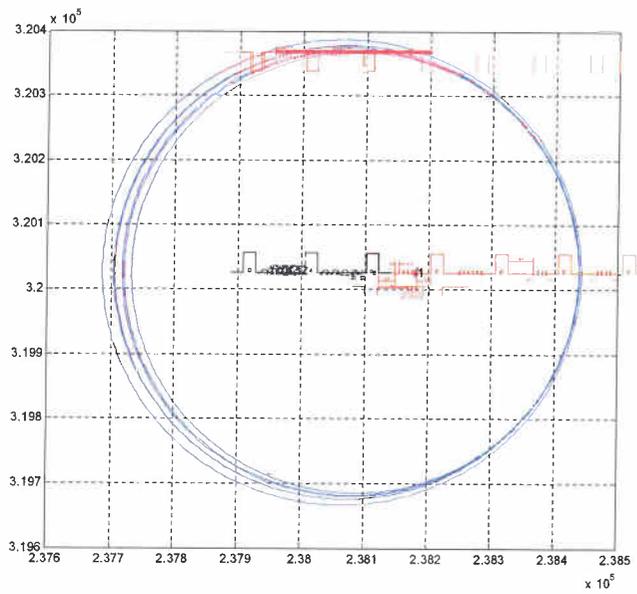
Figure 8: Void mapped using ellipses at the General Chemical's Mine.

The test results from General Chemical's mine are similar to those from FMC's mine. These mines are adjacent and operate in Trona Bed No. 17. The measured P- and S-wave velocities are 16,740 ft/s and 8,754 ft/s, respectively, for the mine. The recorded wave forms are similar to those obtained from FMC's mine in terms of characteristics of transmitted and reflected signals. The team did not find any difference in characteristics of signals reflected from a water-filled void versus an air-filled void. A void mapped using the ellipse method is shown in Figure 8. The red line in the figure is the reflection boundary of waves. Confirmation drilling was not necessary at this site, since the test area was fully accessible and surveyed.
