Serious Accident

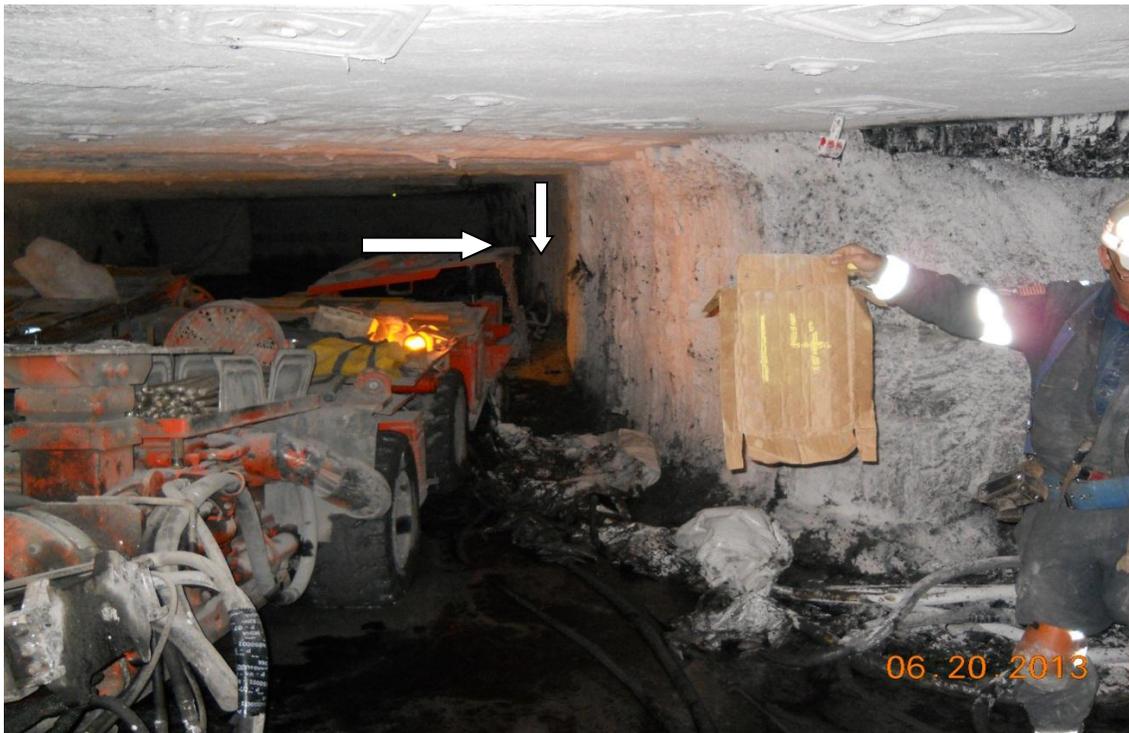
On June 20, 2013 a 32-year old miner with eleven years mining experience was seriously injured while working at an underground mine. The accident occurred when the victim was attempting to move around the rear of the energized roof bolting machine with close clearance between the machine and the outby coal rib. The bolt machine operator was at the inch tram controls located toward the center front of the machine. He repositioned the machine toward the right or inby direction to install a permanent roof support (spot bolt), pinning the victim between the machine at the main control station canopy and the coal rib. The accident resulted in serious internal abdominal injuries.

- All persons shall remain in a safe location away from pinchpoints created by either the continuous mining machine and/or other equipment.
- Machine operators should be aware of the RED ZONES and PINCHPOINTS of their machine and quickly de-energize the machine when a miner enters these areas.
- All persons entering the work area of energized mining equipment should communicate their intentions and location verbally and by other methods to assure their safety.
- Never assume that mobile equipment operators can see you.
