Fatality #12 - September 18, 2013

Falling/Sliding Material – Kentucky – Crushed, Broken Limestone NEC

Gaddie-Shamrock LLC - Caldwell Quarry

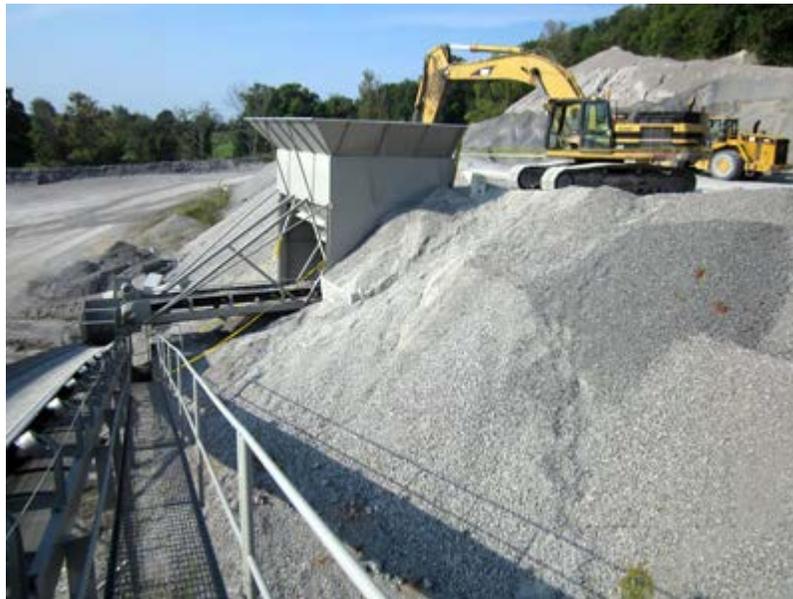
METAL/NONMETAL MINE FATALITY - On September 18, 2013, a 56-year old front-end loader operator with 16 years of experience was killed at a crushed stone operation. The victim was attempting to remove a rock from a pug mill hopper when he was engulfed by the material in the hopper.

- Establish and discuss policies and procedures for safely clearing a hopper.
- Equip hoppers with mechanical devices or other effective means of handling material so persons are not required to work where they are exposed to entrapment by sliding material.
- Install a heavy screen (grizzly) to control the size of material and prevent clogging.
- Task train persons to recognize all potential hazardous conditions and to understand safe job procedures for elimination of the hazards before beginning work.
- Before working on or near equipment, ensure that the discharge operating controls are deenergized and locked out.
- Wear a safety harness and lanyard, which is securely anchored and tended by another person, prior to entering bins, hoppers, tanks, or silos.
