PRODUCT NOTICE — SNAPHOOKS

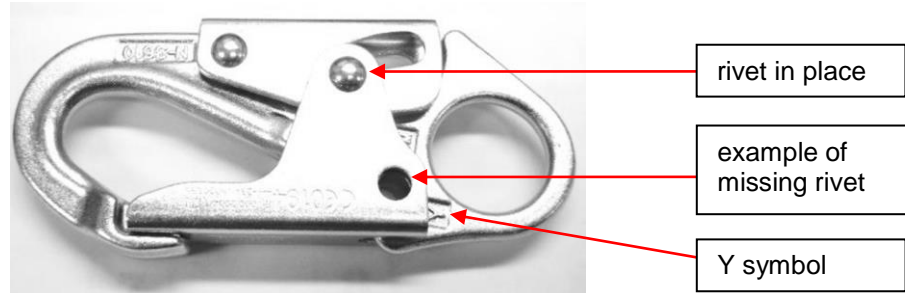
Capital Safety is aware of an assembly issue with snaphooks manufactured by a supplier. These snaphooks are widely used components in fall protection products. The issue concerns missing or improperly installed rivets (see photograph below). The manufacturer symbol is a stamped “Y” as shown in the photograph.

The picture above is a representative model snaphook – other models are also affected.

Capital Safety has verified that the supplier implemented an appropriate corrective action program. The supplier’s notification (above) has an imbedded video demonstration of its revised process.

We want to remind users to conduct a pre-use inspection of all fall protection safety equipment prior to use as per instructions in the user manuals. If a missing or incompletely installed rivet is identified in a snaphook on a Capital Safety product, the product should be removed from service and returned via distribution for replacement under warranty. (See figure 1 & 2 below.)
