STRUCTURAL HAZARDS – STEEL BINS

Steel storage bins can hold a large amount of material and if they fail, the consequences can be fatal. From 2012 to 2014, there have been 5 reported failures in the U.S. mining industry. Bin failures are often preventable with periodic inspection and maintenance. The following common deficiencies can lead to structural failure and bin collapse, placing miners at risk of fatal injuries caused by crushing, pinning and entrapment.

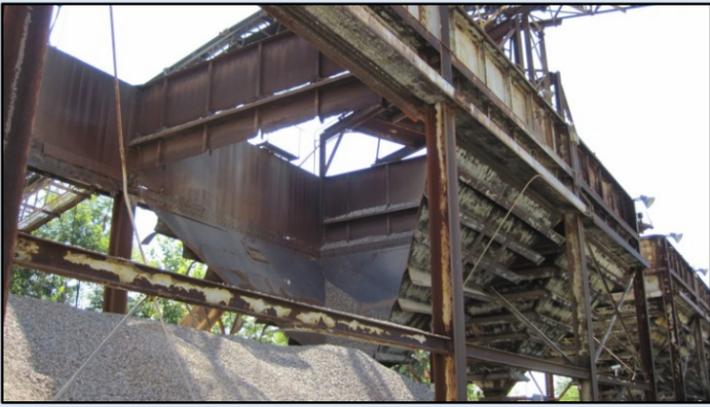
Gravel storage bin failure September 2014

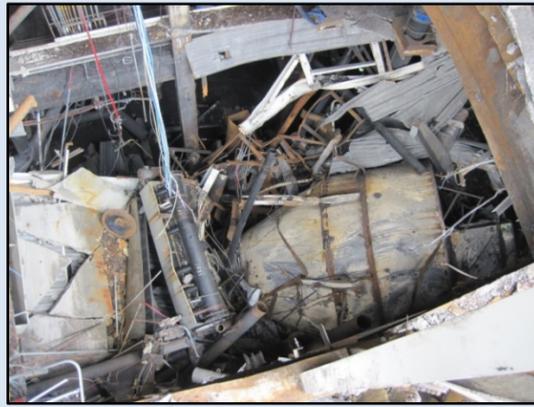
Magnetite bin failure May 2014

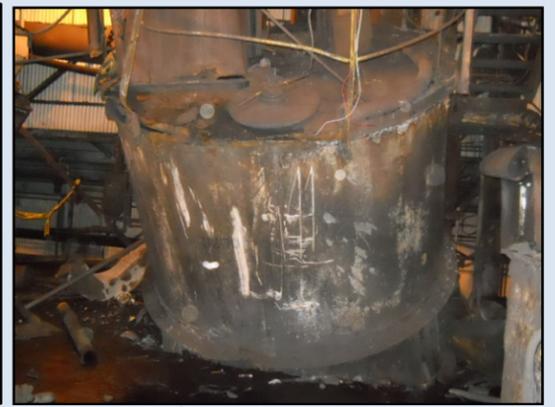
Magnetite bin failure February 2013

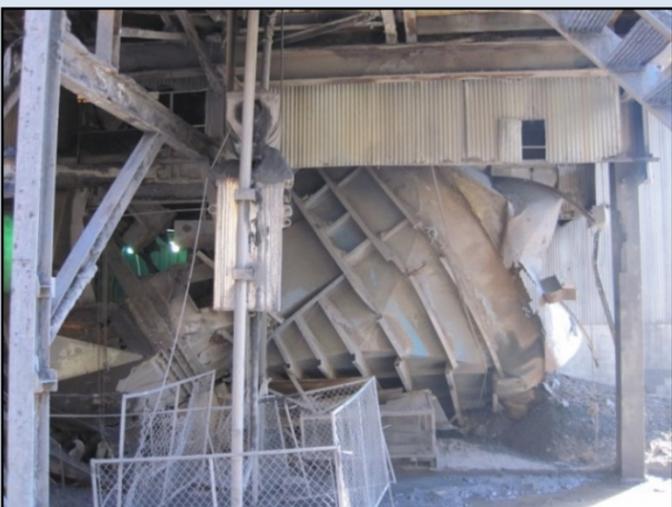
Coarse refuse bin failure November 2012

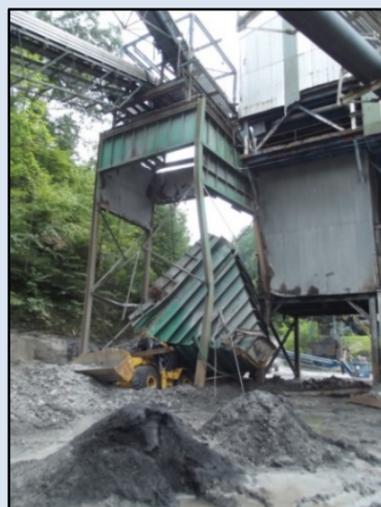
Coarse refuse bin failure August 2012
