Southern WV Accident Alert

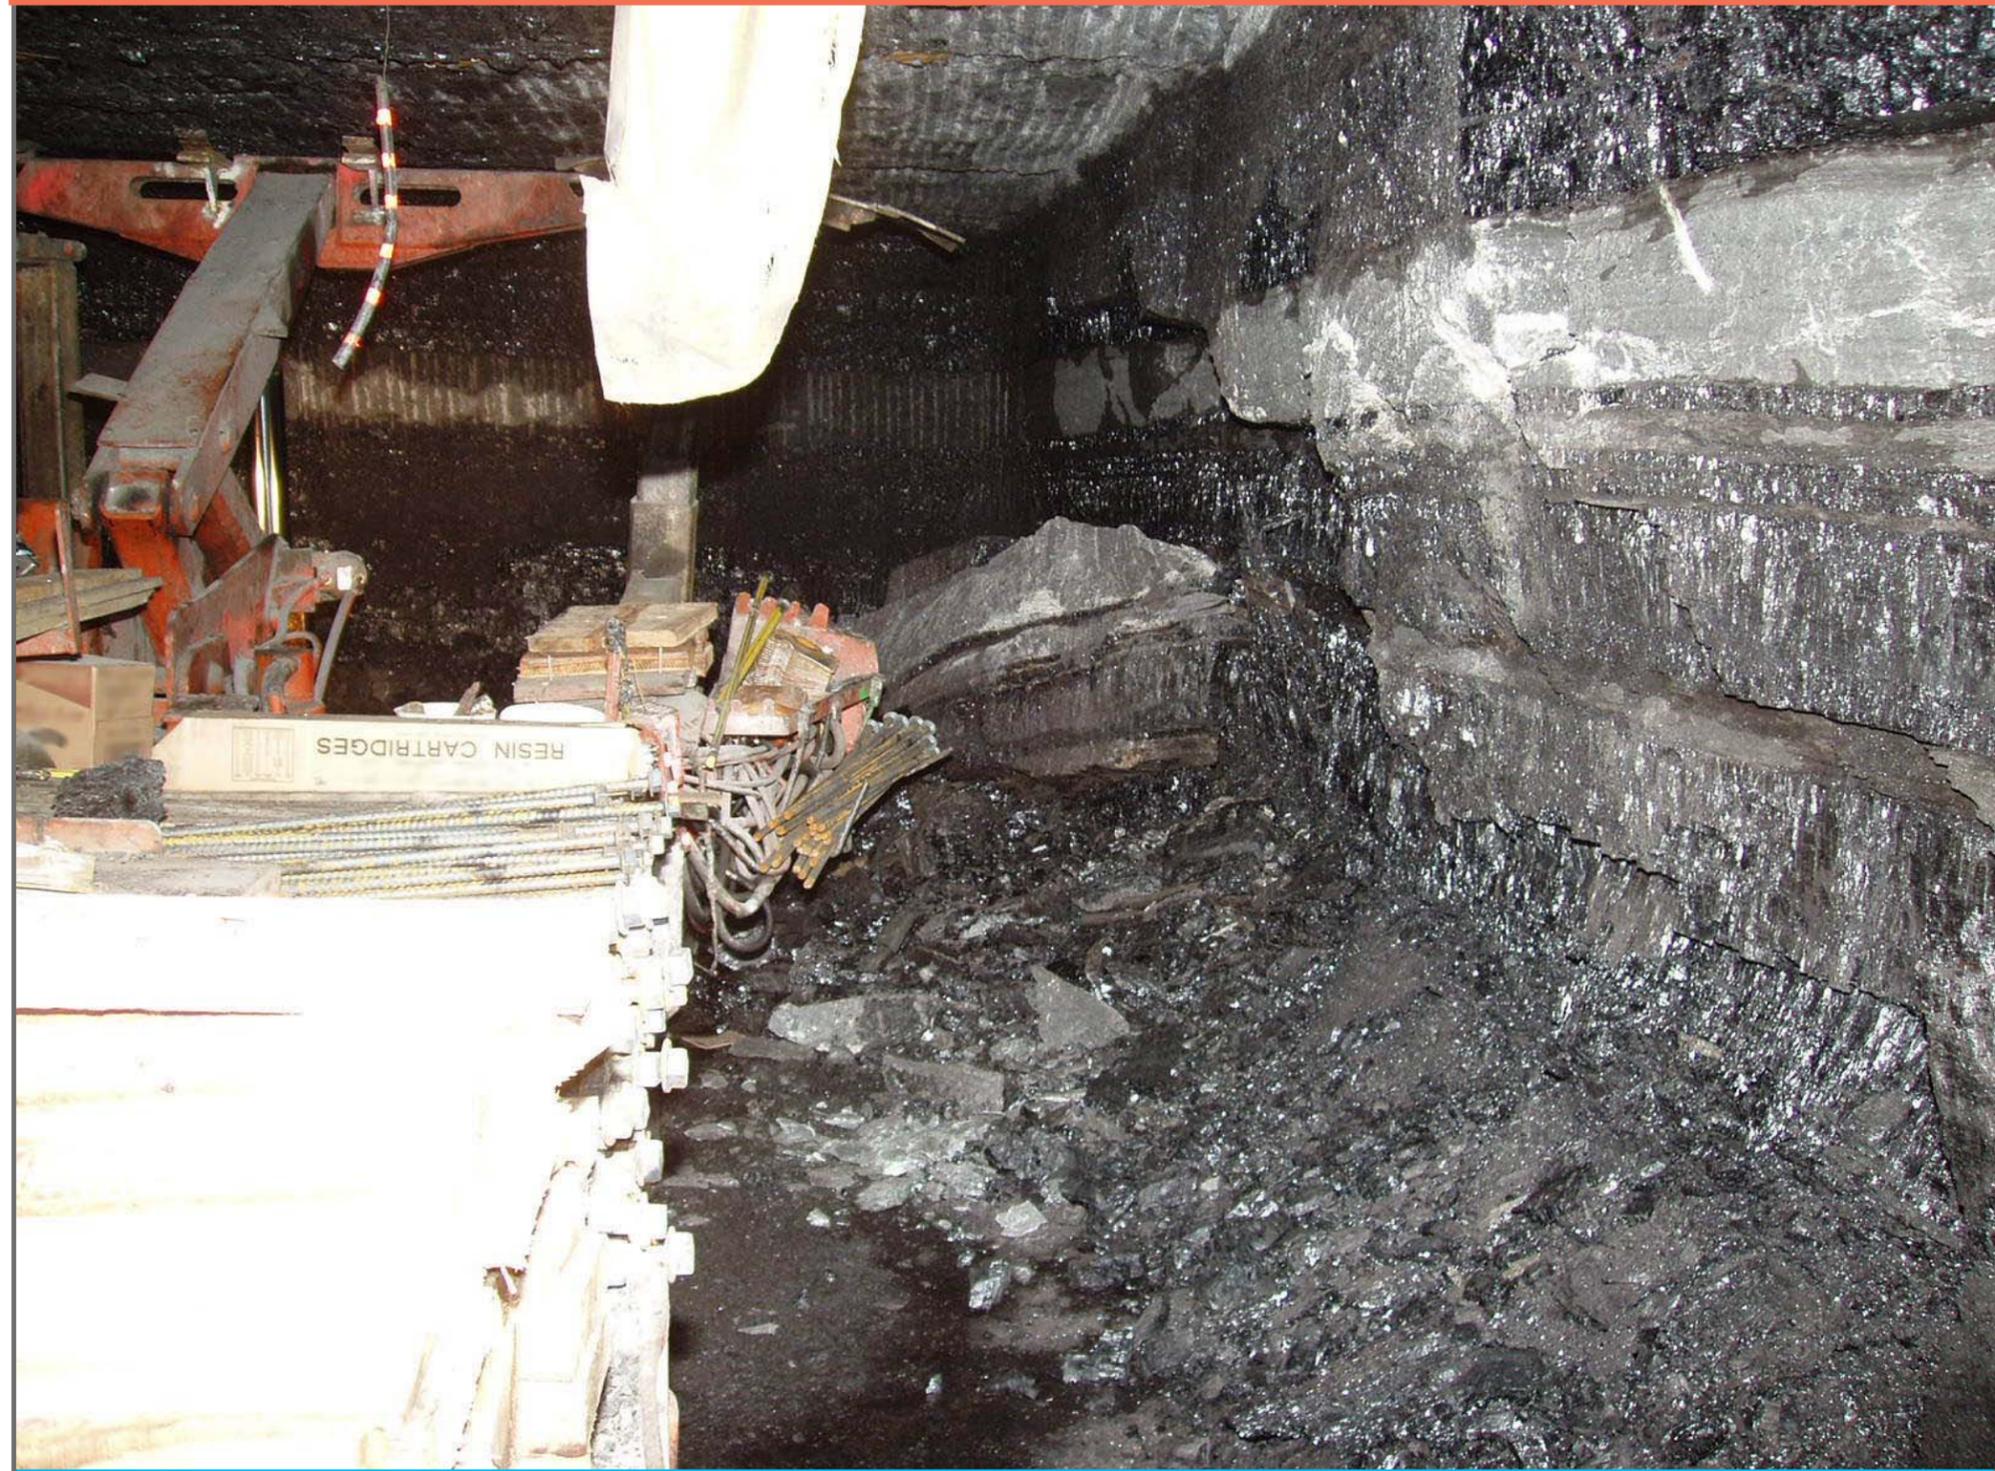
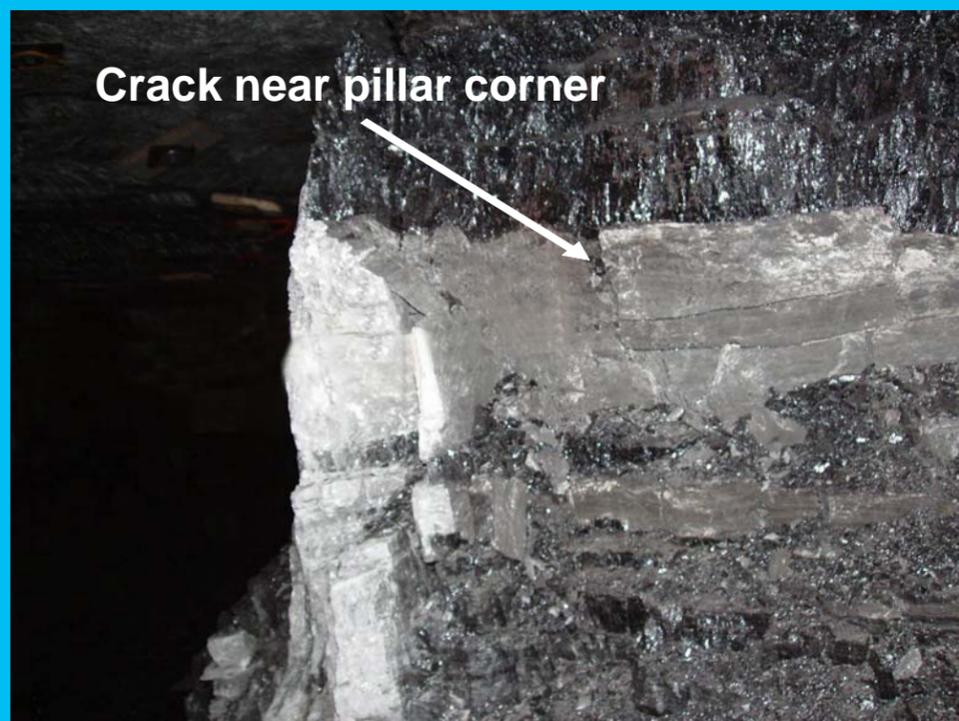
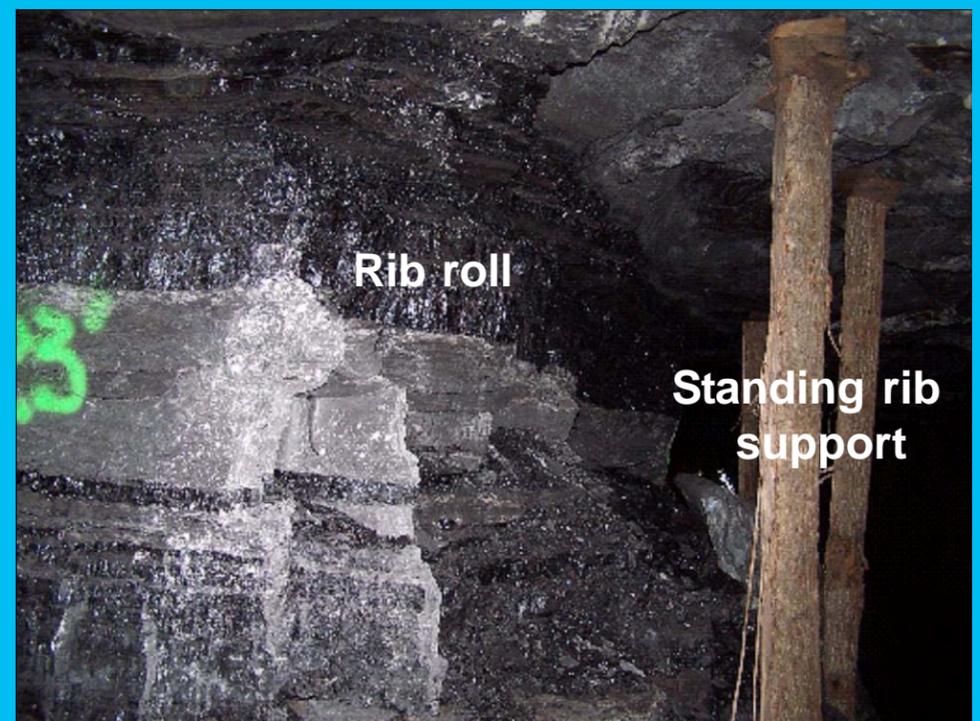
A roof bolting machine operator was fatally injured in a rib roll accident while installing roof bolts near the active face. The section was developing under approximately 1,000 feet of cover. Mining had occurred in a coal seam approximately 65 feet above this mine creating additional pressure on the coal ribs. Mining height on the section averaged 8 1/2 feet.

Preventive Practices:

- √ Examine roof and ribs frequently during work assignments.
- √ Never assume a rib is safe because it has been scaled or cut down.
- √ Where needed, active rib supports (bolts) should be installed instead of passive supports (posts or jacks).
- √ Be aware of overmining, undermining, and deep cover conditions and adjust mining and roof/rib supports accordingly.
