Southern WV Accident Alert

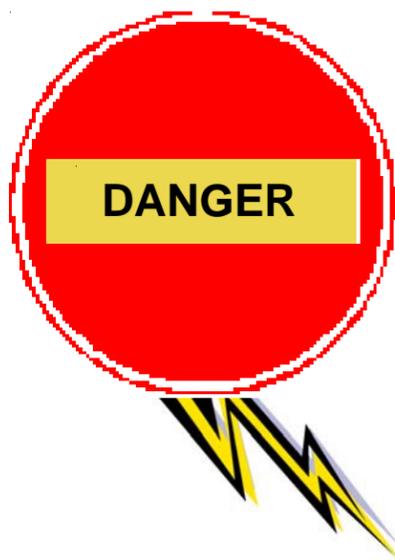
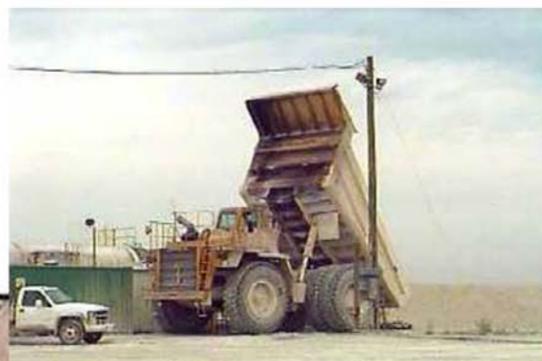
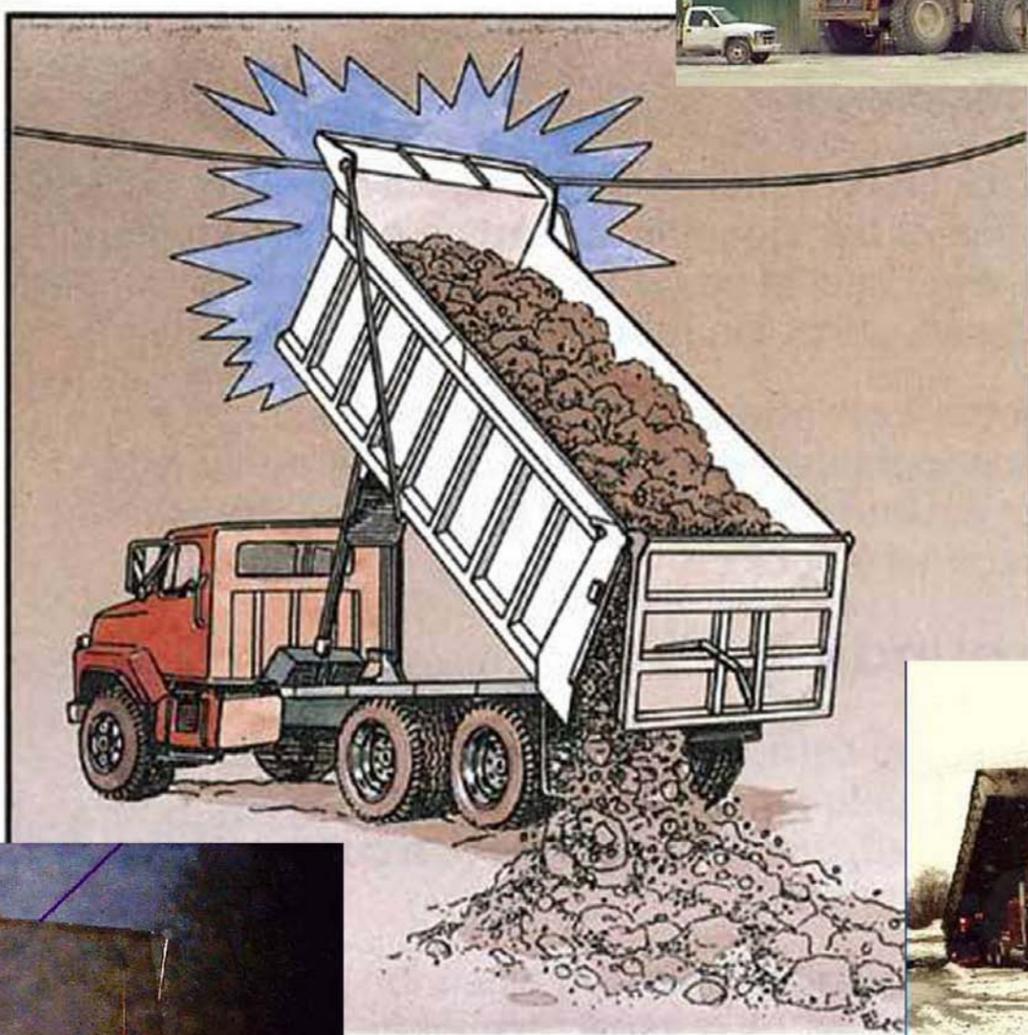
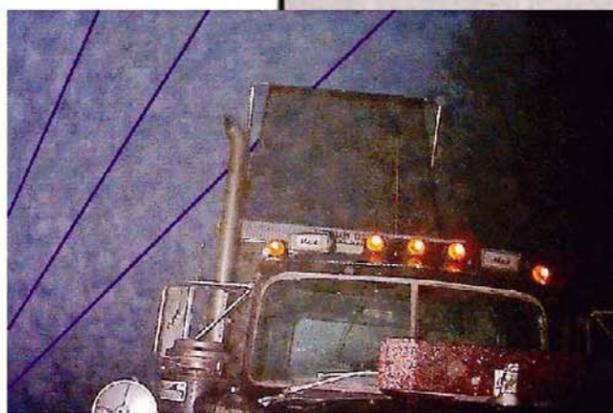
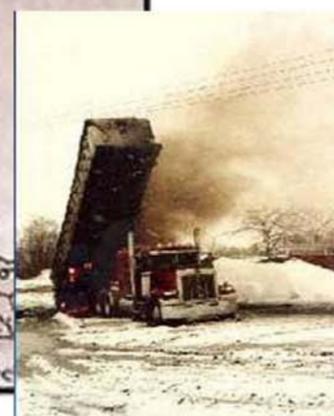
A near miss electrical accident occurred when a Caterpillar 777 rock truck driver emptied his load of coal at the dump site and pulled away without lowering his bed. After traveling approximately 200 yards, the raised bed contacted a telephone trunk line which caused the high voltage line crossing the roadway to break and contact the cab of the truck. The truck operator remained in the truck cab until company personnel were able to positively determine that the power lines were de-energized. The truck driver sustained no injuries from the occurrence.

- ✓ Do not move the vehicle while the bed is raised or while operating a tarping device.
- ✓ Look for any low clearance powerlines before raising the bed or a tarping device.
- ✓ If your vehicle contacts a powerline:
 - ✓ Lower the bed or tarp (only from inside the cab) to break contact with the powerline, if possible.
 - ✓ Stay in the vehicle until it can be verified that the power is de-energized.
 - ✓ Do not allow anyone to come in the vicinity of the vehicle.
- ✓ Install in-cab warning devices that will give an alert:
 - ✓ When the truck is moved with the bed in the raised position.
 - ✓ When there are nearby high-voltage power lines.
