Coal Mine Fatal Accident 2005-05

Operator:	Consolidation Coal Company
Mine:	Shoemaker Mine
Accident Date:	May 11, 2005
Classification:	Powered Haulage
Location:	Dist. 3, Marshall County, WV
Mine Type:	Underground
Employment:	429
Production:	16,365 tons/day

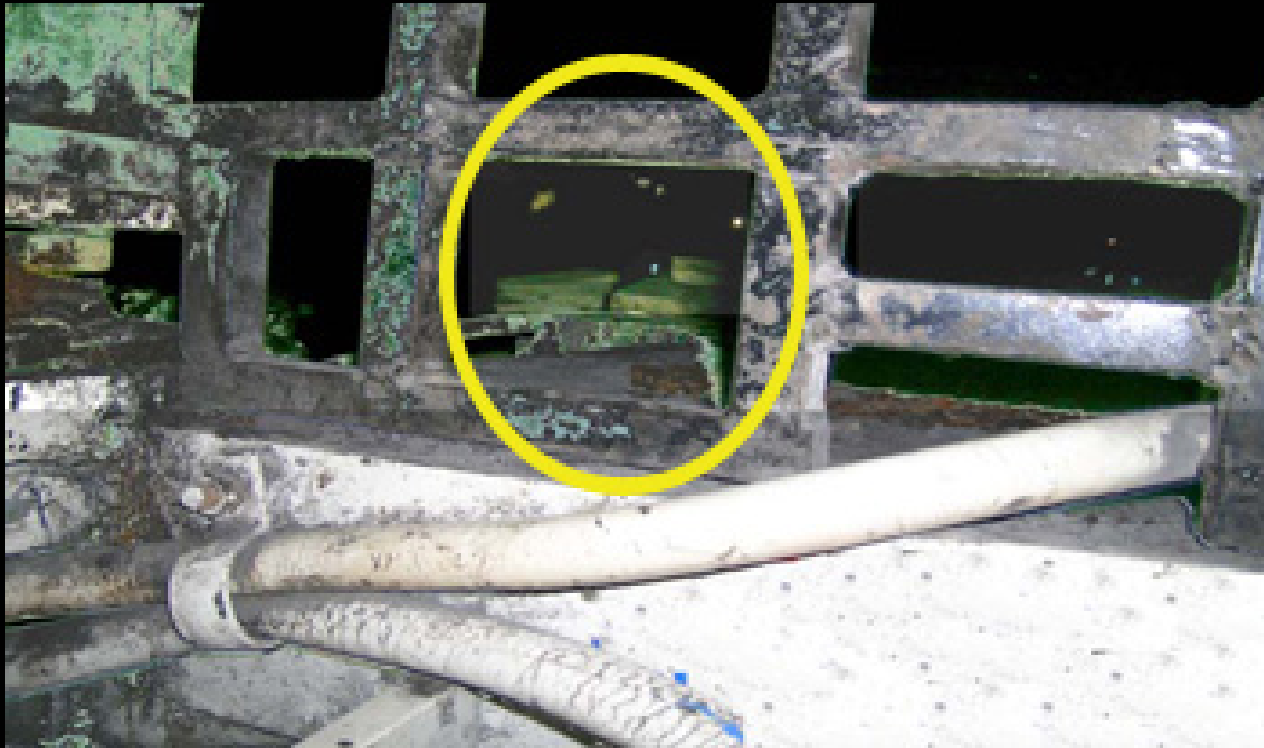
The scoop was equipped with a "duck bill" attachment and loaded with wedging materials. The victim was last seen by the scoop operator walking approximately 5-6' ahead of the scoop in the left front area. Just before the accident, the scoop operator looked away from the victim to examine the right coal rib. The victim was crushed and fatally injured beneath the "duck bill" of the scoop.

The photo above shows the view from the operator's compartment toward the victim's location. Only the cap lamp of a person, standing at the victim's location (indicated by the yellow ellipse), was clearly visible from this view.

Corrective Action: Mine management modified their comprehensive mine safety program to address the safe location of persons in the vicinity of operating mobile rubber tire equipment. All underground personnel were reinstructed regarding the safe location of persons around operating mobile rubber tire equipment. Management should routinely observe work habits and monitor enforcement of the newly established policies in the comprehensive mine safety program.

- Remain a safe distance from moving equipment until it has passed.
- Walk behind moving mobile equipment when traveling in the same entry.
- When operating mobile equipment, ensure that other workers are in a safe area before moving the equipment.
- When necessary to walk or work in the area of moving mobile equipment, wear reflective clothing to ensure a high visibility.
