## Coal Mine Fatal Accident 2006-22

Operator:	Mystic LLC
Mine:	Candice 2
Accident Date:	April 7, 2006
Classification:	Powered Haulage
Location:	Dist. 4, Boone Country, West Virginia
Mine Type:	Underground Coal Mine
Employment:	137
Production:	3,000 Tons/Day

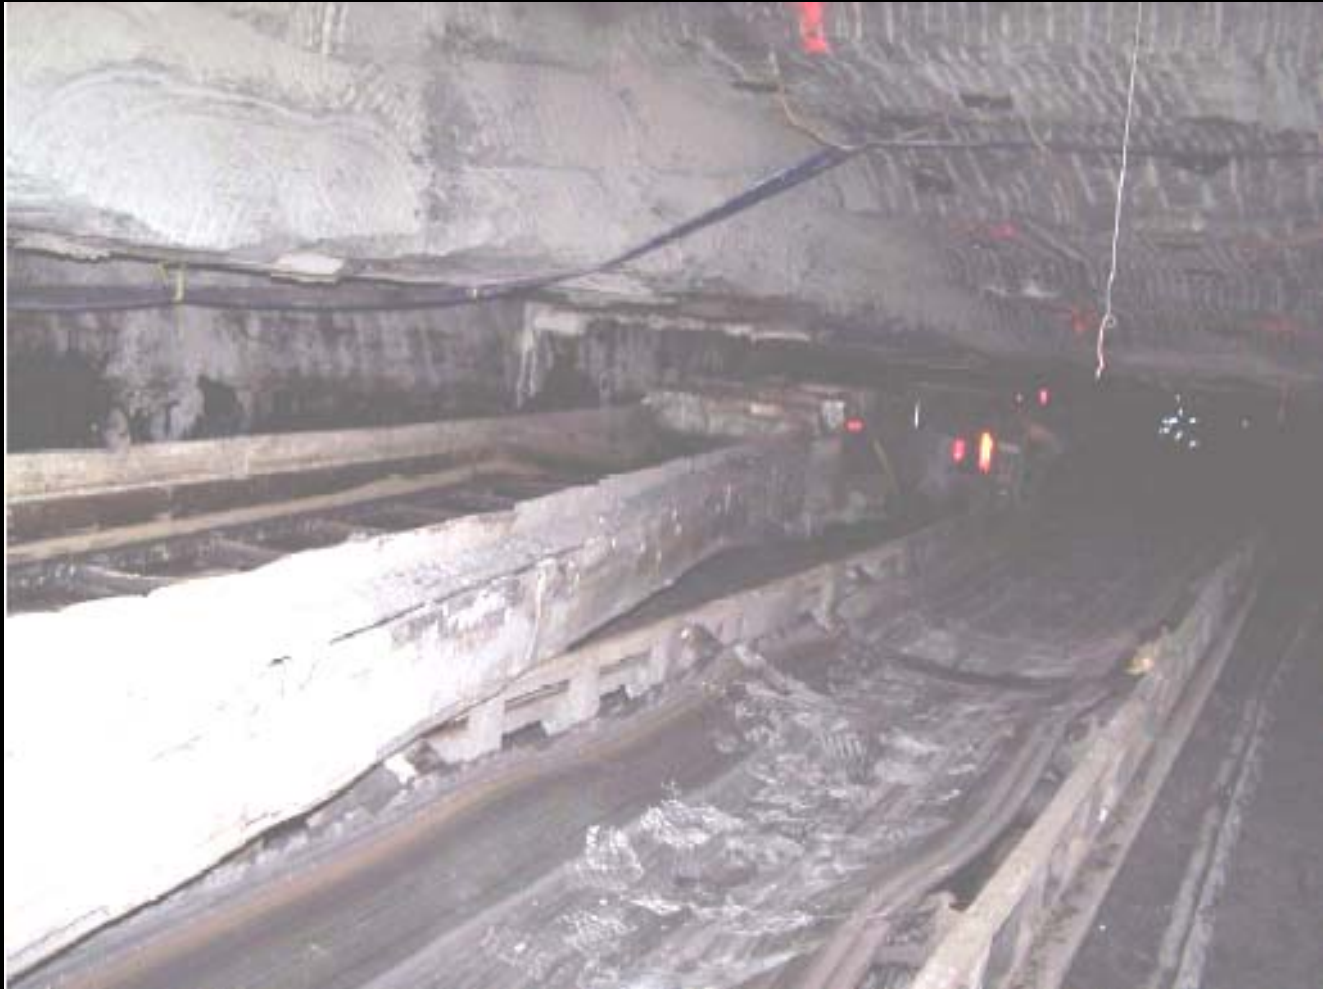
At approximately 12:15 p.m., on Friday, April 7, 2006, a 53-year old mobile bridge operator with 32 years of mining experience was fatally injured when he was caught in the pinch point between the mobile bridge conveyor boom, the low-low belt framing and the tail dolly.

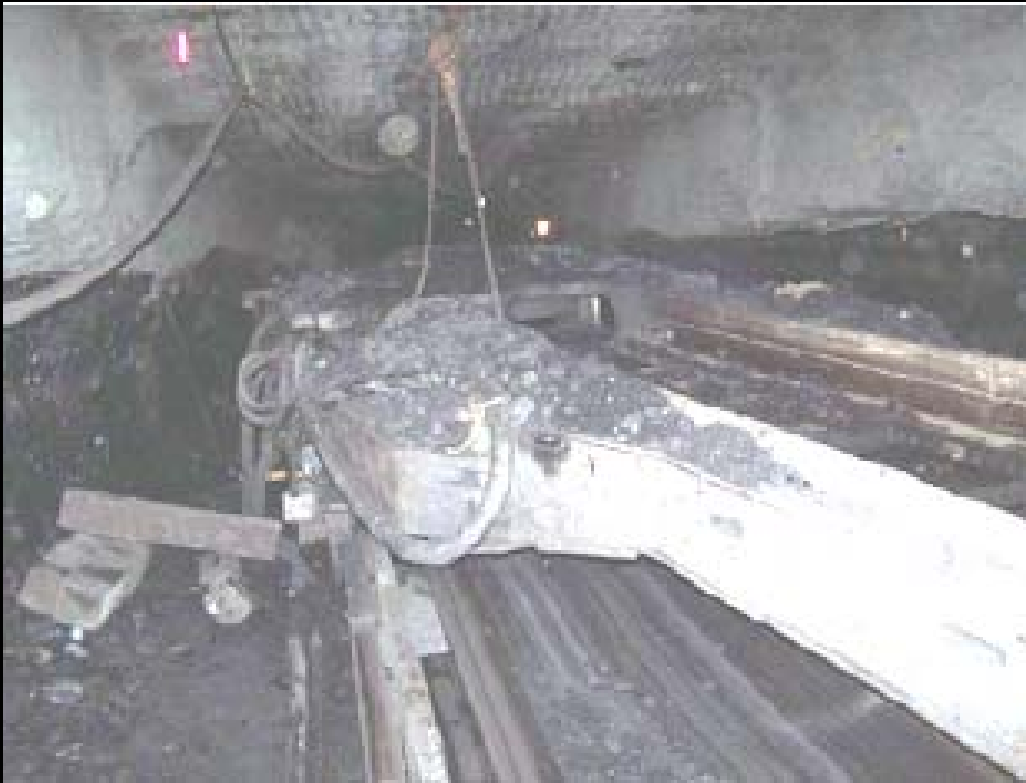
The accident occurred because the continuous haulage system was restarted without following the proper communication procedure to ensure all mobile bridge operators were ready to move the system. Other factors

contributing to the occurrence of the accident were safety devices installed on the continuous haulage system which did not reliably disable the machines, the continuous haulage system was not disabled prior to the #1 mobile bridge operator exiting the operator's compartment, and the location of the victim in the pinch point area between the mobile bridge conveyor and the low-low belt structure. Work practices and procedures contributed to the accident.
