Coal Mine Fatal Accident 2007-10

Operator:	Jim Walter Resources, Incorporated
Mine:	No. 3 Mine
Contractor:	Hopper and Chandler Steel Erectors, Inc. (S098)
Accident Date:	July 30, 2007
Classification:	Fall of Person
Location:	Dist. 11, Jefferson County, Alabama
Mine Type:	Surface Area of Underground Coal Mine
Employment:	Operator (1) Contractor (10)
Production:	Non-producing Status

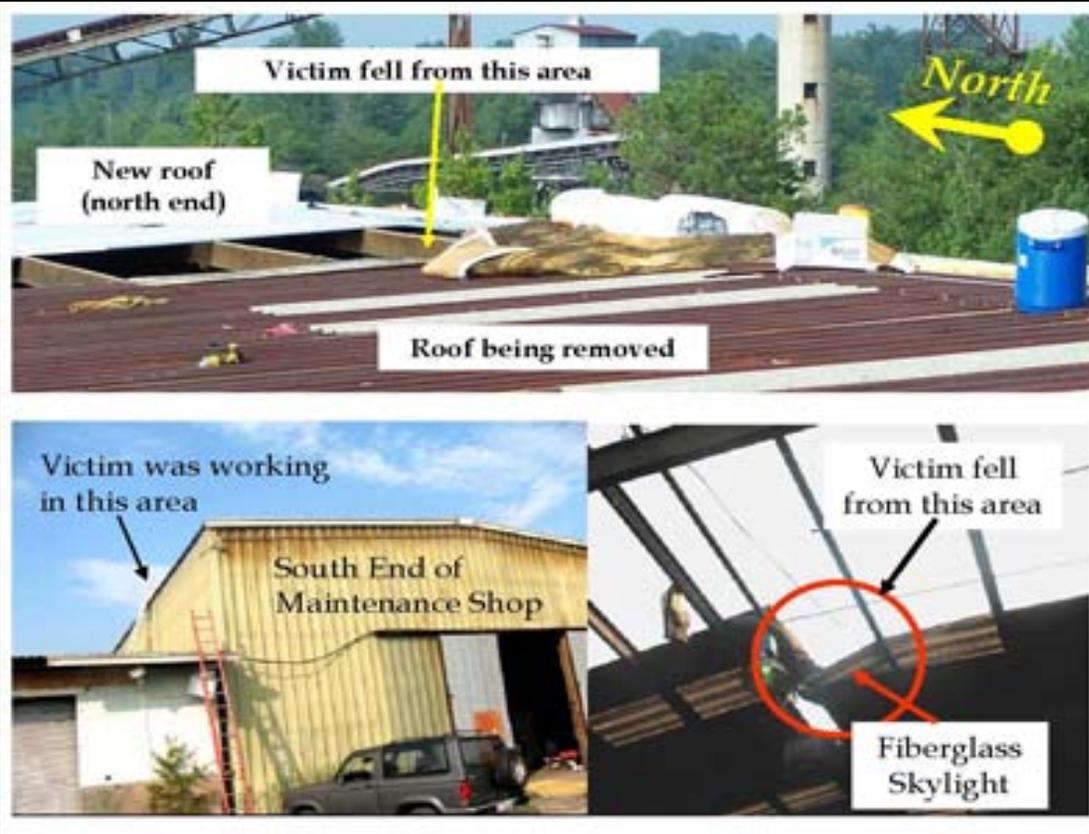
On July 30, 2007, a 27-year old contract laborer with six years experience was fatally injured when he fell through the roof (skylight) of a shop building. Roofing panels were being removed in preparation for a new roof. While a panel was being removed, the victim apparently stepped on a fiberglass skylight panel, and fell approximately 28-feet to the shop floor.

The accident occurred because the victim, although wearing a safety harness, did not have a harness lanyard secured while working in an area where there was a danger of falling. Management officials for the contractor did not comply with the applicable regulation governing the use of fall protection.

Root Cause: The safety harness lanyard of the victim was not secured where there was a danger of falling.

Corrective Action: The contractor developed and implemented a fall protection plan that included the placement of anchorage points that were used by all workers when roofing activities were allowed to continue.

Root Cause: The management officials for the contractor did not comply with the applicable regulation governing the use of fall protection.

Corrective Action: JWR personnel provided training to all contractor personnel on MSHA requirements for fall protection.
