**Fatality #1 - January 7, 2013**  
**(Victim Died January 19, 2013)**  
**Fall of Highwall – Kentucky – Crushed, Broken Limestone NEC**  
**Lafarge West, Inc – Three Rivers Quarry**

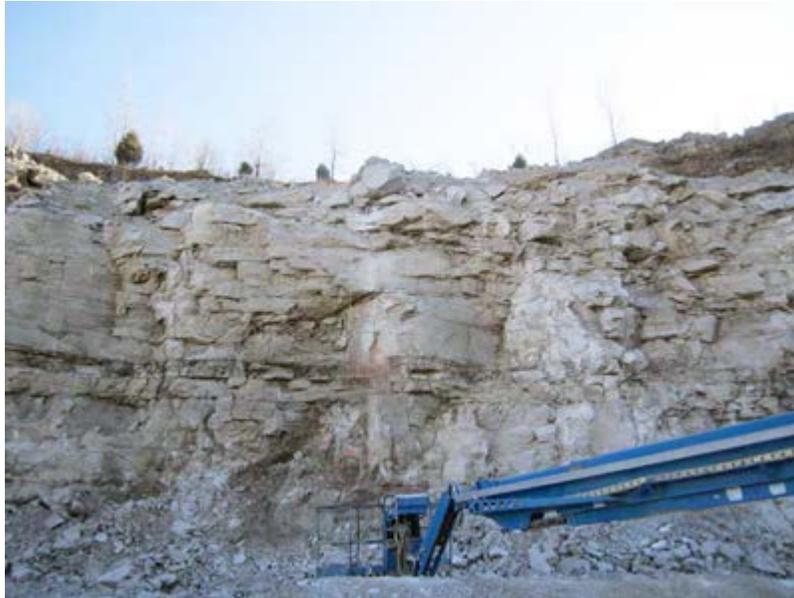
**METAL/NONMETAL MINE FATALITY** - On January 7, 2013, a 49-year old assistant plant manager with 30 years of experience was injured at a crushed stone operation. The victim was working on a lift, taking samples from a highwall, when a large rock fell and struck him. He was hospitalized and died on January 19, 2013.

- Establish and discuss safe work procedures for working near highwalls. Identify and control all hazards.
- Train all persons to recognize adverse conditions and environmental factors that can decrease highwall stability and understand safe job procedures to eliminate all hazards before beginning work.
- Look, Listen and Evaluate pit and highwall conditions daily, especially after each rain, freeze, or thaw.
- Remove loose or overhanging material from the face. Correct hazardous conditions by working from a safe location.
- Ensure that work or travel areas and equipment are a safe distance from the toe of the highwall.
