## RECOMMENDED GUIDELINES on REPAIR or REBUILD and MAINTENANCE of CIRCUIT BREAKERS

(NOTE: Pictures used are only examples.)

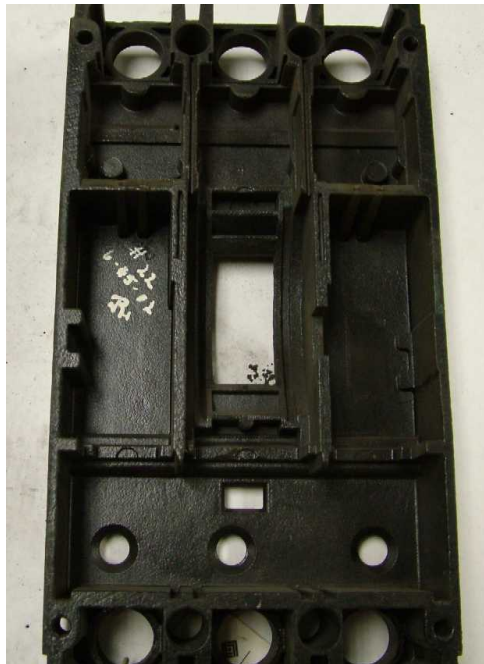
- c. Circuit breaker full load current, voltage, and type should be present.
2. Shot Blasting
- Shot blasting removes resin from the case and may weaken the structure so that it could fail under a catastrophic event inside the breaker, such as an arc blast. This is an indicator for further inspection.

Figure 3: Shot Blasted and Painted

Paint on the outside of the case does not pose a hazard. However, painting could mask other hazards. Therefore, paint on the exterior of a circuit breaker case is cause to have the mine operator open the circuit breaker for a more in depth inspection.

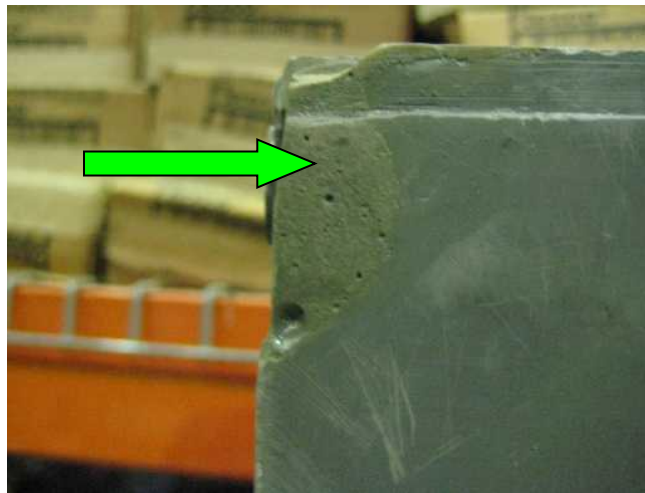
Cases repaired and/or modified using epoxy can be hazardous. A damaged case can be weak enough that an event occurring inside the circuit breaker can cause the case to fail and rupture causing the epoxy to become shrapnel that can injure personnel nearby. The patching material may not be enough to restore the case's strength. Some patching material may be conductive and can cause a shock hazard.

Figure 4: Epoxy Repair to Case Corner

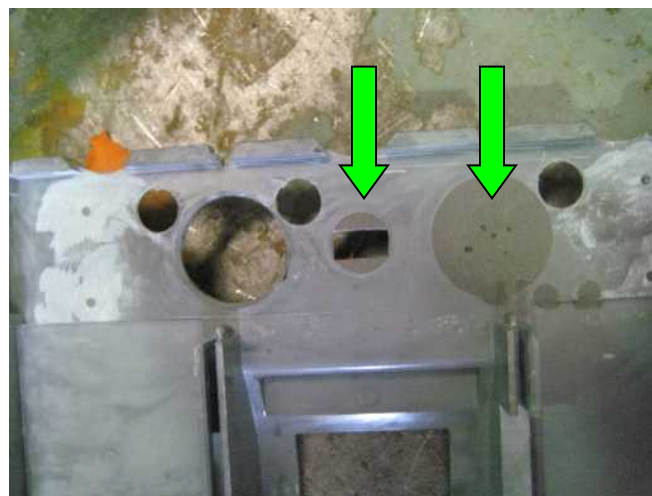
Figure 5: Epoxy Modification to Cover

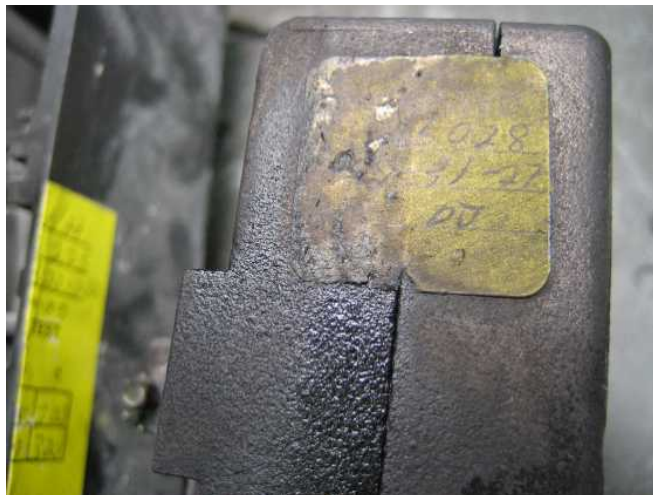
Signs of overheating (such as carbon smears, warped or melted case, and/or burnt areas) are cause for having the mine operator open a circuit breaker for a more in depth inspection or removal from service. These are indicators that the circuit breaker case integrity has been compromised. Signs of overheating are also indicators that the electrical insulation between the phases may have been compromised through carbon tracking.

Figure 7: Bubbled & Charred

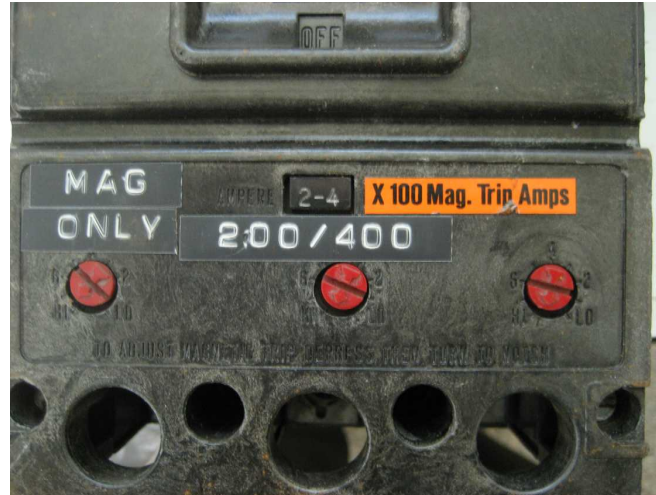
If the circuit breaker trip unit is not properly set, it can cause damage to the cable it is protecting. It also poses the hazards of shock and fire. The trip unit must be visibly identified to ensure it is adjusted correctly.

Figure 8: Settings on High

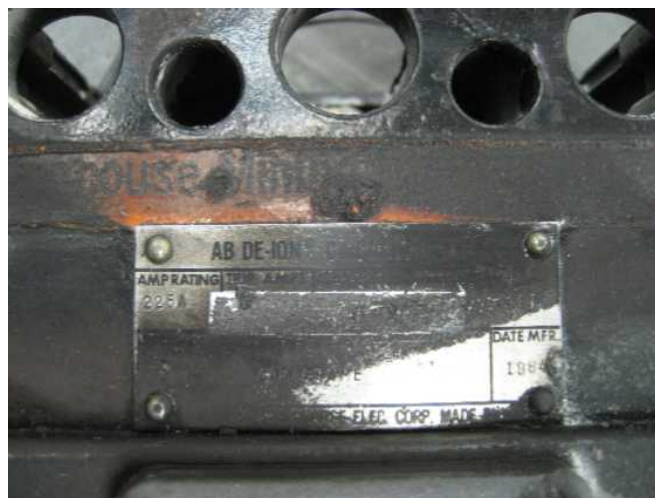
Circuit breakers should not have anything attached to the case, and especially not with metallic fasteners. However, some of the older circuit breakers still in use have metallic ID tags fastened to the outside of the breaker with metal rivets. The metallic plate is an indicator to inspect for insulating material inside the breaker. These rivets must not extend to the inside of the case. If the rivet hole is drilled through, it must be insulated with a suitable dielectric. Failure to follow this requirement could allow a dangerous electric potential to be present on the exterior of the breaker, which could be contacted by personnel.

Figure 9: Metallic Tag (Painted)
