Inspection Code E01 Event No. 4120376

Company Name Performance Coal Company

Mine Name Upper Big Branch Mine - South

Mine I.D. Number 46-08436

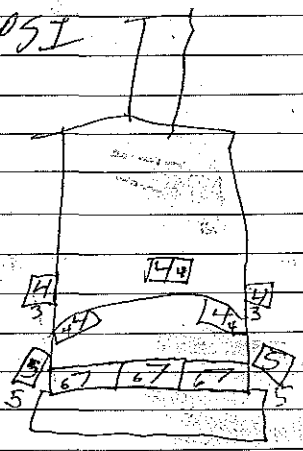
029-0 Left Miner

100 PSI

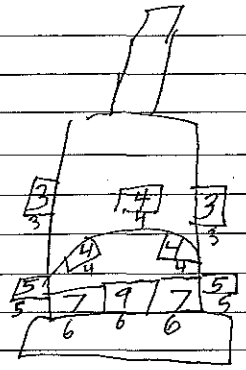
030-0 Right Miner

80 PSI

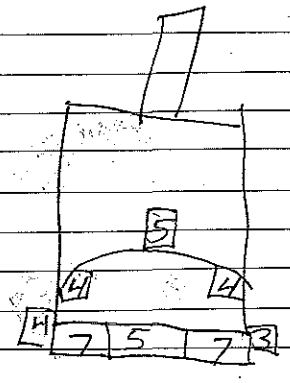
100 PSI
Left Miner
