Appendix A - Persons Participating in the Investigation

Appendix B - Victim Data Sheets

Appendix E - AAI May 5, 2000, Report
Barrier Pillar to Protect Bleeders for Panel 15, South of West Mains

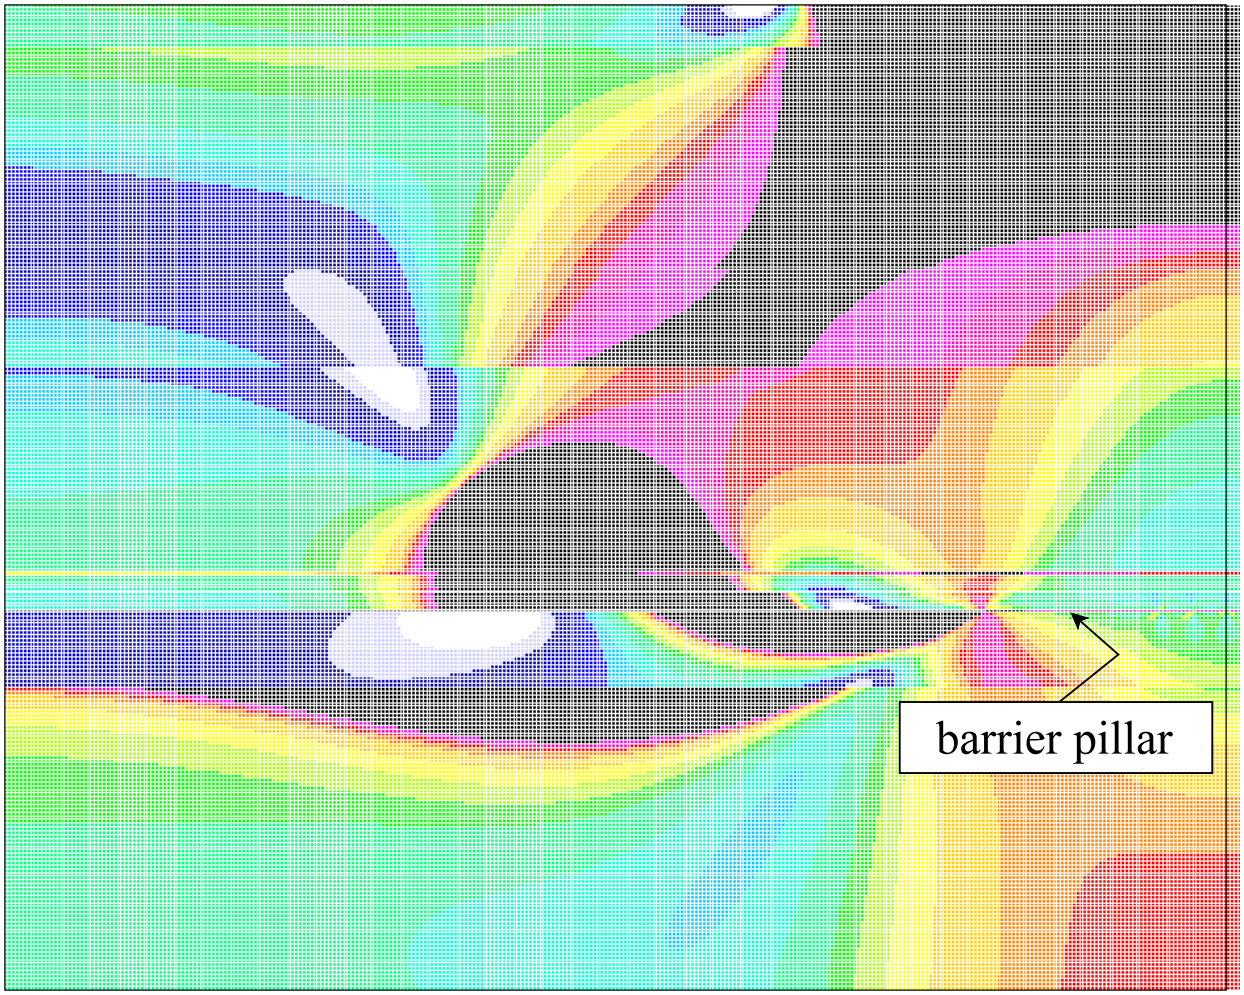
An expanded half-mesh view is shown in Figure 10 where the yield zones are more clearly seen. Strata flexure in tension and failure is indicated near seam level in the roof outside the barrier pillar rib. Floor failure below is also evident in Figure 10. Interestingly, yielding is small in the immediate sandstone floor, but is extensive in the Masuk shale below.

Figure 10. A half-mesh view of element safety factors showing dark (black) zones of yielding mainly in horizontal tension associated with strata flexure.
