# DIESEL PARTICULATE MATTER

# COAL DIESEL EXHAUST GAS EVALUATION/ISSUES

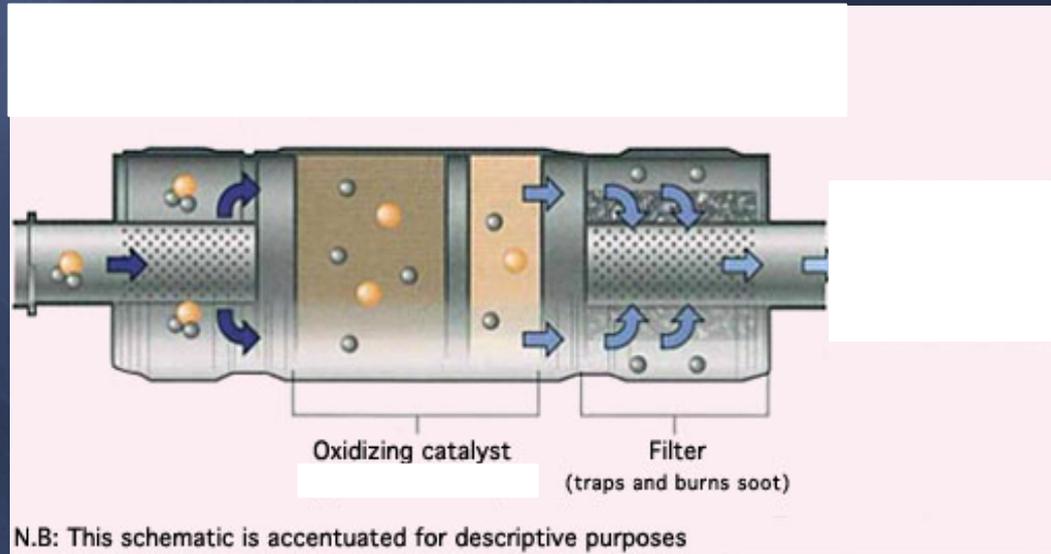
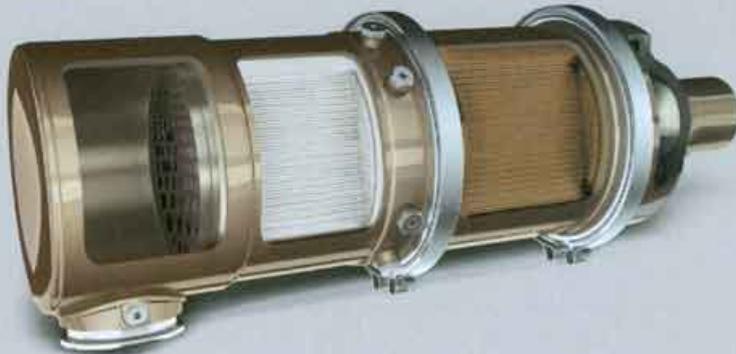
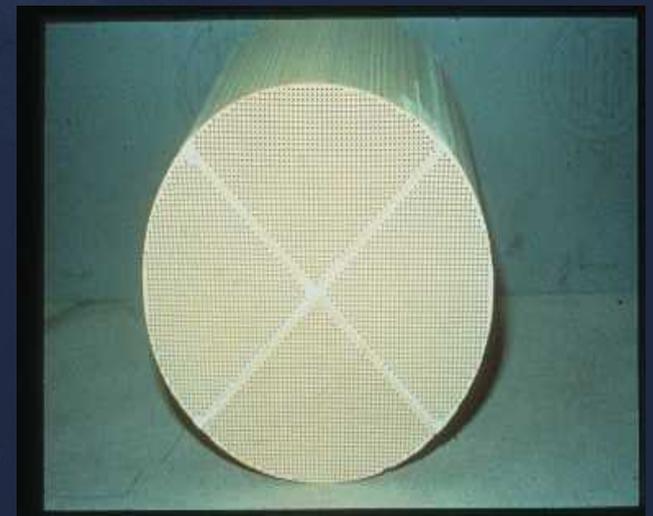
# DOC with DPF

- ▣ Current issues related to an aftertreatment that is improperly sized for the engine
- ▣ Larger aftertreatment device is producing more NO<sub>2</sub> than needed in handling DPM resulting in excess NO<sub>2</sub> being released into the mine environment
- ▣ Configuration of exhaust system may contribute to problem of using wrong size aftertreatment due to concerns for engine backpressure limits

# Oversized DPF to Maintain BP due to Exhaust Route

- ▣ Mine operators test diesel equipment outfitted with a platinum catalyst aftertreatment
- ▣ Remove from service those not meeting the approval; correct deficiencies
- ▣ Ensure DPF purchased is appropriate for the engine
- ▣ Can contact the following persons at MSHA's Approval and Certification Center for assistance in the selection of appropriate diesel aftertreatment.
  - ▣ Phil McCabe                      304-547-2315
  - ▣ Jeffrey Moninger                304-547-2324
