**Independent Review of MSHA's
Actions at Crandall Canyon Mine
Genwal Resources, Incorporated
Huntington, Emery County, Utah**

Earnest C. Teaster, Jr.

Joseph W. Pavlovich

July 21, 2008

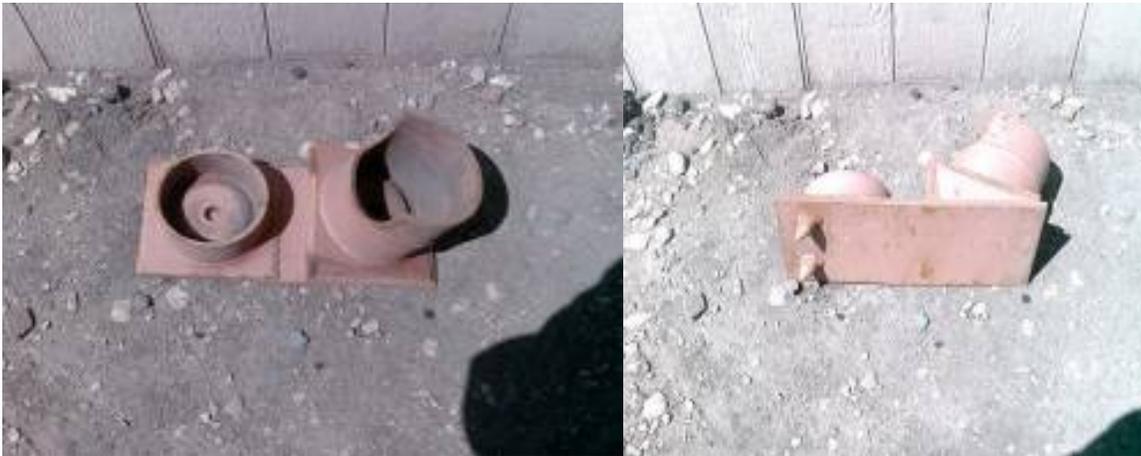
One inspector stated that he was aware of an angled-base bracket that could be used with two Rocprops™ to provide additional lateral support. He had observed this device at other mines and was aware of its ability to withstand lateral forces. The base plate had two sockets for the placement of the Rocprops™, one near-vertical and one angled at approximately 60-degrees. Two spikes, approximately two inches long, were welded to the bottom of the base plate to penetrate the mine floor and resist movement. One Rocprop™ would be pressurized against the roof, just off of vertical, and the second Rocprop™ would be pressurized between roof and floor at an angle, which would wedge the support in tighter if lateral forces were exerted. The photos below show the angled-base bracket and its installation at another mine.
