Coal Mine Fatal Accident 2004-05

Operator:	Raw Coal Mining Company, Inc.
Mine:	Cucumber Mine
Accident Date:	February 10, 2004
Classification:	Powered Haulage
Location:	District 4, McDowell County, WV
Mine Type:	Underground
Employment:	39
Production	650 tons/day

Coal Mine Fatal Accident 2004-05 Powered Haulage

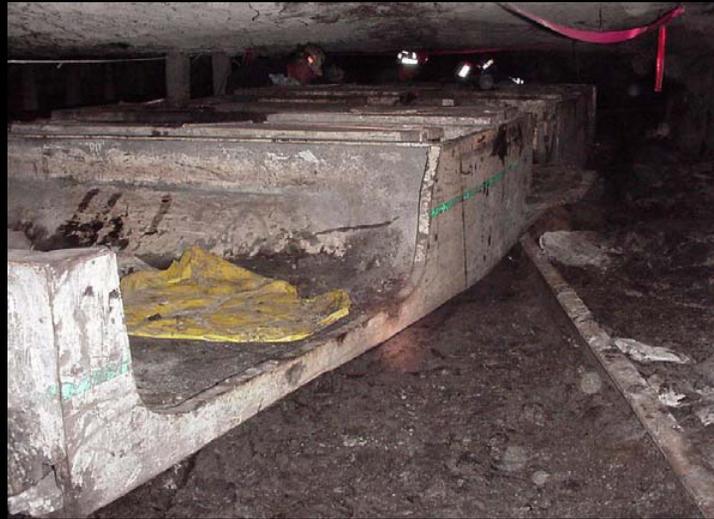
- On Tuesday, February 10, 2004, at 7:35 a.m., a 25-year old roof bolting machine operator with 7 years of mining experience was fatally injured while operating an open-type, battery-powered, track-mounted personnel carrier.
- The personnel carrier entered the track portal through an open airlock door and continued to gain speed as it descended an 8 to 21% grade on damp to wet rails for approximately 139' where it struck the closed inby airlock door.
- The victim was fatally injured during the impact with the inby airlock door.
- The personnel carrier traveled an additional 320' before derailing.
