Coal Mine Fatal Accident 2004-12

Operator:	Jim Walter Resources, Inc.
Mine:	No. 7 Mine
Accident Date:	June 16, 2004
Classification:	Powered Haulage
Location:	District 11, Tuscaloosa County, AL
Mine Type:	Underground
Employment:	415
Production	17,600 Tons/Day

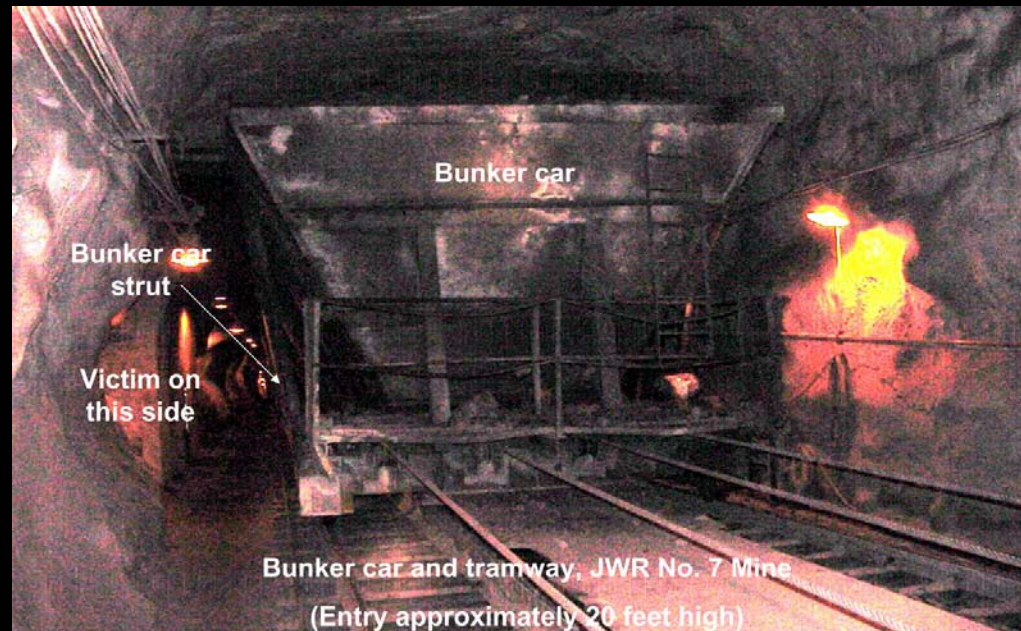
View from the catwalk in front of the production shaft control room above the accident site.

Bunker car
support beam

Upright Channel

Location of
victim

The victim sustained fatal injuries while performing his normal job duties from a position in which a pinch-point between a stationary upright steel channel and a bunker car support beam was created by movement of the bunker cars.

Contributing causes to the accident include leaving the upright sensor channel in place after removing the automatic system from service, inadequate warning devices, and lack of an emergency stop system accessible to miners working around the bunker.

Corrective Actions: The mine operator removed the upright channel.

Corrective Actions: The operator installed additional strobe lights and an audible warning system that sounds once the bunker movement control lever is activated and before the bunker cars move. In addition, a radio-linked pull-cord system was installed along both sides of the bunker. This pull-cord system stops movement of the bunker cars if the cord is pulled or if a receiver fails to detect the radio signal. The operator has also implemented new procedures for personnel working in the bunker area. These procedures include making initial contact with the control room operator to let the operator know the location of work, the number of people performing the work, and the type of work to be performed. These work crews will have radio communication with the control room operator. The procedures also require that the strobe lights, audible alarm, and pull-cord systems be checked for proper operation by the control room operator at the beginning of the operator's shift.
