Coal Mine Fatal Accident 2004-19

Operator:	Consolidation Coal Company
Mine:	Buchanan Mine #1
Accident Date:	September 26, 2004
Classification:	Powered Haulage
Location:	District 5, Buchanan County, VA
Mine Type:	Underground
Employment:	418
Production	18,000 Tons/Day

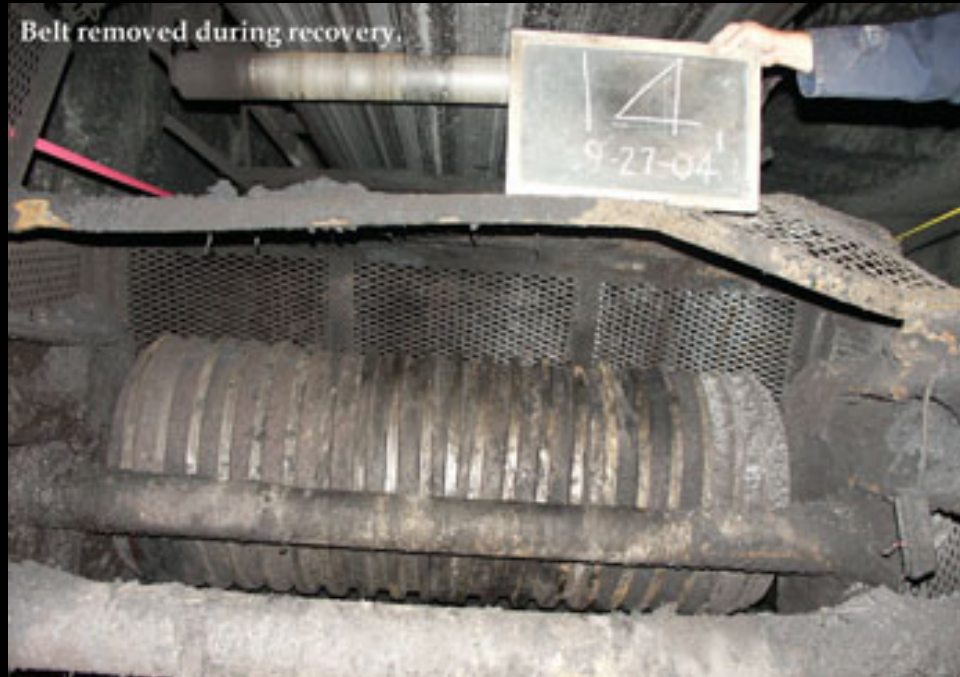
At approximately 7:00 p.m., on Sunday, September 26, 2004, a 46-year old utility worker with 12 years mining experience was fatally injured when he came in contact with an underground belt conveyor and tailpiece roller while they were in motion.

The victim was attempting to install a belt scraper at the tailpiece. He attached a chain to the scraper and attempted to throw the other end of the chain between the belts. The chain became caught between the top of the bottom belt and the tail roller, which caused the chain, scraper, and victim to be pulled through the tail roller.

The victim sustained fatal injuries when he was caught between the conveyor belt and tail roller of an underground belt conveyor. The primary cause was performing maintenance work with the belt conveyor running.

Corrective Actions: An Action Plan was submitted to MSHA by the coal company. The plan states that all employees will be given additional training. Mine management will also conduct weekly job observations on employees that normally have duties that require lock-out and tag procedures. These observations will be recorded on appropriate forms.

- Never perform work on a moving conveyor belt!
- Always de-energize equipment and use lockout and tag-out procedures! Ensure that power is off with a visual disconnect before any work is performed on such equipment.
- "Think before you act" - Always identify safety hazards before beginning any work task.
- Ensure that machinery is blocked against motion before performing maintenance or repairs.
- Follow company safety procedures.
- Stay out of areas along a moving conveyor belt where clearance is restricted.
