Coal Mine Fatal Accident 2004-29

Operator:	Tennco Incorporated
Mine:	Valley Creek Mine No. 2
Accident Date:	December 21, 2004
Classification:	Machinery
Location:	District 7, Claiborne County, KY
Mine Type:	Underground
Employment:	28
Production	1100 Tons/Day

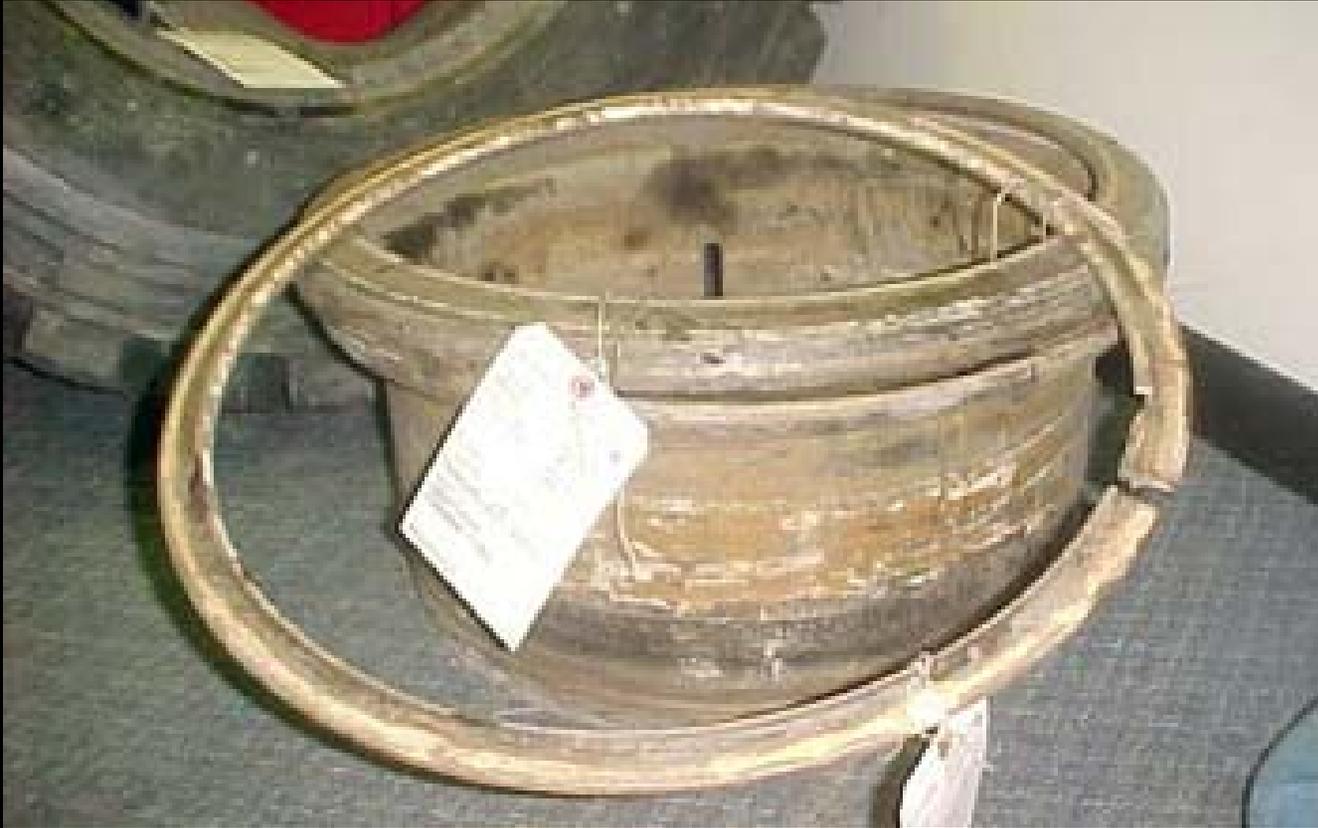
At 4:10 a.m. on Tuesday, December 21, 2004, a 62-year old maintenance/repairman with 33 years of mining experience was underground installing a previously assembled wheel and tire on a Joy 10SC shuttle car. The lock ring and flange separated from the wheel and struck the victim. He died on January 4, 2005, from the injuries sustained in the accident.

The accident occurred when the lock ring and flange separated from the rim assembly violently during the mounting of the 1200-20 air filled tire. The exact mechanism of the lock ring and flange separation could not be determined. The accident resulted from the cumulative effect of deficiencies that occurred during the assembly, handling, and mounting of the wheel and tire unit.

Corrective Actions: The mine operator eliminated the use of split rim air filled shuttle car tires and is now using foam filled tires which do not present the same hazards as air filled tires.
