MNM Fatal 2004 - 02

- Falling Material Accident (New Mexico)
- January 30, 2004
- Sand and Gravel Operation
- Plant Manager
- 60 years old
- 40 years experience

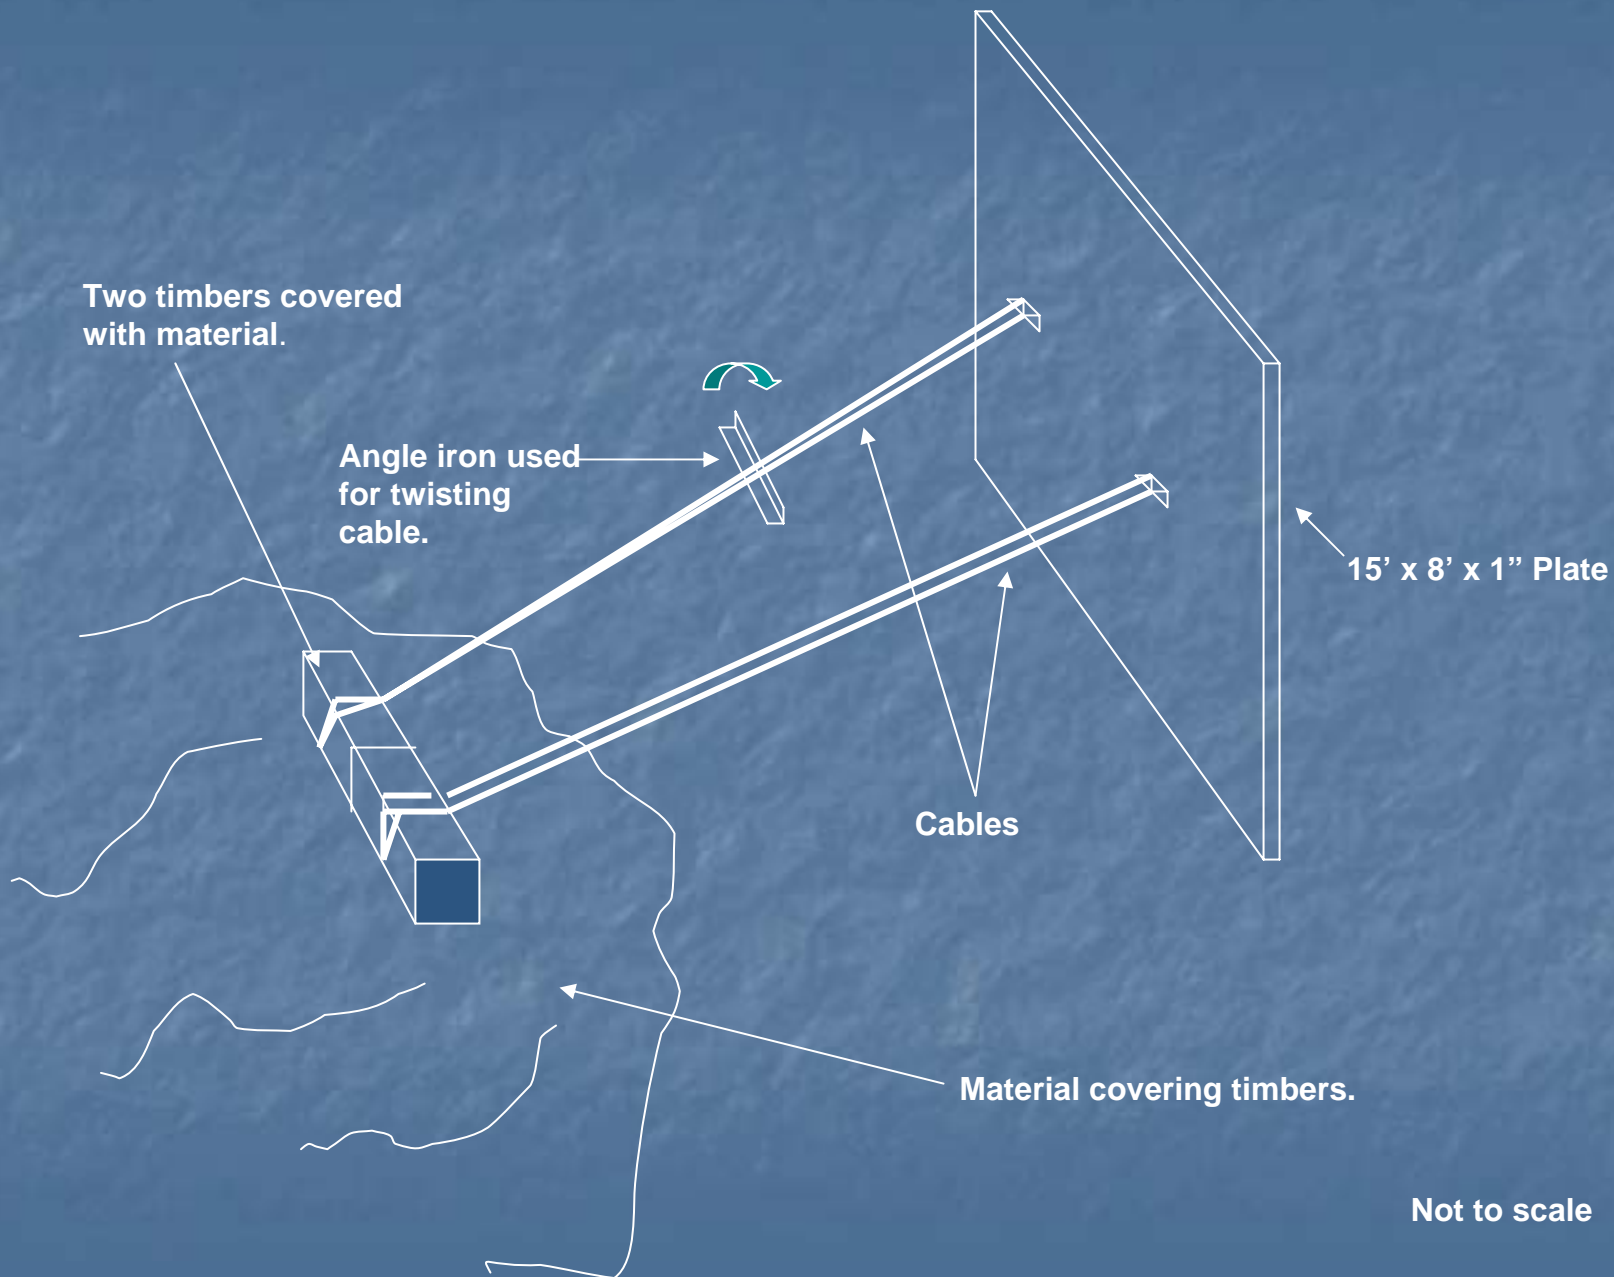
Why Did Accident Occur?

- Plate was resting on its edge leaning against plant.
- No steps taken to block or secure plate.
- Victim positioned himself in fall zone of plate.
