## Coal Mine Fatal Accident 2005-14 & 15

Operator:	Bell County Coal Corporation
Mine:	Preparation Plant
Accident Date:	August 19, 2005
Classification:	Powered Haulage
Location:	Dist. 7, Bell County, Kentucky
Mine Type:	Preparation Plant
Production:	5,000 tons raw coal processed/day

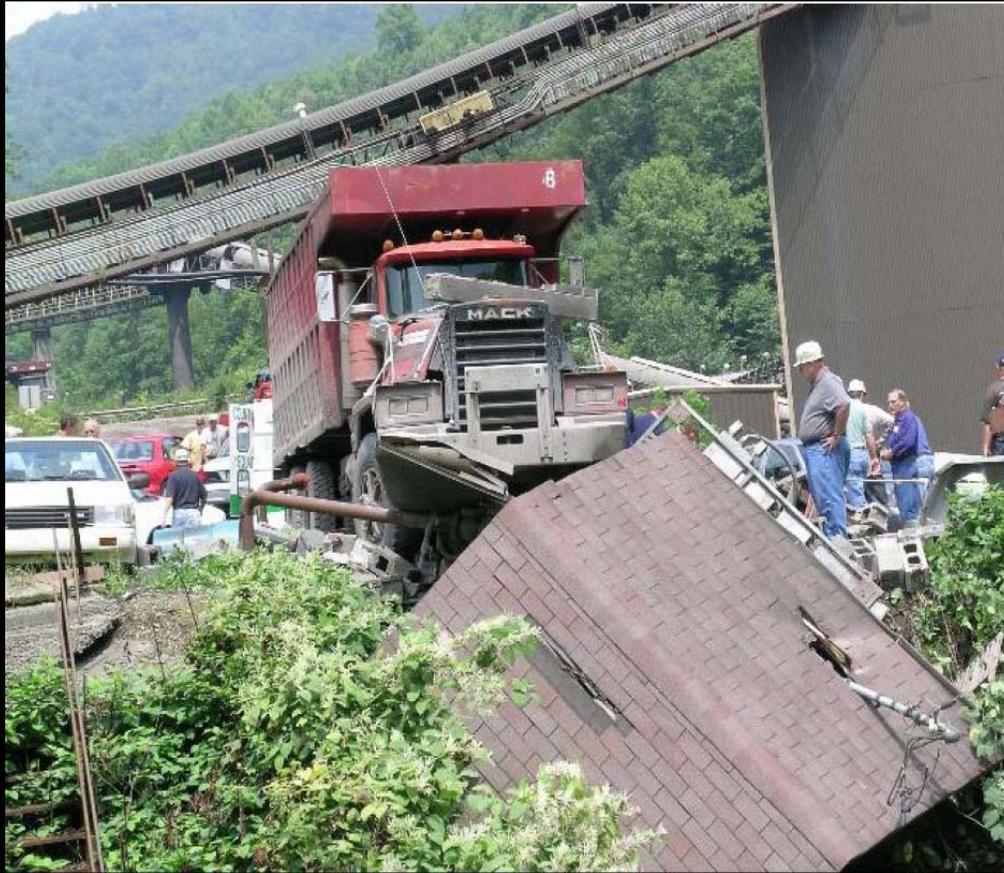
On August 19, 2005, operations at the preparation plant proceeded normally from the 7:00 a.m. starting time until approximately noon. The contract refuse truckers had emptied the refuse bin and were waiting for it to refill to resume hauling. Since it was near lunch time, and it would be several minutes before the bin would be refilled, victim A, a truck driver suggested that they go to the pump house for lunch. This was the typical meeting location for the truckers and was less than 50 feet from the bin.

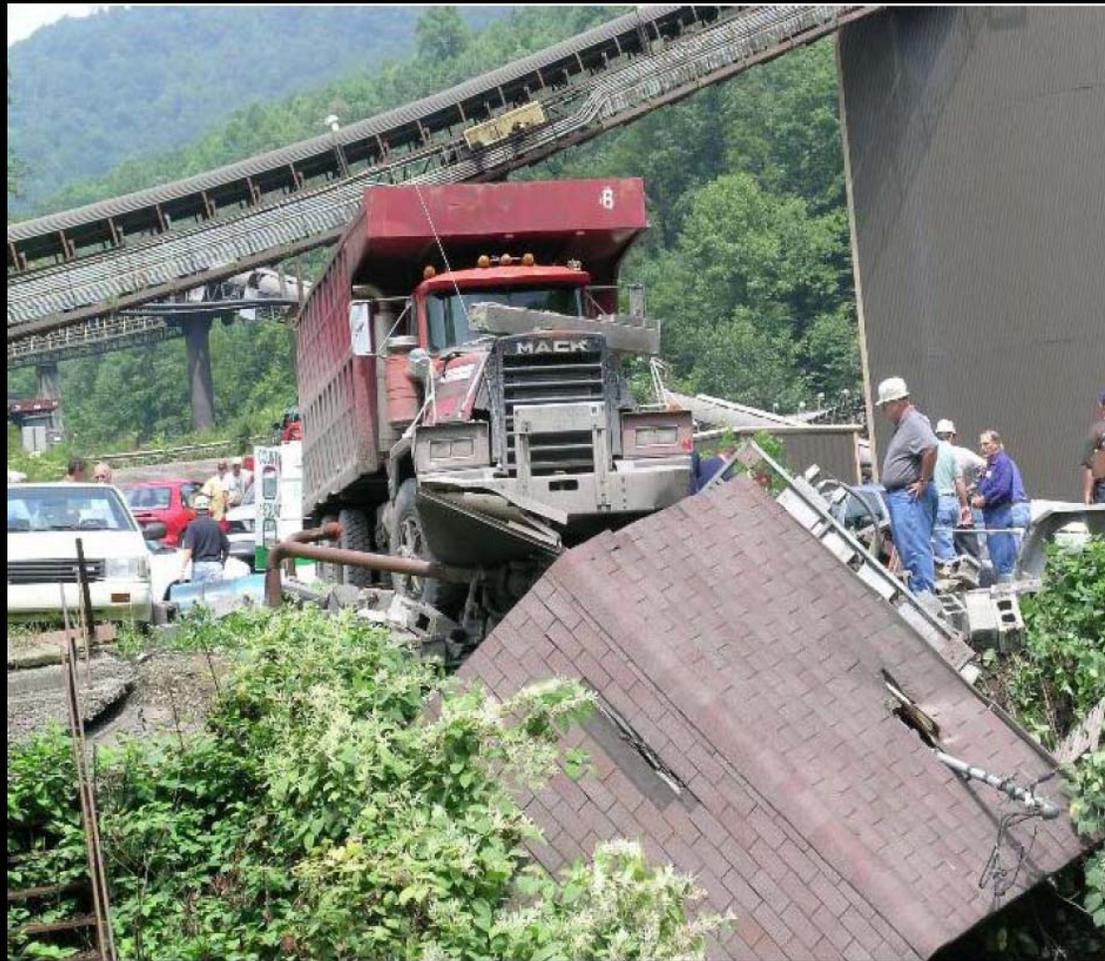
**Human Factors:** Urine and blood samples were obtained from the driver of the runaway truck shortly after the accident. A toxicology analysis was conducted with the results as follows: Alcohol content of blood - 0.00gram/100 ml. Drug content of blood - No drugs identified; Drug content of urine - presence of Cannabinoid Metabolite(s) indicated.
