Coal Mine Fatal Accident 2005-18

Operator:	Reading Anthracite Company
Mine:	Wadesville - P33
Accident Date:	December 6, 2005
Classification:	Powered Haulage
Location:	Dist. 1, Schuylkill County, PA
Mine Type:	Surface Mine
Production:	1,130 tons coal/day

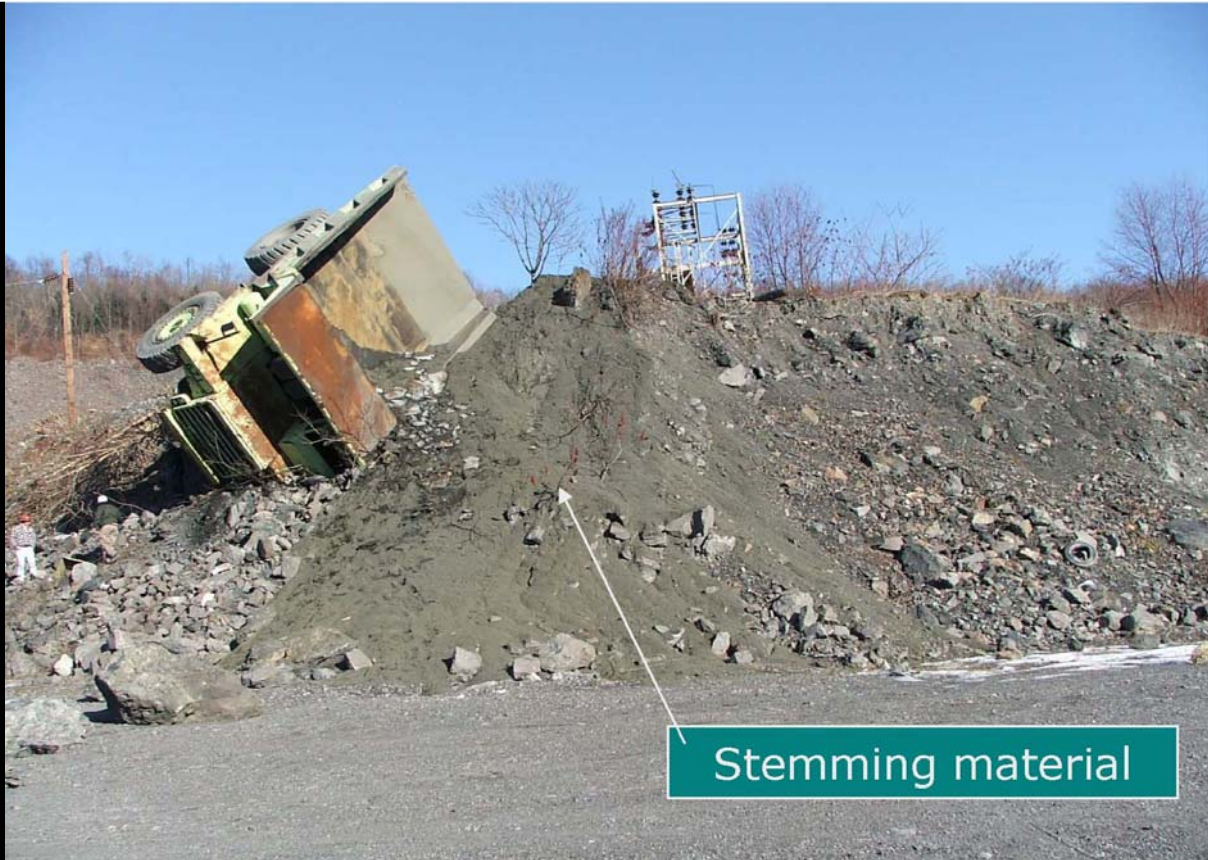
The victim was assigned to operate a front-end loader to transport stemming material. He found that the stemming stockpile was empty and drove the front-end loader to the blasting area and told the blasting foreman. The foreman asked him to drive a truck hauling stemming material from the preparation plant to the blasting area.

Even though a snowfall of approximately 2.5 inches occurred two days prior to the accident, the haul road was found in a safe condition.

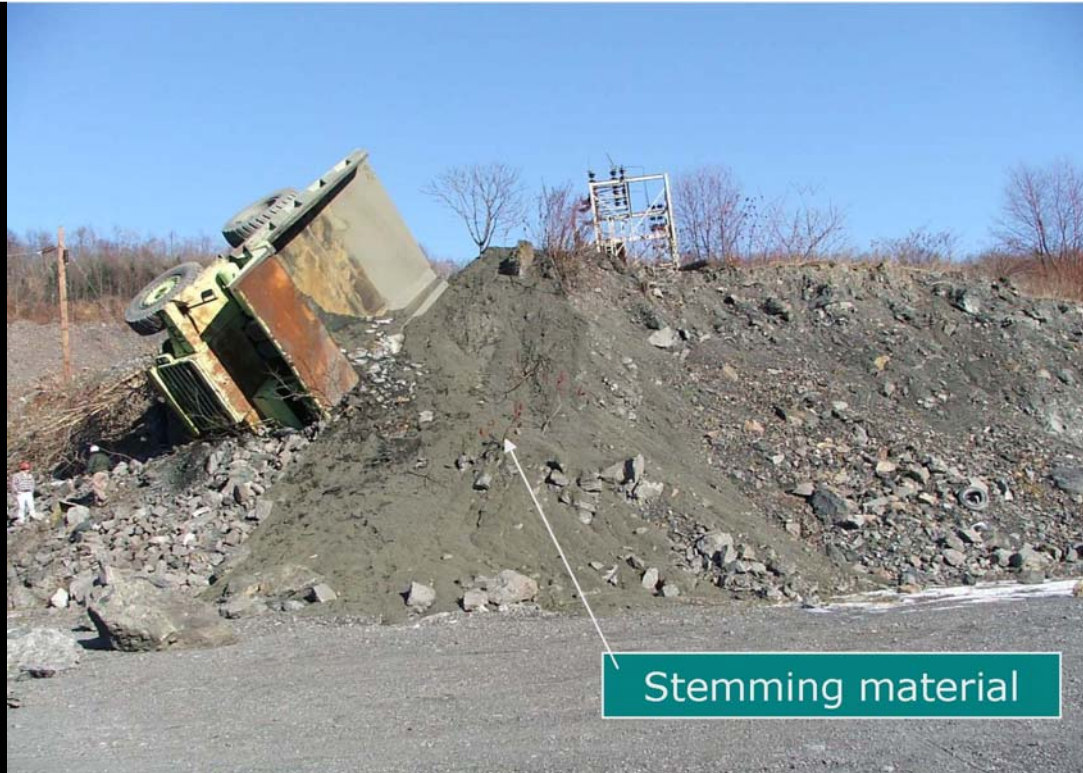
The foreman requested the mechanics to start a haul truck to transport stemming material. The mechanics started a Euclid R-85 haul truck, Company No. 671. This truck was used primarily to haul stemming material but had not been operated for four to six weeks.

Later that day, the Euclid R-85 haul truck was loaded with the fifth load of stemming material. Another front-end loader operator told the victim that this would be the last load of the day. The victim did not see any oil leaks or puddles of oil when the truck left the loading area.
