REPORT OF INVESTIGATION

Underground Nonmetal Mine  
(Trona)

Fatal Powered Haulage Accident

Big Island Mine and Refinery  
OCI Wyoming LP  
Green River, Sweetwater County, Wyoming  
Mine I.D. No. 48-00154

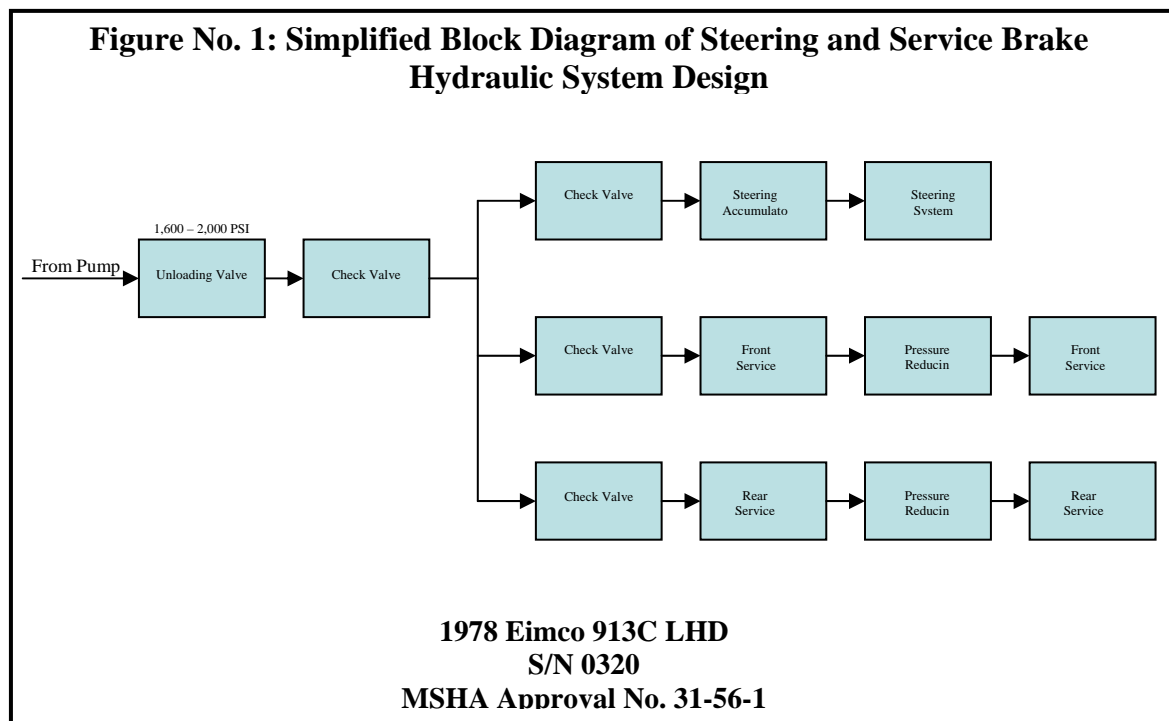
brake hydraulic system design. The steering and brake systems were designed so a common pump provided supply pressure to both systems. Supply pressure was maintained between 1,600-2,000 pounds per square inch gage (PSIG) when the engine was running through the use of an unloading valve.

Each of the three circuits (steering, front and rear service brakes) had a check valve that isolated the respective circuits in the event of a single component failure in one of the other circuits. An accumulator provided reserve pressure to bring the machine to a controlled stop in the event of an engine shut down. A one gallon, nitrogen charged bladder-type accumulator was used in the steering system and a one quart, nitrogen charged bladder-type accumulator was used in each of both the front and rear service brake systems. The service manual for the machine stated that the pre-charge pressure for all three accumulators was 900 PSIG. Hydraulic pressure to the front and rear brake circuits was modulated through pressure reducing valves controlled by the service brake foot pedal.

Functional tests conducted on the service brake system and a visual inspection of selected components that were removed identified that the check valve immediately downstream of the unloading valve, the check valves for each of the service brake systems, and both accumulators for each of the service brakes systems were defective. Figure No. 2 represents the simplified block diagram of

steering and service brake hydraulic system with the defects identified (illustrated with a line through the respective defective component blocks).

The effect of these defects did not allow the forklift to maintain pressure in either of the two service brake circuits once the engine was shut down.

Two significant results were found when the service brakes were tested. The operator would not be able to apply the service brakes once the engine was shut down because both service brake circuits would immediately lose pressure. Also, the operator would not be able to continue to hold the machine on the grade in the accident area with the service brakes once the engine was shut down because both circuits would immediately lose total pressure.

Visual inspection of all three check valves indicated that they would not prevent backflow due to missing and/or damaged internal components. Attempts were made to charge the two service brake accumulators after they were removed from the machine but neither of them would hold any significant pressure. Audible leaks were detected within the bladders of these two accumulators.

The defective components (the check valve immediately downstream of the unloading valve, the two service brake check valves, and the two service brake accumulators) were replaced and the system was re-tested. With the forklift maintained as recommended by the manufacturer, the operator would be able to continue to hold the machine with the service brakes applied with the engine shut down.
