REPORT OF INVESTIGATION

Fatal Underground Coal Burst Accidents
August 6 and 16, 2007

Crandall Canyon Mine
Genwal Resources Inc
Huntington, Emery County, Utah
ID No. 42-01715

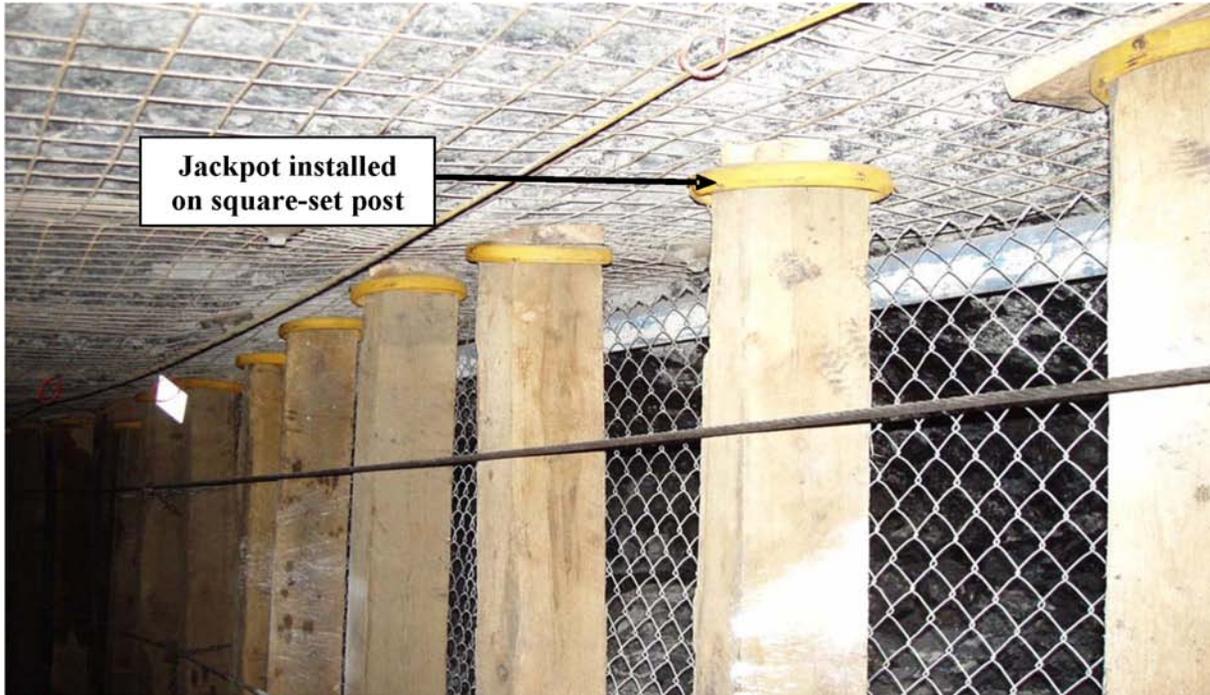
Figure 5 - Hardwood Posts Installed with Jackpots in No. 1 Entry

As specified in the plan, pressurized roof-to-floor standing supports were installed along pillar ribs for protection from pillar bursts. On August 8, 6 x 8-inch hardwood wood posts were installed on both sides of the No. 1 entry beginning at crosscut 118, narrowing the roadway to 14 feet. These posts were capped with Jackpots to actively preload each support between the roof and floor (see Figure 5). The wood posts were installed in the No. 1 entry to midway

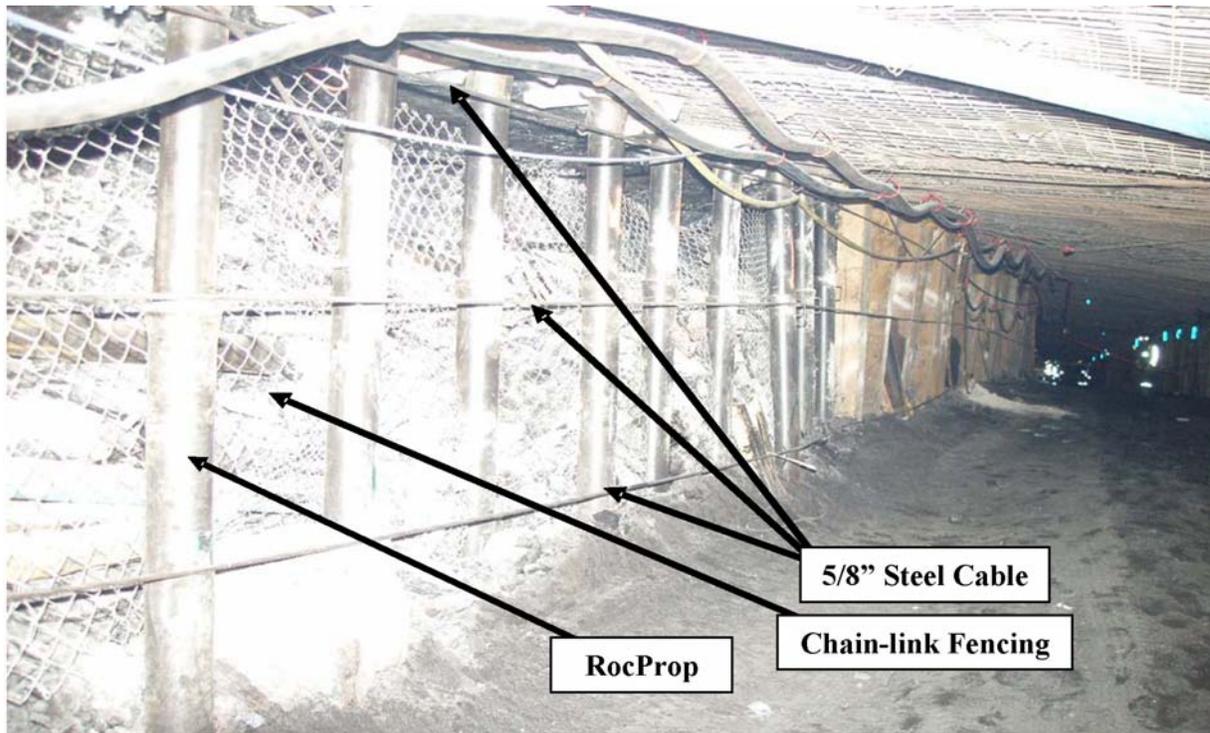
Figure 6 - RocProps, Cables, and Chain-link Fencing Installed in the No. 1 Entry

between crosscut 119 and 120 until RocProps (telescoping steel supports expanded with high pressure water) were available. Thereafter, RocProps were used exclusively as roof-to-floor support (see Figure 6). After the supports were installed, chain-link fence was installed between the rib and the row of supports to confine dislodged coal and to protect miners and the roadway. Additionally, 5/8-inch steel cables were wrapped around the RocProps to secure them from being dislodged.

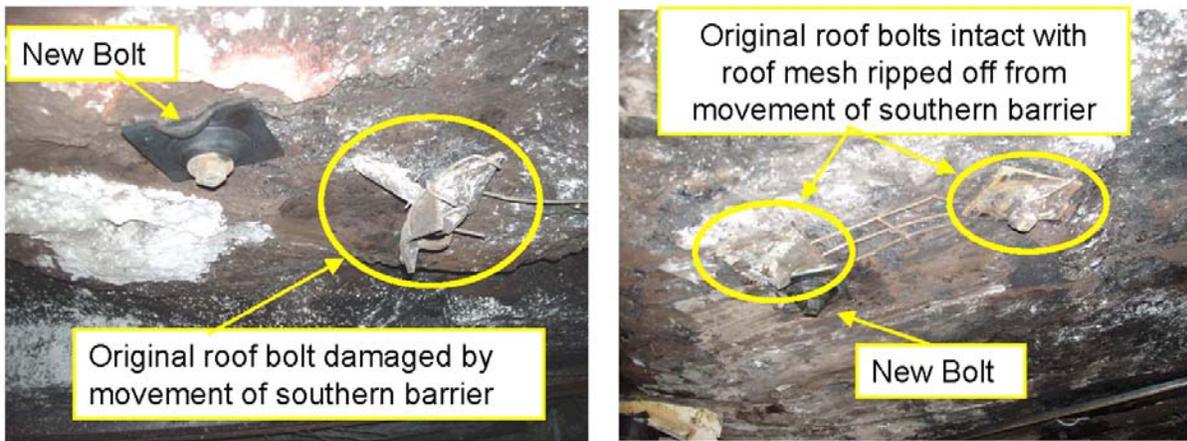
As loading advanced inby crosscut 123, rescuers observed that part of the barrier south of the No. 1 entry had moved northward as a result of the initial August 6 ground failure. The barrier rib had shifted northward as a unit, as much as 10 feet. In some areas the displaced barrier slid along the immediate roof and tore loose the original roof mesh (see Figure 7). In other areas, the immediate roof was carried northward and damaged the original installed roof bolts (Figure 8).

Figure 7- Damaged Roof Bolts and Torn Mesh after August 6 Accident Resulting from Northward Movement of Southern Barrier

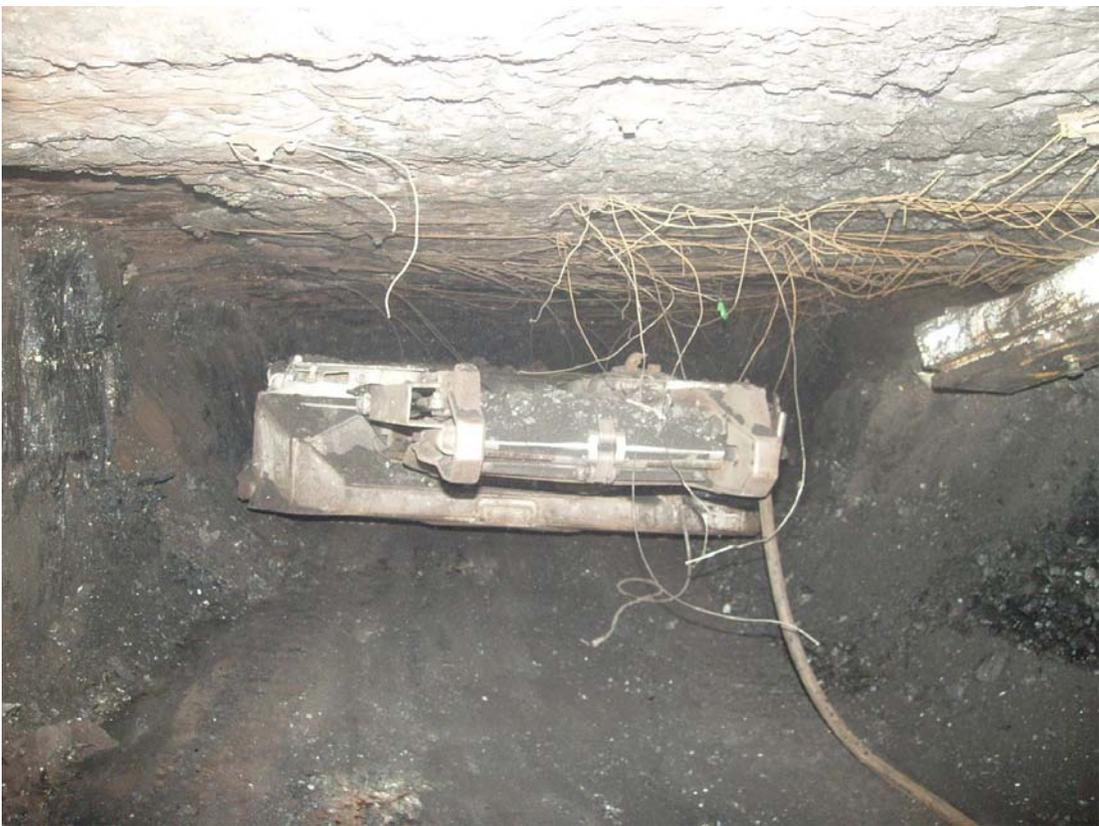
Figure 11 - Continuous Mining Machine in Loading Area Inby Crosscut 124

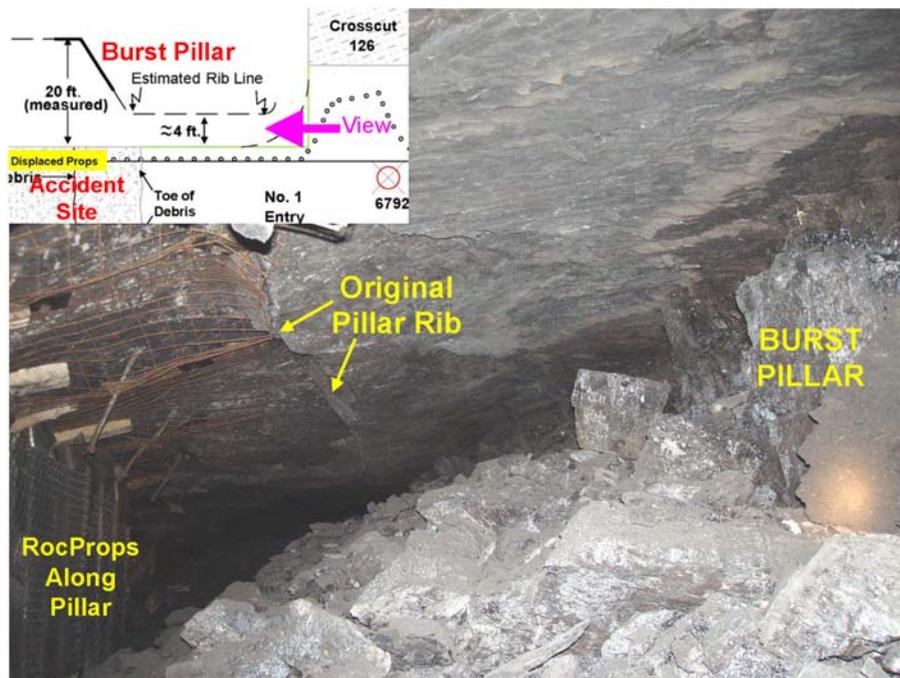
At 6:38 p.m., as the crew completed installing ground support in the clean-up area, the coal pillar between the No. 1 and No. 2 entries burst. Coal was thrown violently across the No. 1 entry during the magnitude 1.9 seismic event. The burst created a void up to 20 feet deep into the pillar at the roof line (see Figure 12 and Figure 13, view indicated by arrow). The dislodged coal threw eight RocProps, steel cables, chain-link fence, and a steel channel toward the left side of the entry, striking the rescue workers and filling the entry with approximately four feet of debris (see Figure 14). Heavy dust filled the clean-up area, reduced visibility, and impaired breathing. Oxygen deficient air from the inby area migrated over the miners. The dust and oxygen deficiency were slow to clear due to damaged ventilation controls.

Figure 12 – Damage to Outby Portion of Pillar on Right Side of No. 1 Entry (Outby August 16 Accident Site)

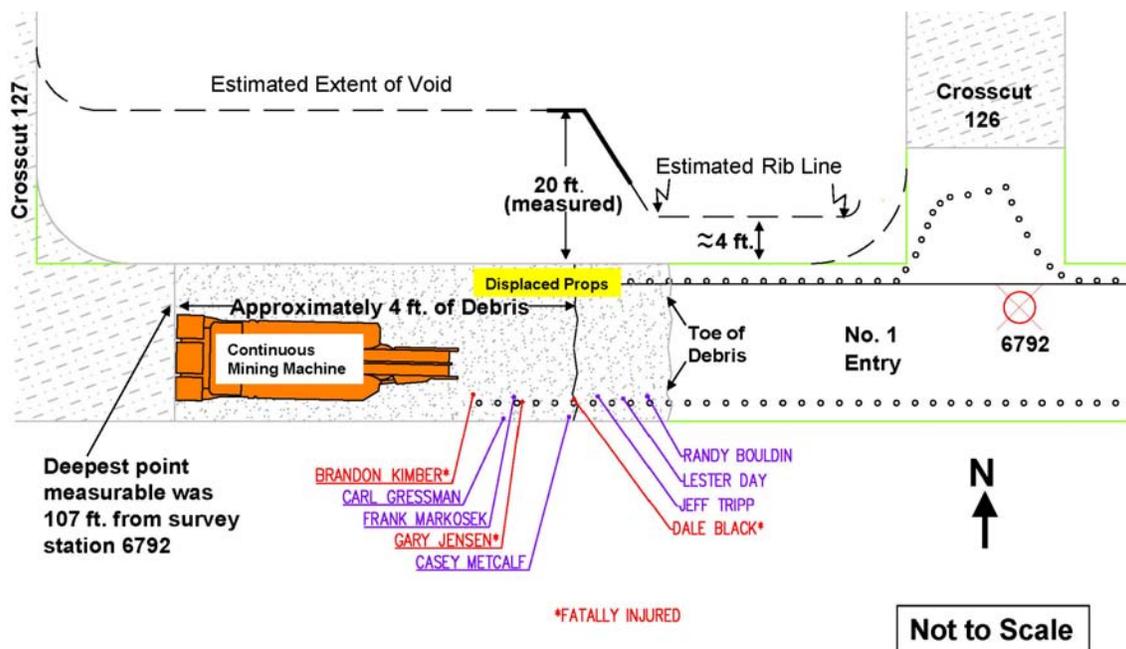
Figure 14 - August 16, 2007, Coal Burst Effects and Location of Injured Miners

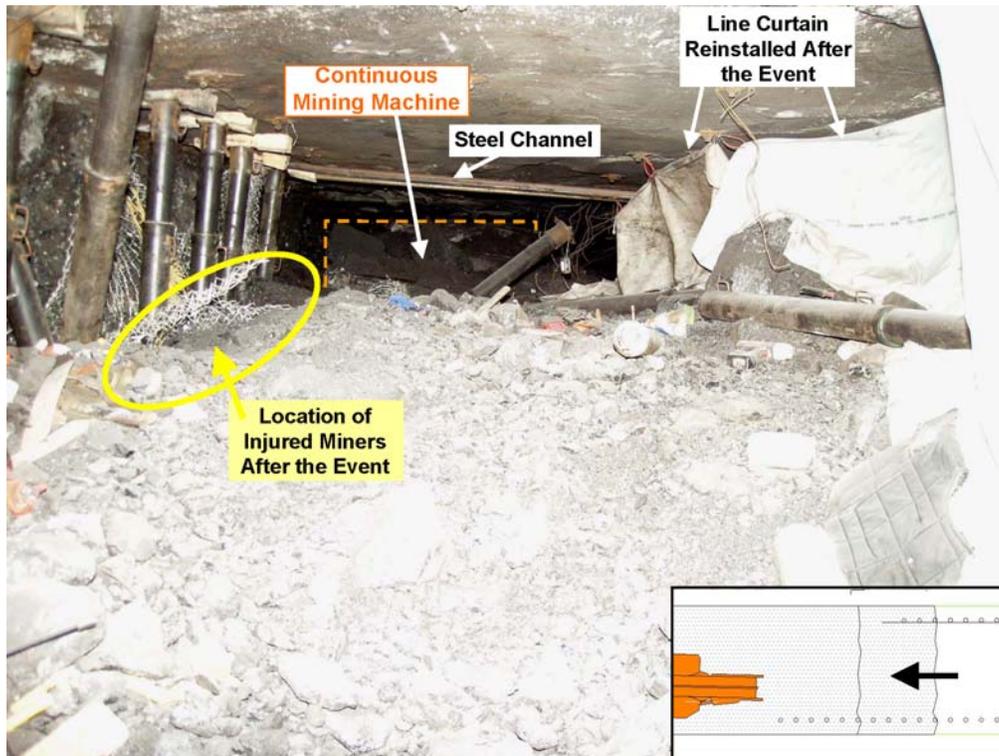
Harper rejoined Mann and Ward. Harper helped Day get a ride outside while Mann and Ward continued inby to assist other victims. As the miners were working to free the injured miners, several factors were slowing their efforts. Not only were rescuers dealing with the quantity of burst material, the roof and rib support that had been installed to protect the workers was now part of the rubble. The electrical cable and water line used to operate the continuous mining machine, along with the line curtain used for ventilation of the clean-up area, were also hindering the recovery of the injured miners (refer to Figure 15).

Figure 15 – Clean-up Area Following the Fatal August 16, 2007, Accident
The direction and location of camera view is denoted by black arrow in the insert.

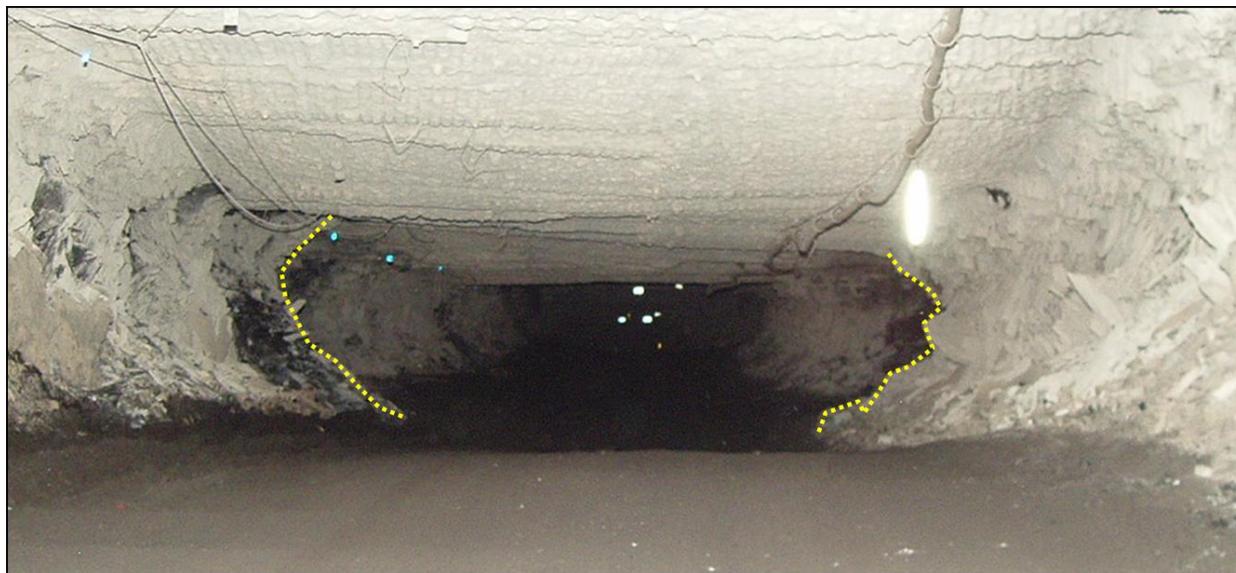
Areas of Main West developed with continuous haulage were mined an average of approximately 20 to 21 feet wide (based on measurements from 1991 era mining east of crosscut 107). In the newer development, entries and crosscuts were mined 18 feet wide, although the approved roof control plan permitted a maximum mining width of 20 feet. Throughout the mine, pillars showed an hour glass rib profile (see Figure 24). Consequently, mining widths measured at mid pillar often were wider than the original excavated width. The hour glass rib profile was evident when overburden exceeded approximately 1,100 feet and was more pronounced as the depth increased. For example, measurements made during the accident investigation beneath 1,500 feet of cover indicated that older entries, which averaged 20.6 feet on development, had hour glassed to 24.7 feet. Similarly, recently mined 18.5-foot wide openings had hour glassed to an average of 22.4 feet.

Figure 24 - Hour Glass Shape of Stressed Pillars

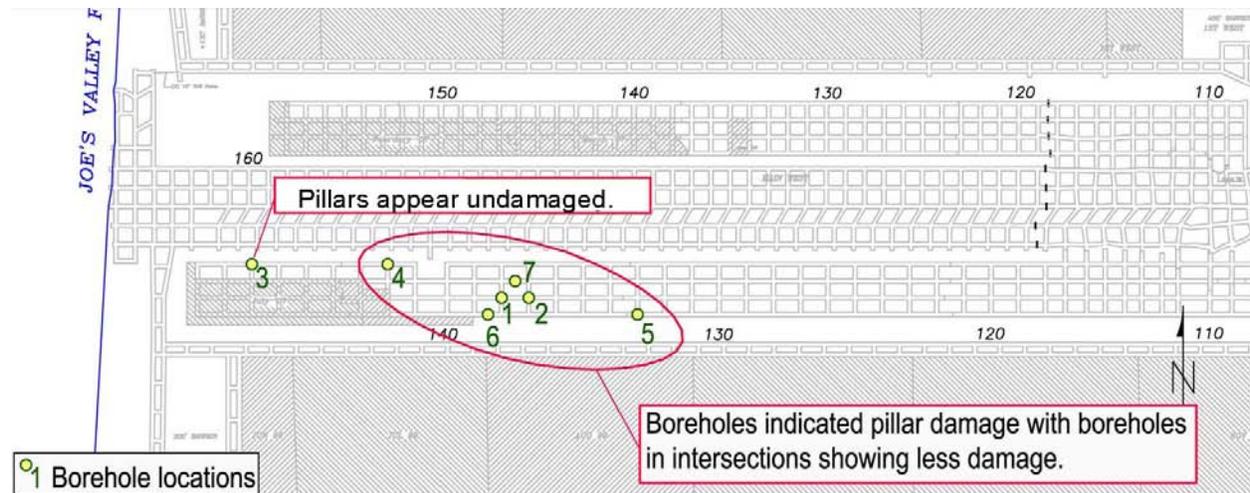
Conditions determined by the boreholes and visual observations from borehole cameras set the western boundary of the collapse between Borehole Nos. 3 and 4. Borehole No. 4 and others to the east of that location indicated that the mine openings contained rubble. Boreholes in the entries were filled or nearly filled with rubble while boreholes in the intersections contained less rubble. Figure 29 depicts the borehole locations.

Figure 29 - Borehole Locations and Conditions Observed

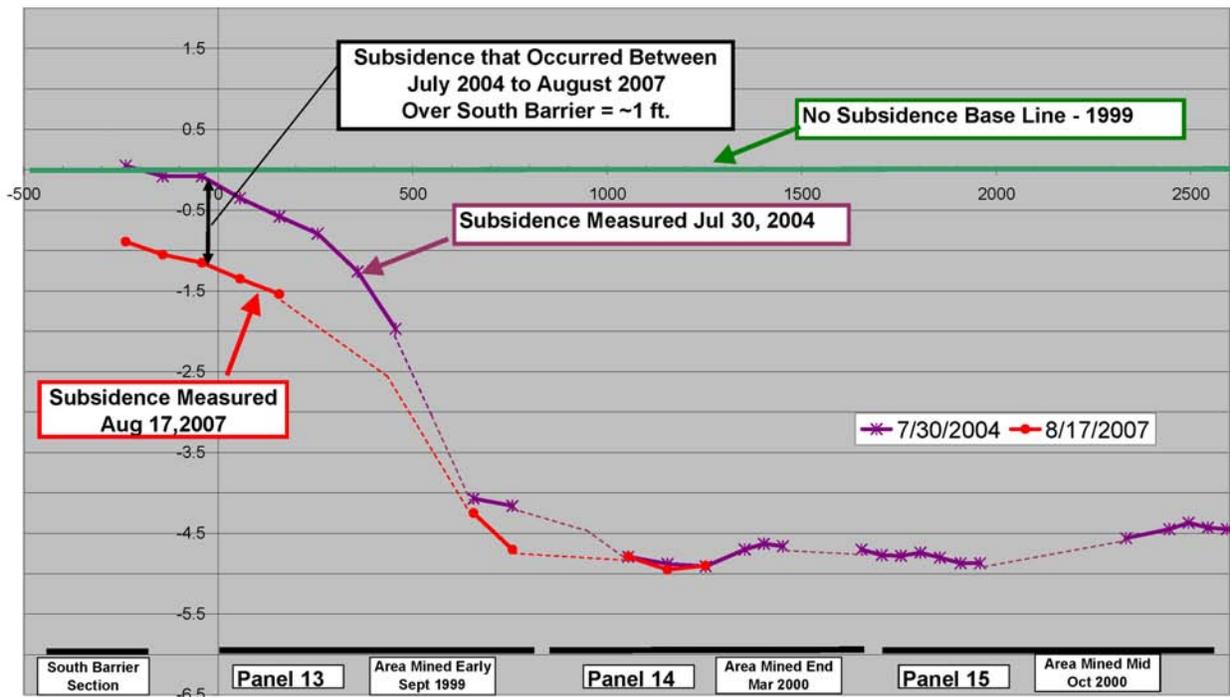
Figure 30 - Subsidence Profiles over Panels 13 to 15
Measurements from 2004 and 2007, vertical scale exaggerated

The longwall subsidence behavior observed in Figure 30 is somewhat typical of the Wasatch Plateau. In this region, strong, thick strata in the overburden control caving characteristics and are responsible for the high abutment stresses and long abutment stress transfer distances discussed in the ground control analysis portion of this report. Subsidence data collected elsewhere in the region indicates that the amount or extent of cantilevered strata at panel boundaries varies. Data presented in Figure 30 indicate that subsidence adjacent to the South Barrier section was incomplete over more than half the width of Panel 13. The figure also demonstrates that additional subsidence over the panel and the adjacent barrier was observed between 2004 and 2007. To determine how much of the recorded movement during the 3-year period was associated with the August accidents, Interferometric Synthetic Aperture Radar (InSAR) analyses were conducted.

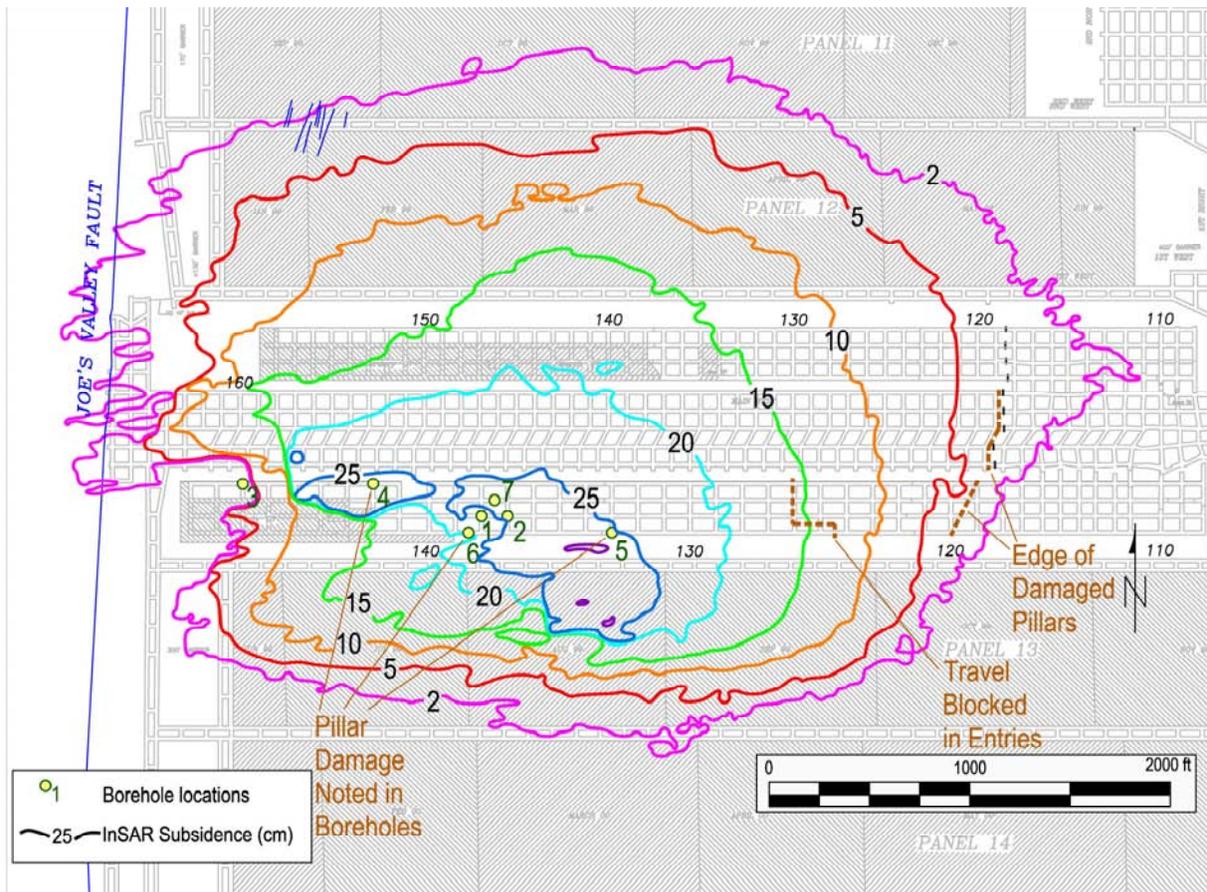
Figure 31 - Surface Deformation from Neva Ridge InSAR Analyses (June to Sept. 2007)

The InSAR analysis generally confirms the magnitude of subsidence determined in the GPS survey and further constrains the time in which the subsidence occurred. The analysis also provides insight to the lateral extent of the collapse zone. As illustrated in Figure 31, the surface area affected by the collapse extends approximately 1 mile east-to-west and $\frac{3}{4}$ miles north-to-south. At seam level, subsidence principles suggest that the extent of the collapse would be less laterally but greater vertically than the surface expression implies.

The area of greatest subsidence, and therefore the greatest damage at seam level, was centered on the 121-foot wide barrier between the South Barrier section and longwall Panel 13. A maximum displacement of nearly 12 inches was observed over the barrier pillar about 500 feet outby the last known location of the entrapped miners. Borehole No. 5 penetrated the mine workings near the point of maximum displacement and confirmed that the damage was severe there as demonstrated by the observation that the void space in that intersection was only 0.5 feet.

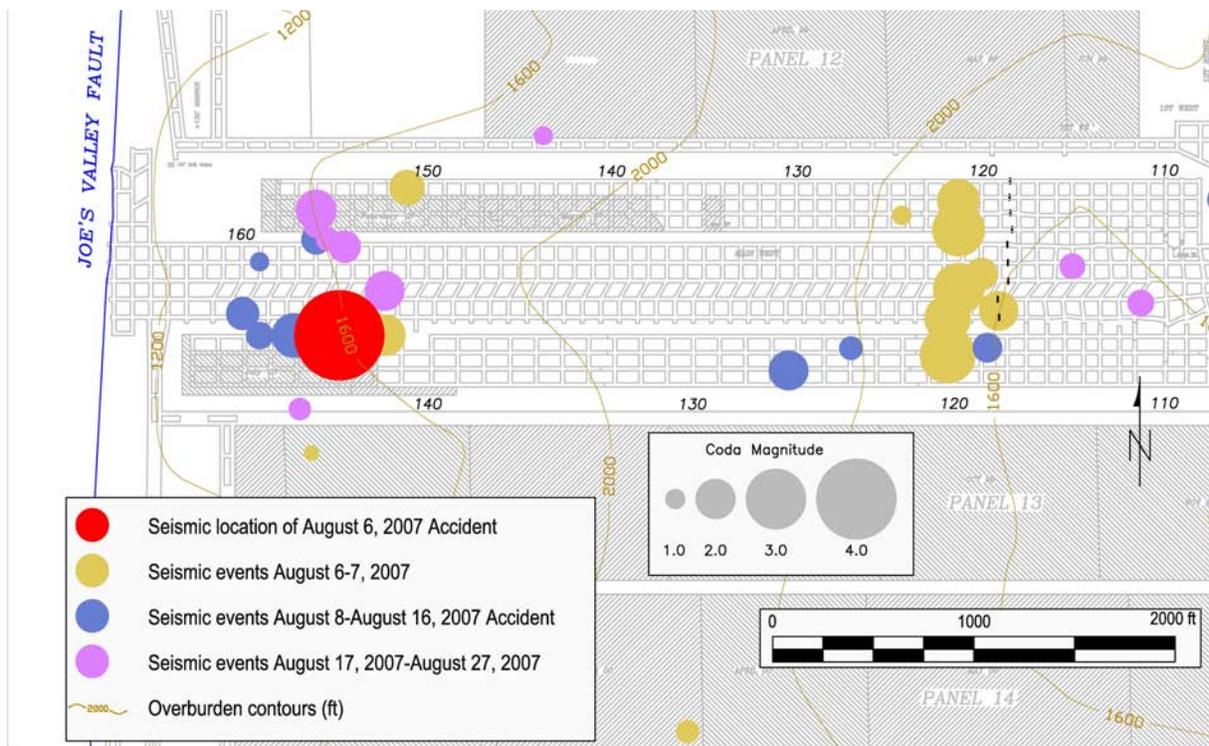
Figure 32 – Double Difference Locations of Seismic Events, August 6-27, 2007

Refined double difference locations of seismic events for the period of August 6 to August 27, 2007, are shown in Figure 32. These refined locations were unavailable until three months after all rescue efforts had been suspended. The August 6 event is indicated by the red circle and the twelve events that occurred within 37 hours afterward are represented as tan circles; the radius of each circle corresponds to the relative magnitude of the events. Activity during the first 37 hours after the accident was predominantly located on the outby side of the collapse area. Conversely, seismic activity for the time period August 8-27 (shown as blue and magenta circles) was concentrated on the inby side of the collapse area. Very few events were located near the north and south boundaries of the collapse area.

Seismologic analyses indicated that the August 6, 2007, event was dominantly a collapse mechanism but the waveforms also included a smaller shear component. A likely explanation was shear displacement along a vertical plane with movement downward on the east side. The plane would have a strike of approximately 150 degrees azimuth. This conclusion is substantiated by InSAR analyses which show a more abrupt displacement on the western side of the collapse area than on the eastern side. Steeper subsidence in this region could be consistent with movement on a steeply dipping, north-south oriented plane between the North and South

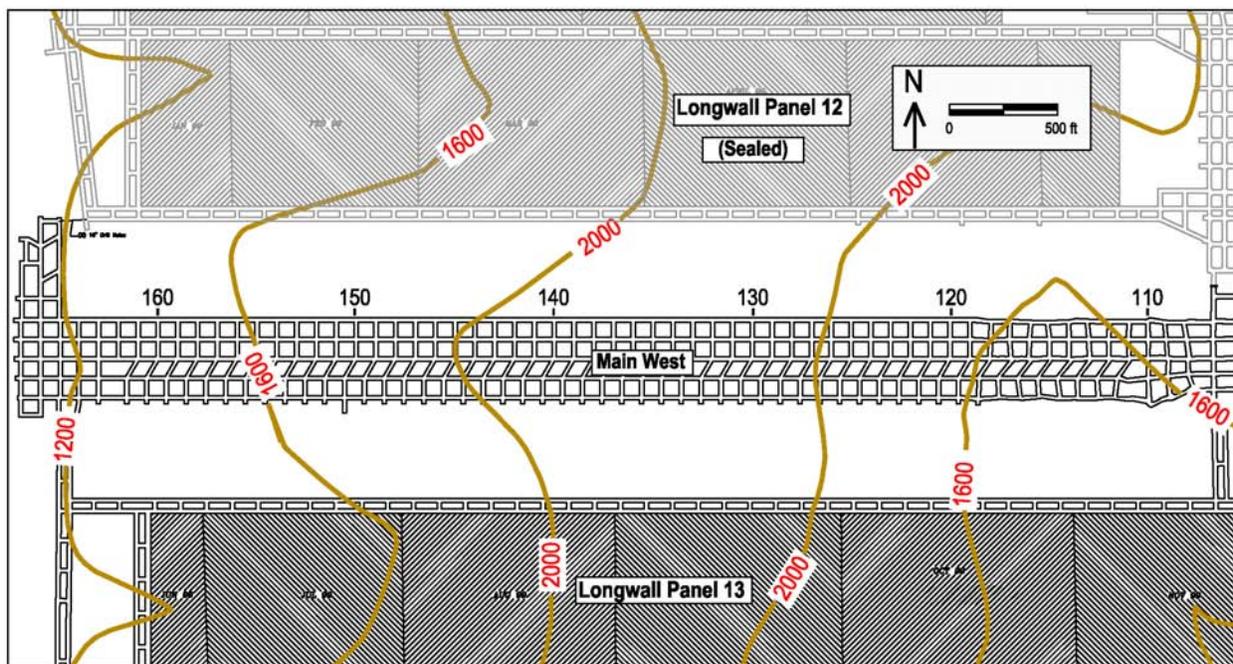
Figure 34 – Initial Main West Barrier Pillars after Panel 13 Mining showing Overburden

Longwall panels were mined parallel to the Main West entries between 1997 and 2003. Six panels were mined north of Main West (Panels 7 to 12) and six were mined to the south (Panels 13 to 18). Barrier pillars measuring approximately 450 feet wide were established between Main West and the adjacent longwall Panels 12 and 13 (see Figure 34).

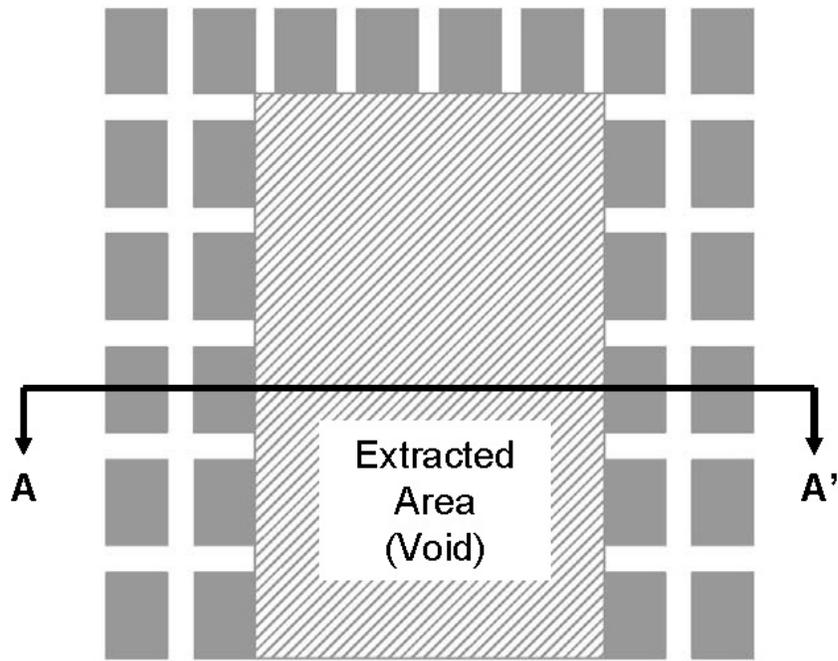
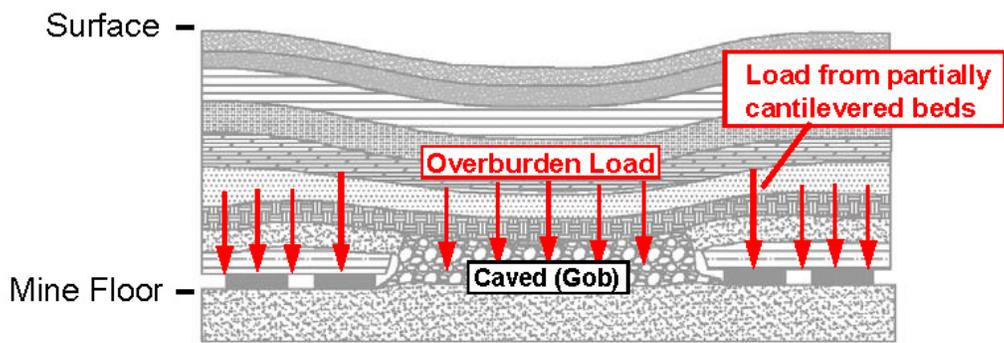
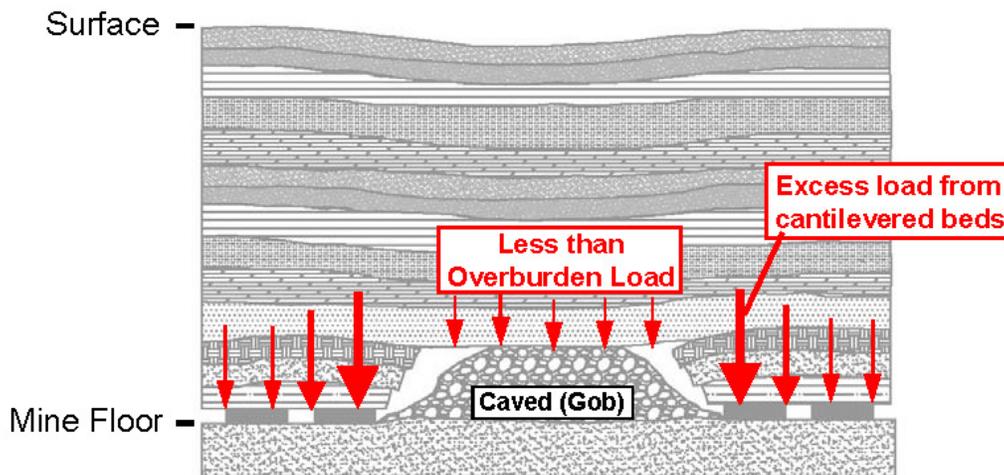
Figure 35 - Abutment Stress due to Cantilevered Strata from Mining

In retreat mining operations (longwall or pillar recovery), barrier pillars are used to protect workings from abutment loading associated with panel extraction and to separate active workings from worked out areas. As a block of coal is mined, the immediate roof above the block falls into the void created by mining. At shallow depths and with suitably wide panels, the roof failure can propagate to the surface and allow much of the weight of the overburden to be transmitted directly to the mine floor in the caved area. A portion of the overburden usually cantilevers over the void near the edges (see Figure 35). These cantilevered strata create load on the void boundaries in excess of the typical overburden load that would be carried.

In deep overburden and/or in narrow extraction areas, failure may not propagate to the surface. Instead, strata near the excavation can fail and fall into the void while higher strata may simply sag onto the fallen lower layers. The strength and stiffness of rock layers in the mine roof generally dictate the degree to which the uncaved layers sag and transfer load into the broken material (gob). If the rock layers are strong and thick, load can be transferred across the void created by mining in much the same way that an arch bridge rests on abutments at either of its ends. This abutment stress is usually highest near the excavation and lessens with distance away from the caved area.

Abutment stresses are transferred from extracted areas to adjacent workings (see Figure 35). The stresses are highest near pillared areas (referred to as "gob") and diminish with distance. Rules of thumb used to estimate abutment stress transfer distance are discussed in Appendix T. However, longer transfer distances have been observed in some mines in the Wasatch Plateau. In a paper titled *"Long load transfer distances at the Deer Creek Mine,"* Goodrich et al.⁹ wrote:

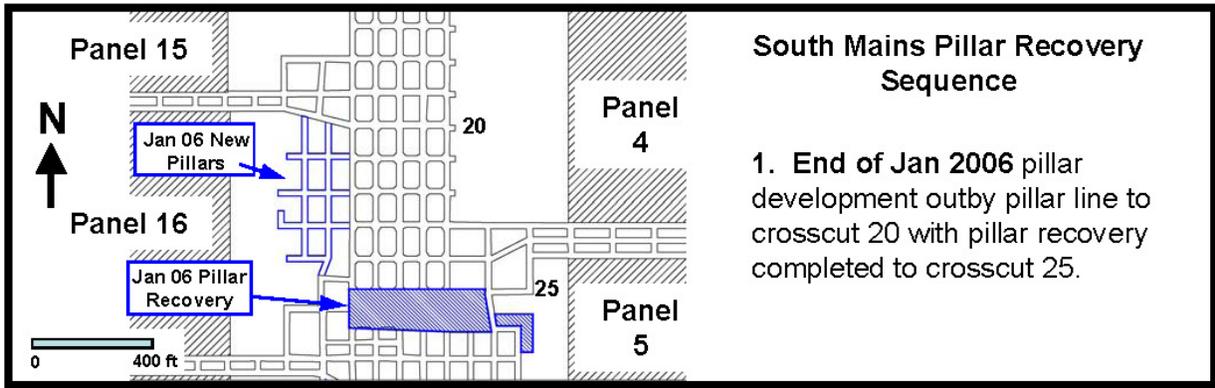
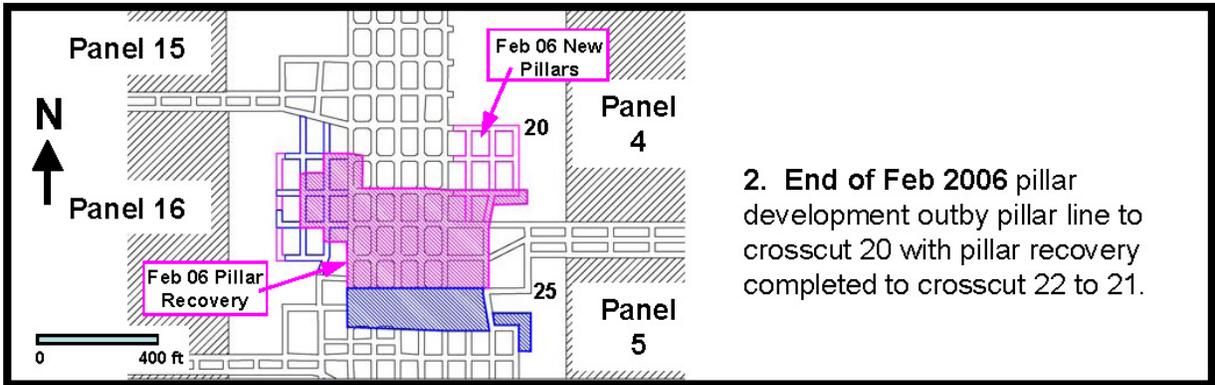
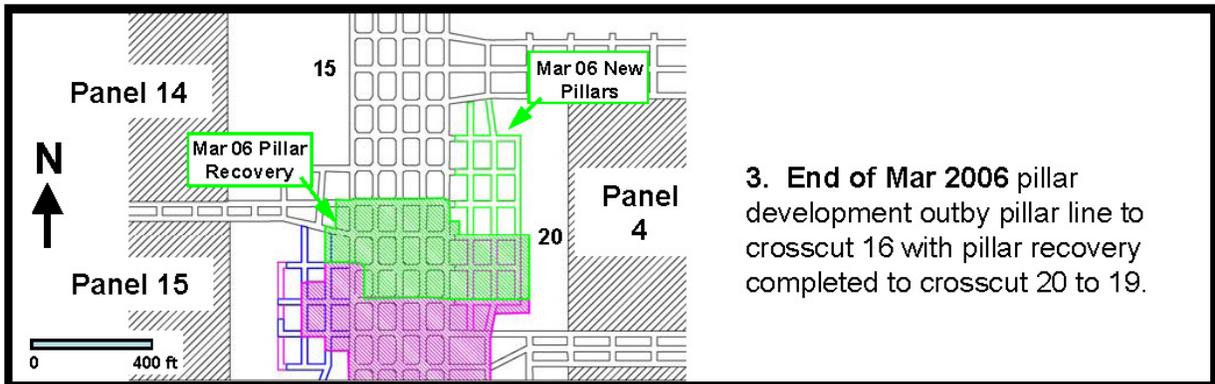
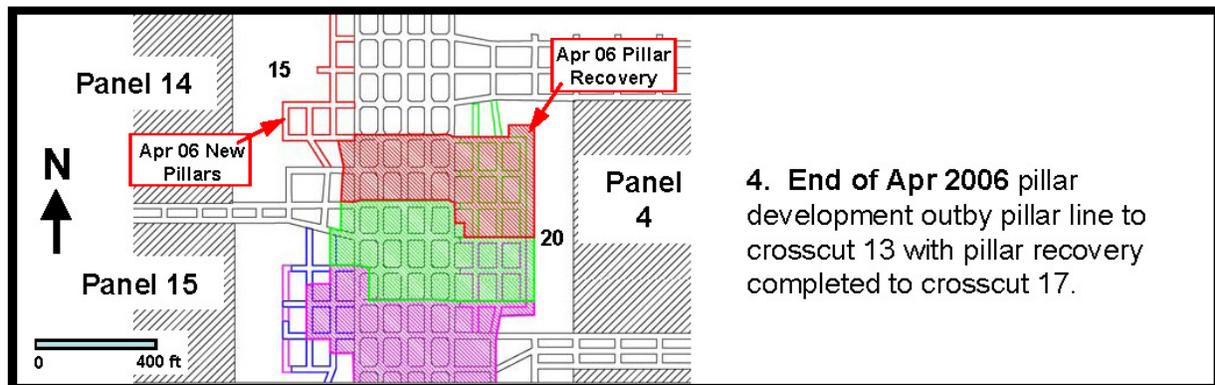
Figure 36 – South Mains “Rooming Out” Pillar Recovery Sequence

South Mains Pillar Recovery. The South Mains pillaring process involved mining a series of 3-4 rooms east and/or west from the original 5-entry main, typically 3 crosscuts deep into the adjacent longwall barrier pillars (see Figure 36). The newly formed pillars were typically the same dimensions as the original South Mains pillars (approximately 80 x 112-foot centers). The new pillars and the original South Mains pillars were then extracted. This process was repeated along the length of the South Mains, where overburden ranged from 700 to 1,520 feet.

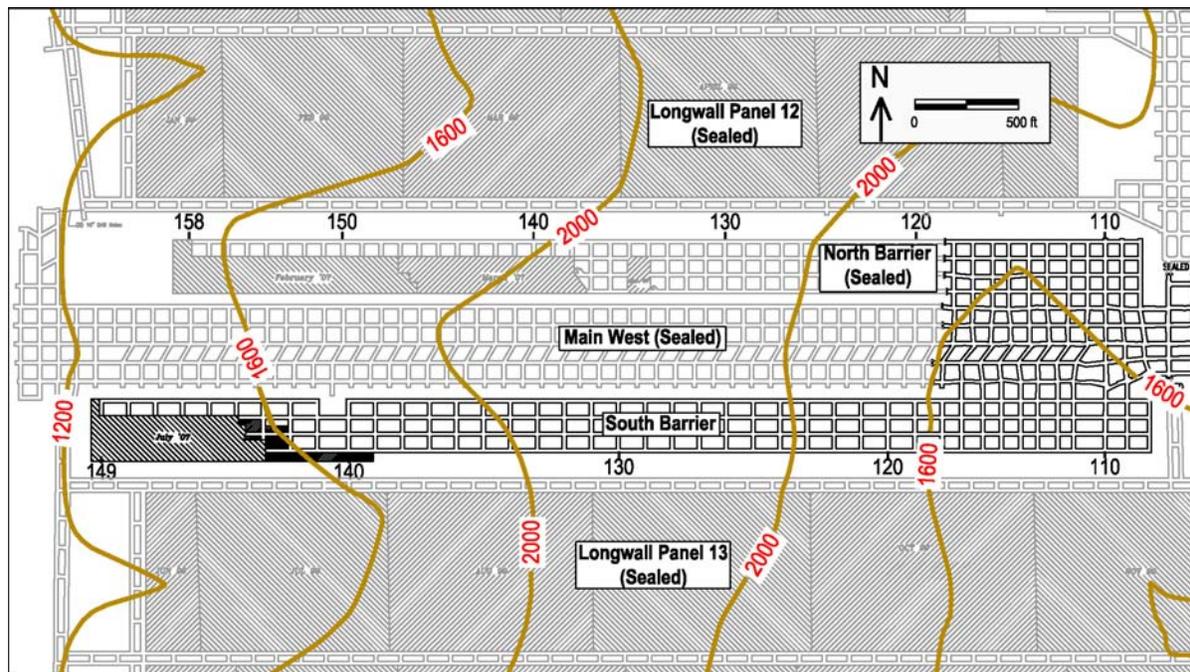
Figure 37 - North Barrier Section Mining showing Overburden

In contrast to the sequential development and recovery plan used in the South Mains, four entries were driven on 80 x 92-foot centers through the Main West North Barrier prior to retreat. The original 448-foot barrier width was reduced during development to 135 feet between the section and Panel 12 to the north and to 53 feet between the section and the sealed Main West to the south (see Figure 37). One implication of this approach was that the load bearing capacity of these barriers (i.e., their ability to support front and side abutment loading during pillar recovery) was reduced. Another was that entries used to access the working faces were subjected to abutment loading during development.

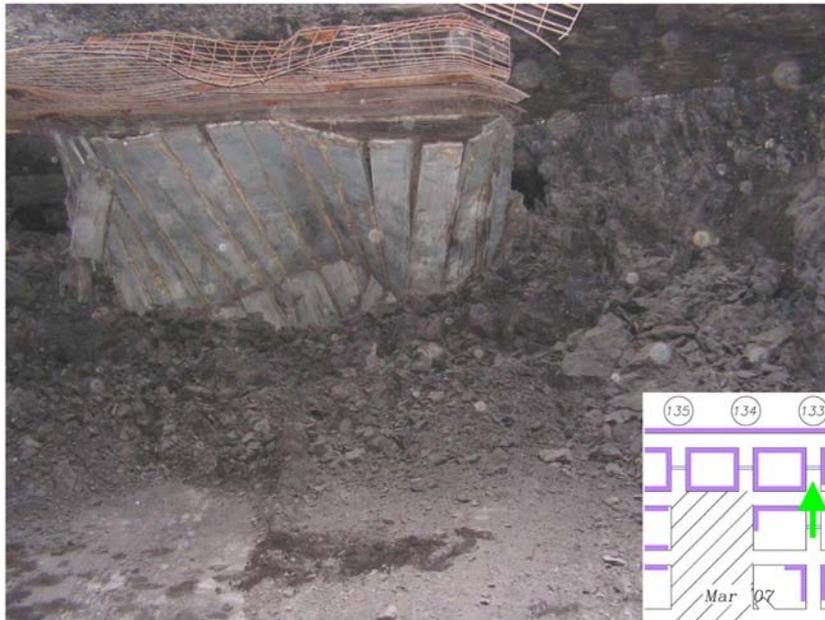
Figure 38 – Stopping Damaged during March 2007 Coal Outburst Accident on North Barrier Section

At the request of Adair, AAI personnel observed conditions in the section on March 16, 2007. The site visit was documented by photographs and a map showing pillar, entry, and crosscut conditions from crosscut 131 to 145. Figure 38 and Figure 39 illustrate a damaged stopping and conditions in the No. 4 entry from a collection of photos taken on March 16, 2007 (see Appendix O to view additional pictures). AAI's notes and photographs confirmed Falk's representation of conditions on the section in his report. The North Barrier section was sealed on March 27, 2007.

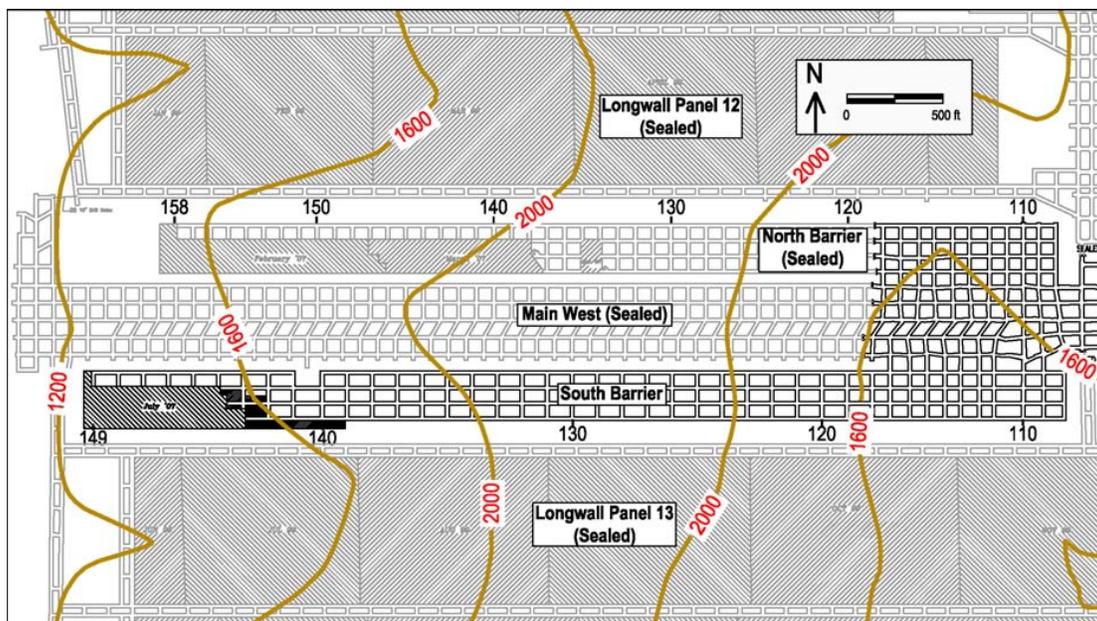
Figure 40 - South Barrier Section Mining showing Overburden

In the South Barrier section, pillar length was increased by 38 feet (from 92 to 130-foot center-to-center – see Figure 40). AAI indicated that this change *“increases the size and strength of the pillars’ confined cores, which helps to isolate bumps to the face and reduce the risk of larger bumps overrunning crews in outby locations.”*

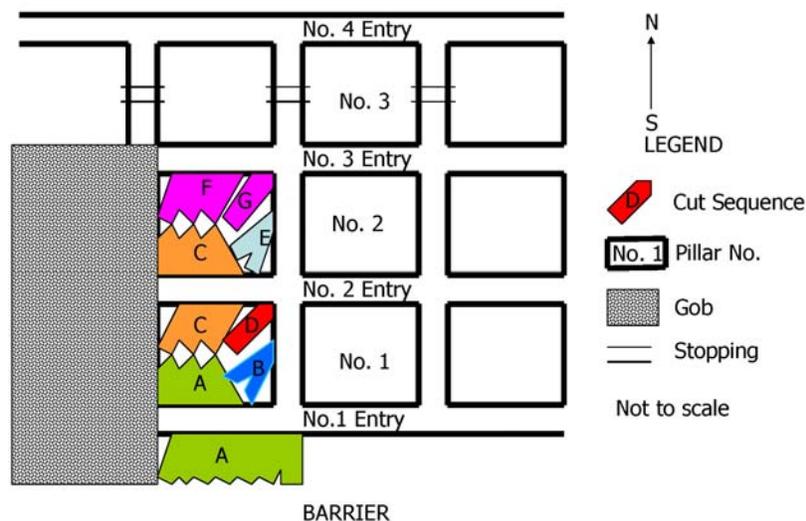
Figure 41 - South Barrier Section Pillar Recovery Cut Sequence

The cut sequence when mining a row of pillars is shown in Figure 41. Half of the No. 1 pillar and the barrier to the south were mined simultaneously, right and left, from the No. 1 entry (Sequence A). The remainder of the No. 1 pillar and the No. 2 pillar were then mined as they had been in the North Barrier section (Sequences B, C, D, E, F, and G).

Coal production resumed at 10:35 a.m., as the day shift crew mined the remaining cuts from either side of the No. 2 entry inby crosscut 142. Adverse ground conditions in the No. 3 entry prevented mining the north half of the damaged pillar (cut F and G as shown on Figure 41). Crew members (including the section foreman) discussed the possibility that management would decide to pull out of the South Barrier section due to similarities between the outburst accident that morning and the events in the North Barrier. The section was visited by mine management, who discussed the conditions with the section foreman. After this discussion, the section foreman informed the crew that they were to begin mining the barrier and skip some pillar rows. The crew moved the continuous mining machine outby crosscut 142 in the No. 1 entry and mined a lift from the barrier pillar. Six cuts were mined from the barrier during the night shift, retreating to near crosscut 141. Mining in the barrier between crosscuts 139 and 142 was prohibited by the approved roof control plan.

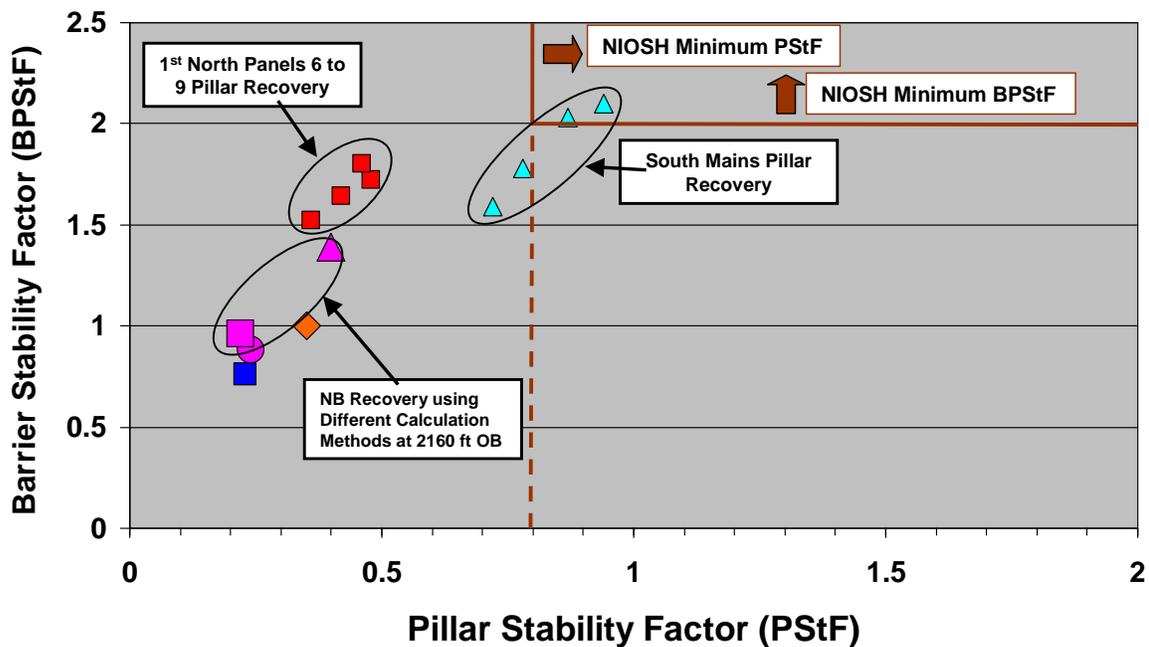
Figure 45 - ARMPS Stability Factors at Crandall Canyon Mine

The four red squares in Figure 45 represent ARMPMS stability factors associated with the 1st North continuous haulage system panels. Although no catastrophic failures were reported, pillar recovery was not trouble-free. Accident records indicate that two injuries resulted from bounces (one of which was a coal burst) during pillar recovery in late 1993 and early 1994 in the 7th Left continuous haulage panel. Also, pillars were abandoned in each panel to alleviate some form of difficult ground condition. Roof coal had been left during development of these panels and this practice may have contributed to the difficulties. Regardless of the reason for leaving the pillars, these unmined zones indicate that pillar recovery was not entirely successful.

The light blue triangles in Figure 45 represent stability factors associated with pillar recovery in the South Mains. Two of the cases satisfied the NIOSH criteria for minimum stability factors. Although no catastrophic failures were reported, miners described “heavy” conditions on the pillar line indicative of high stress and pillar bounces were reported. These conditions led the operator to adopt a pillar recovery sequence in which pillars were extracted exclusively in one direction rather than alternating the direction between successive rows. Reportedly, less “thumping” was experienced on the pillar line when the pillars were extracted exclusively from west-to-east. Also, interview statements and documents indicate pillar “bouncing” occurred during pillar extraction in the South Mains. Two rows of pillars beneath a ridge near the center of South Mains (1520 feet of overburden) were not extracted.

The magenta colored shapes in Figure 45 represent ARMPS stability factors for the North Barrier section determined using the three methodologies discussed earlier. They are grouped together in an oval to signify that all three correspond to the same mining scenario. Regardless of the methodology used, both the pillar stability factor and barrier pillar stability factor fall below the NIOSH recommended values for bump-prone and non-bump-prone ground. The low stability factors indicate that poor ground conditions and/or section failure would be anticipated during pillar recovery.

Summary. ARMPS stability factors for Crandall Canyon Mine pillar recovery scenarios are illustrated in Figure 45. In this figure the vertical and horizontal solid color lines represent NIOSH recommended minimum stability factors (0.8 PStF and 2.0 BPSStF). The recommended NIOSH values (0.8 PStF and 2.0 BPSStF) are for overburden deeper than 1,250 feet with strong roof and bump prone ground. ARMPS stability factors that are above or below NIOSH recommended values do not ensure success or failure. However, when stability factors are maintained above the thresholds for both production and barrier pillars, experience (reflected in case studies in the NIOSH database) has demonstrated likelihood for success.
