REPORT OF INVESTIGATION

Fatal Underground Coal Burst Accidents
August 6 and 16, 2007

Crandall Canyon Mine
Genwal Resources Inc
Huntington, Emery County, Utah
ID No. 42-01715

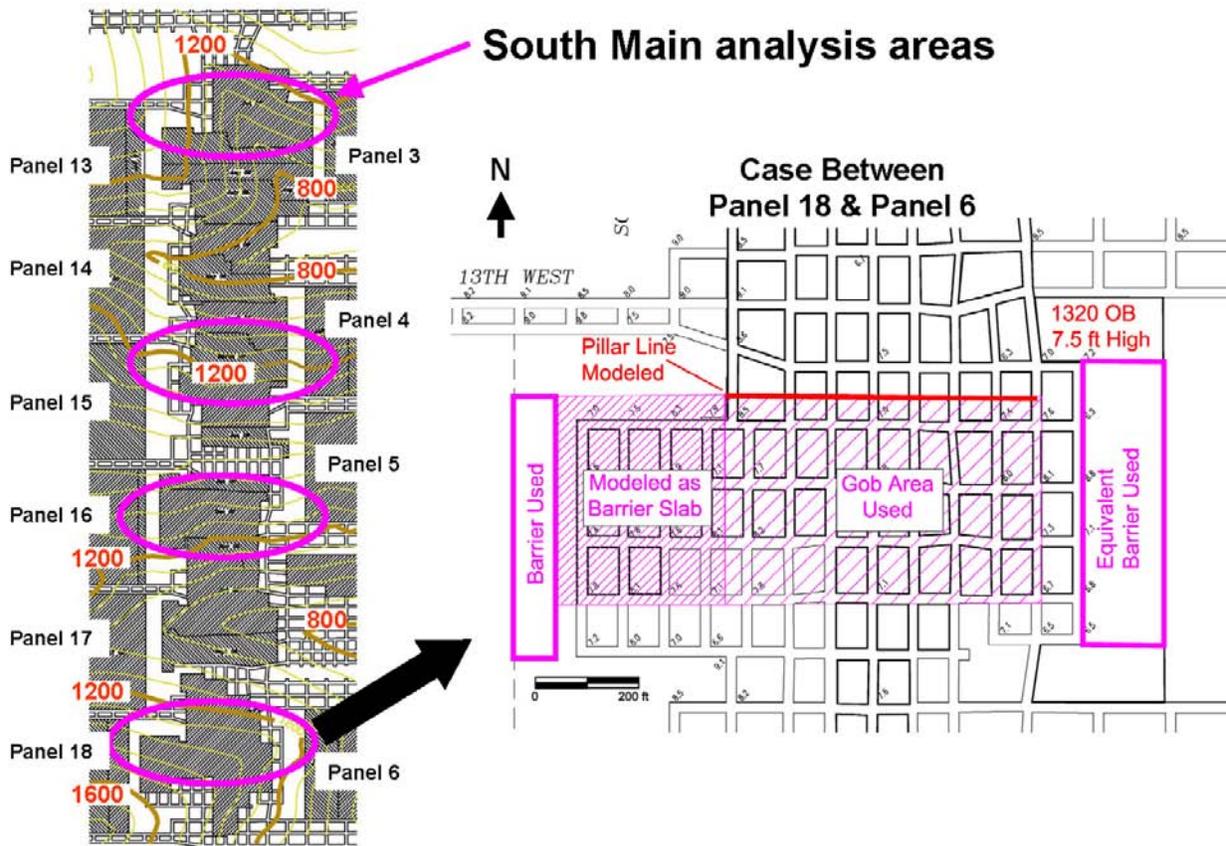
Figure 46 - South Mains ARMPs Calculation Areas

Four areas with relatively high overburden and minimal barrier width to the longwall gobs were selected for back-analysis using ARMPS. The areas were between longwall Panels 6 and 18, Panels 5 and 16, Panels 4 and 15, and Panels 3 and 13 (see Figure 46). At each of these locations, the maximum extraction area and minimum barrier widths were applied in the analysis to subject pillars and barriers surrounding the developing gob to the highest degree of loading. This approach was used to define the lower limit of the historical pillar stability factors associated with pillar recovery in the South Mains. Results of the ARMPS analyses are included in Table 6.

The light blue triangles in Figure 45 represent stability factors associated with pillar recovery in the South Mains. Two of the cases satisfied the NIOSH criteria for minimum stability factors. Although no catastrophic failures were reported, miners described “heavy” conditions on the pillar line indicative of high stress and pillar bounces were reported. These conditions led the operator to adopt a pillar recovery sequence in which pillars were extracted exclusively in one direction rather than alternating the direction between successive rows. Reportedly, less “thumping” was experienced on the pillar line when the pillars were extracted exclusively from west-to-east. Also, interview statements and documents indicate pillar “bouncing” occurred during pillar extraction in the South Mains. Two rows of pillars beneath a ridge near the center of South Mains (1520 feet of overburden) were not extracted.

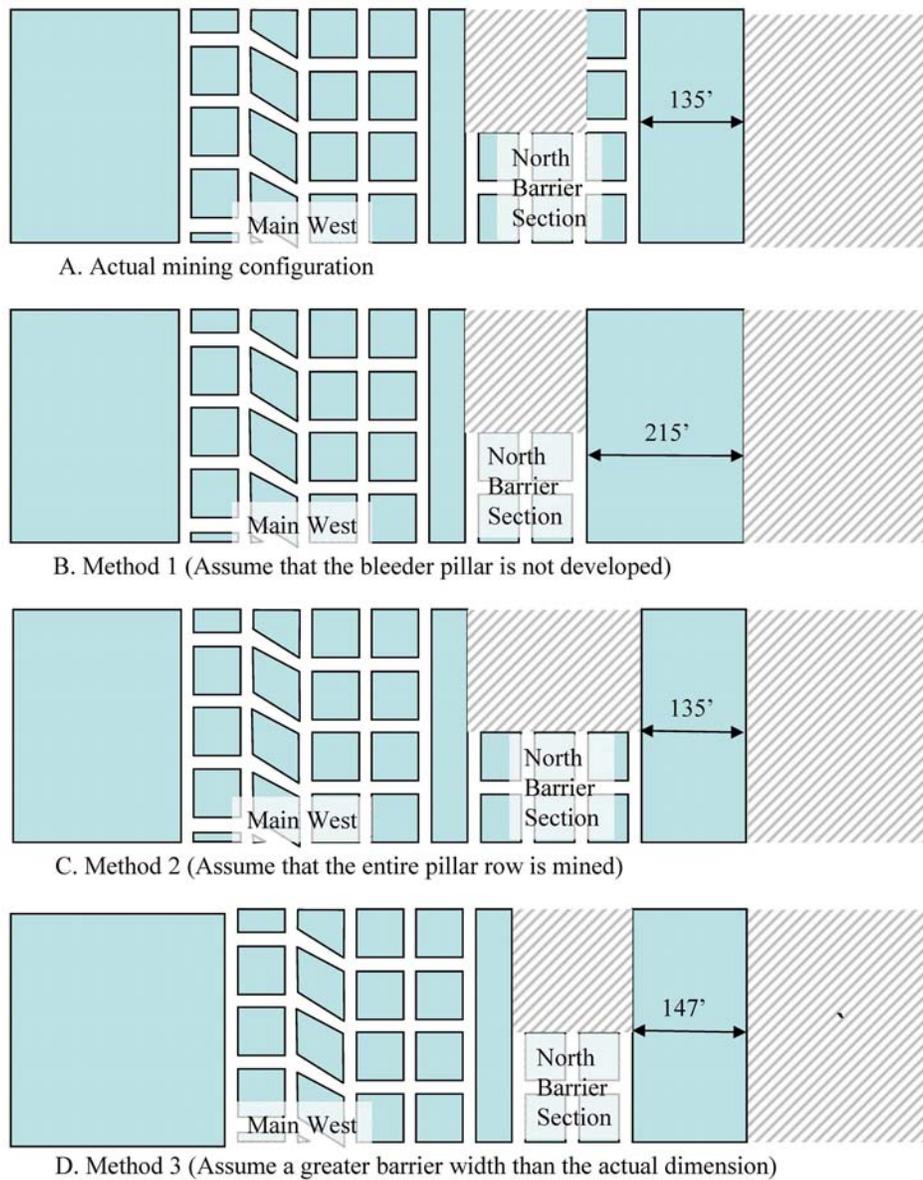
Figure 47 - Methods of Incorporating a Bleeder Pillar in ARMPS Analyses

Each of these approaches uses a different assumed geometry (Figure 47) and provides a different result. The first method generates the highest PStF and the second and third methods generate lower and similar PStF values. Consequently, when compared to NIOSH pillar design criteria from the NIOSH database or pillar design from mine site back-analysis, the first method is more likely to overstate stability than the second or third method. The inappropriateness of Method 1 is evident in the fact that StF's calculated for a retreating section using this method are actually greater than StF's calculated for development using actual pillar and barrier dimensions (see Table 7). When comparing the design to NIOSH or mine site specific design criteria, the second and third methods offer the safest approach.

The magenta colored shapes in Figure 45 represent ARMPS stability factors for the North Barrier section determined using the three methodologies discussed earlier. They are grouped together in an oval to signify that all three correspond to the same mining scenario. Regardless of the methodology used, both the pillar stability factor and barrier pillar stability factor fall below the NIOSH recommended values for bump-prone and non-bump-prone ground. The low stability factors indicate that poor ground conditions and/or section failure would be anticipated during pillar recovery.

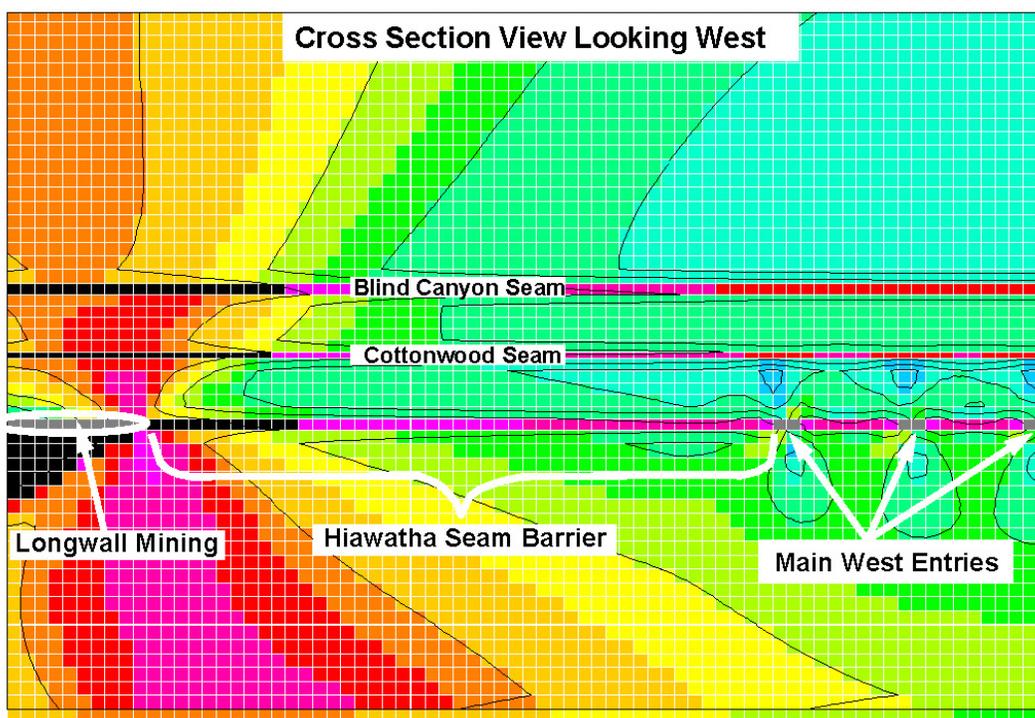
Figure 49 - Element Safety Factors about a Barrier Pillar after Longwall Mining

Longwall Mining. Model results in the second mining stage, longwall panel extraction, indicate that some areas have reached the elastic limit while others are well below (see Figure 49). For example, 25% of the barrier pillar separating the Main West from the longwall panels has yielded in this stage of mining. Although the remainder of the barrier adjacent to the Main West has not yielded, it is highly stressed. The gray elements in Figure 49 indicate mine openings in the Hiawatha seam and the black elements represent element safety factors less than 1.0.

Although yielding is isolated to the longwall side of the barrier opposite Main West, longwall mining has had a significant effect on stress levels in the Main West pillars. The highest SF in the Main West pillars is 1.34 which is substantially less than the values on development. Roof and floor SF’s are in the 4 to 5 range suggesting that they continue to be stable.

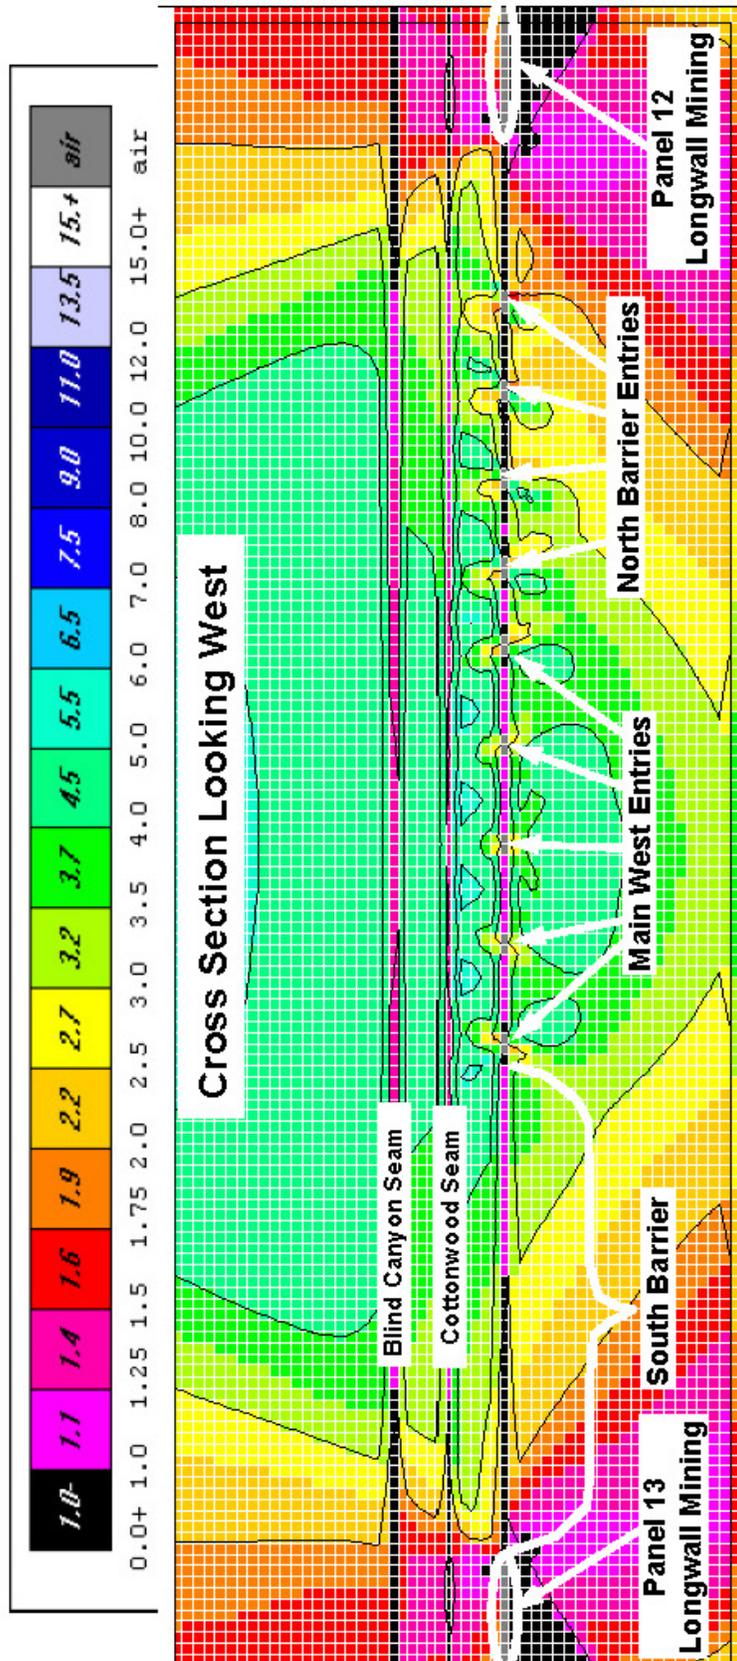
Figure 50 - Element Safety Factor Distribution after North Barrier Section Development

North Barrier Section Development. Model results from the third stage of excavation, development in the North Barrier, indicate that most elements in the north side barrier pillar are now at yield (note the black elements on the right side of Figure 50 at seam level). Rib elements in pillars adjacent to the Main West entries are also at yield. The outside entry of Main West shows ribs yielding in the pillar between it and the new north side barrier pillar entry. The south outside entry ribs show yielding extending 10 feet into the ribs and the highest safety factor in any pillar element in Figure 50 is 1.2.

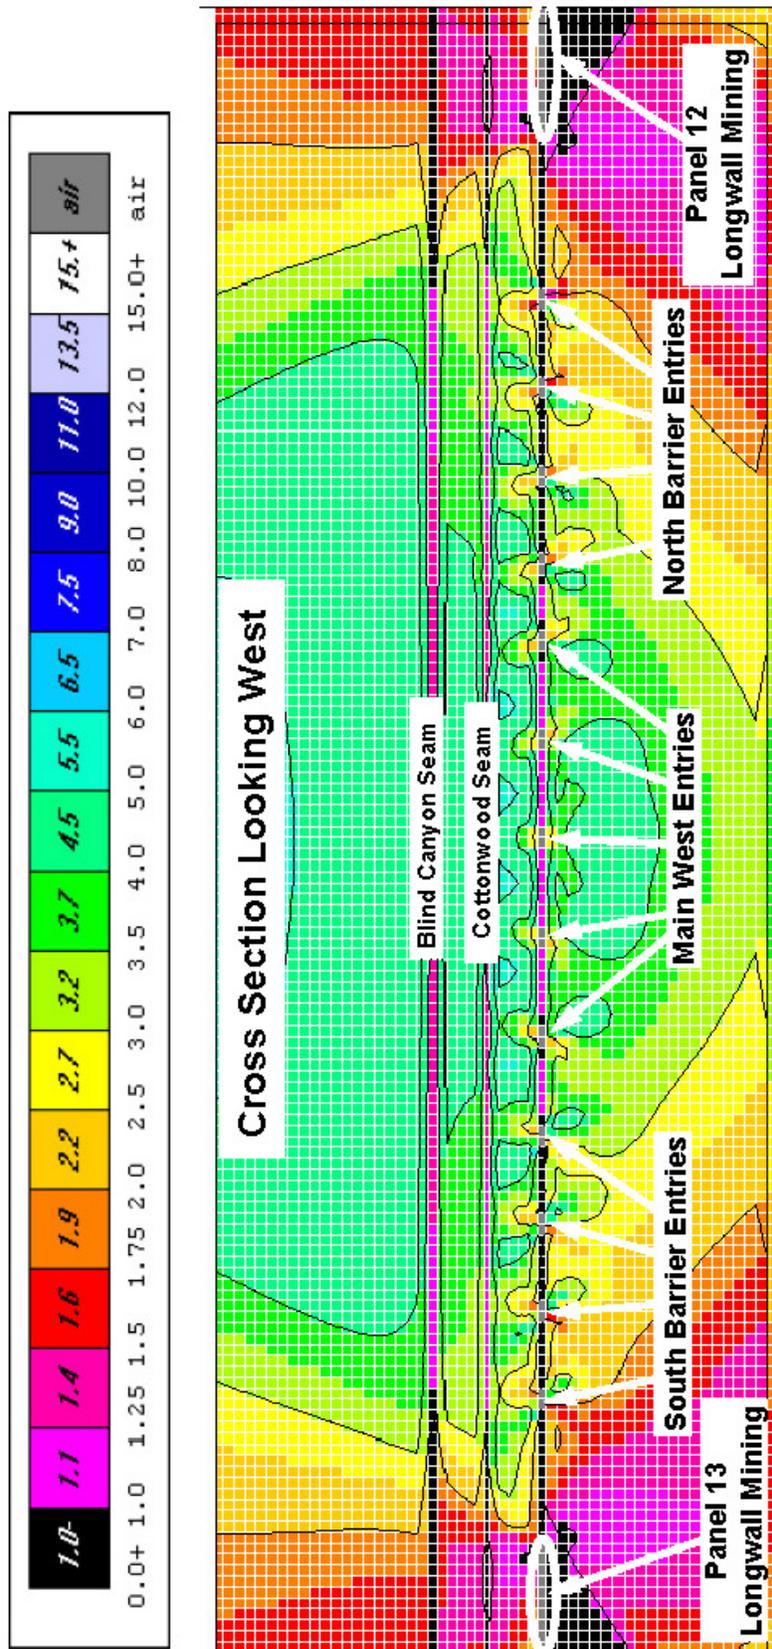
Figure 51 - Element Safety Factor Distribution after South Barrier Section Development

South Barrier Section Development. The fourth and last stage of analysis is entry development in the South Barrier. The distribution of element safety factors at this stage is shown in Figure 51. Almost all elements in the south side barrier pillar are now at yield and all pillar elements across the mining horizon are close to yield. Again, since purely elastic behavior leads to an underestimate of the extent of yielding, it is likely that yielding would spread further and affect portions of the pillars that have not yielded in the elastic model.

Peak vertical stress in the barrier pillars exceeds 38,400 psi, over 9 times the unconfined compressive strength of the coal. Horizontal stress exceeds 7,300 psi. Even so, this high confining pressure is insufficient to prevent yielding. The lowest vertical pillar stress is about 6,000 psi, almost half again greater than the unconfined compressive strength of the coal; the lowest horizontal pillar stress is about 1,500 psi. Any release of horizontal confinement would likely result in rapid destruction of pillars. Additionally, entries nearest to the mined panels are showing reduced roof and floor safety factors. Overlying coal seams are also yielding or are very close to yielding over portions of the barrier pillars, as seen in Figure 51. These model results are indicative of unstable conditions.

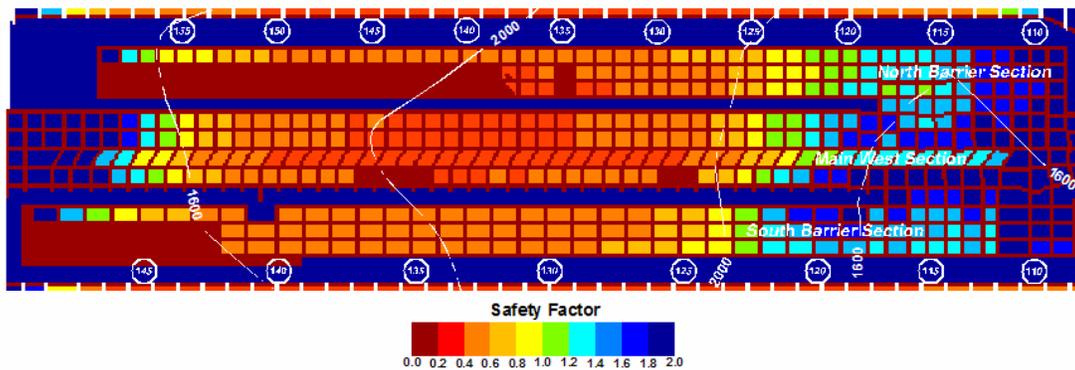
Figure 55 - Optimum Model after August 6 Failure

LaModel Results. The results from the optimum calibrated model for Crandall Canyon Mine are shown in Figure 54 and Figure 55. In these figures, “cooler” colors (green and blue) correspond to safety factors greater than 1.0. “Hotter” colors (yellow, orange, and red) correspond to safety factors less than 1.0 and, therefore, represent pillar failure. It is important to note that LaModel does not calculate any of the details of the coal or overburden failure mechanics. Since the program does not have any dynamic capabilities, it cannot distinguish between a gentle controlled pillar failure and a violent pillar burst. However, coal that bursts must be at, or very near, its ultimate strength at the time of the burst; therefore, it is reasonable in bump prone ground to associate the point of coal failure in LaModel simulations with coal bursts.

In all of these models, once the coal strength was calibrated to the March 10, 2007, North Barrier section outburst, results indicate that the pillars in the Main West were also close to failure. Once the South Barrier was subsequently developed, the model showed that it was very likely for the entire Main West and South Barrier entries to collapse upon the South Barrier development, or just a small perturbation was needed to initiate the collapse.

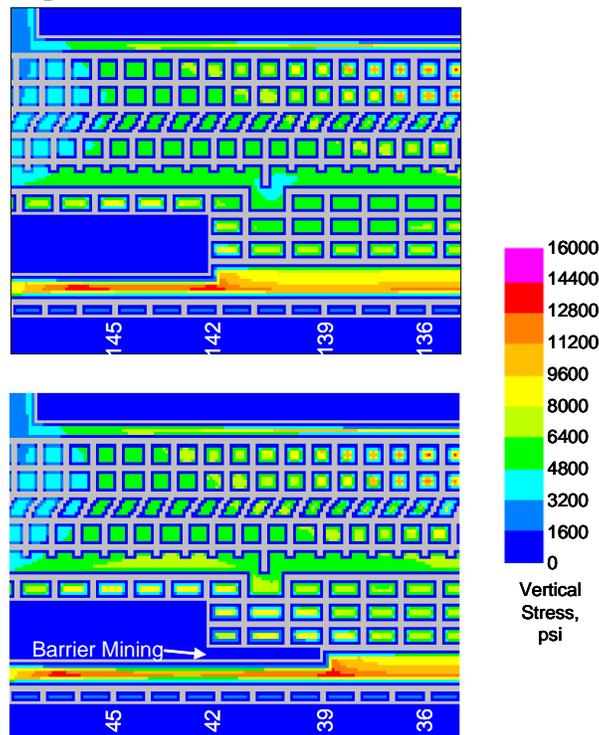
Figure 56 - Distribution of Vertical Stress in the South Barrier Section

The impact of barrier mining was evaluated by observing the distribution of vertical stress in the vicinity of the August 6 mining location. Vertical stresses were determined for the section before and after mining the barrier (see Figure 56). As discussed in the Main West Ground Control History section of this report, eight pillars and the adjacent barrier between crosscuts 139 and 142 were to remain unmined to protect the bleeder entry where it jogged around a sump in the Main West workings. The pillars were not mined but the barrier to the south was mined. Model results indicate that stress levels increased substantially in the pillars adjacent to the sump and were highest in the remnant barrier near the location where the South Barrier section crew was working at the time of the August 6 accident. These stress levels are similar in magnitude to those in the remnant barrier pillar inby crosscut 142 before barrier mining.

Stress redistribution associated with barrier mining occurred over a relatively broad area but diminished with distance from the extracted area. Vertical stress changes throughout the model can be determined by subtracting model results in the grid representing an intact barrier (Figure 56, top) from those in the grid that includes barrier mining (Figure 56, bottom). Negative values reflect stress decreases that result from either element removal (i.e., simulated mining) or yielding. Positive values represent stress increases.

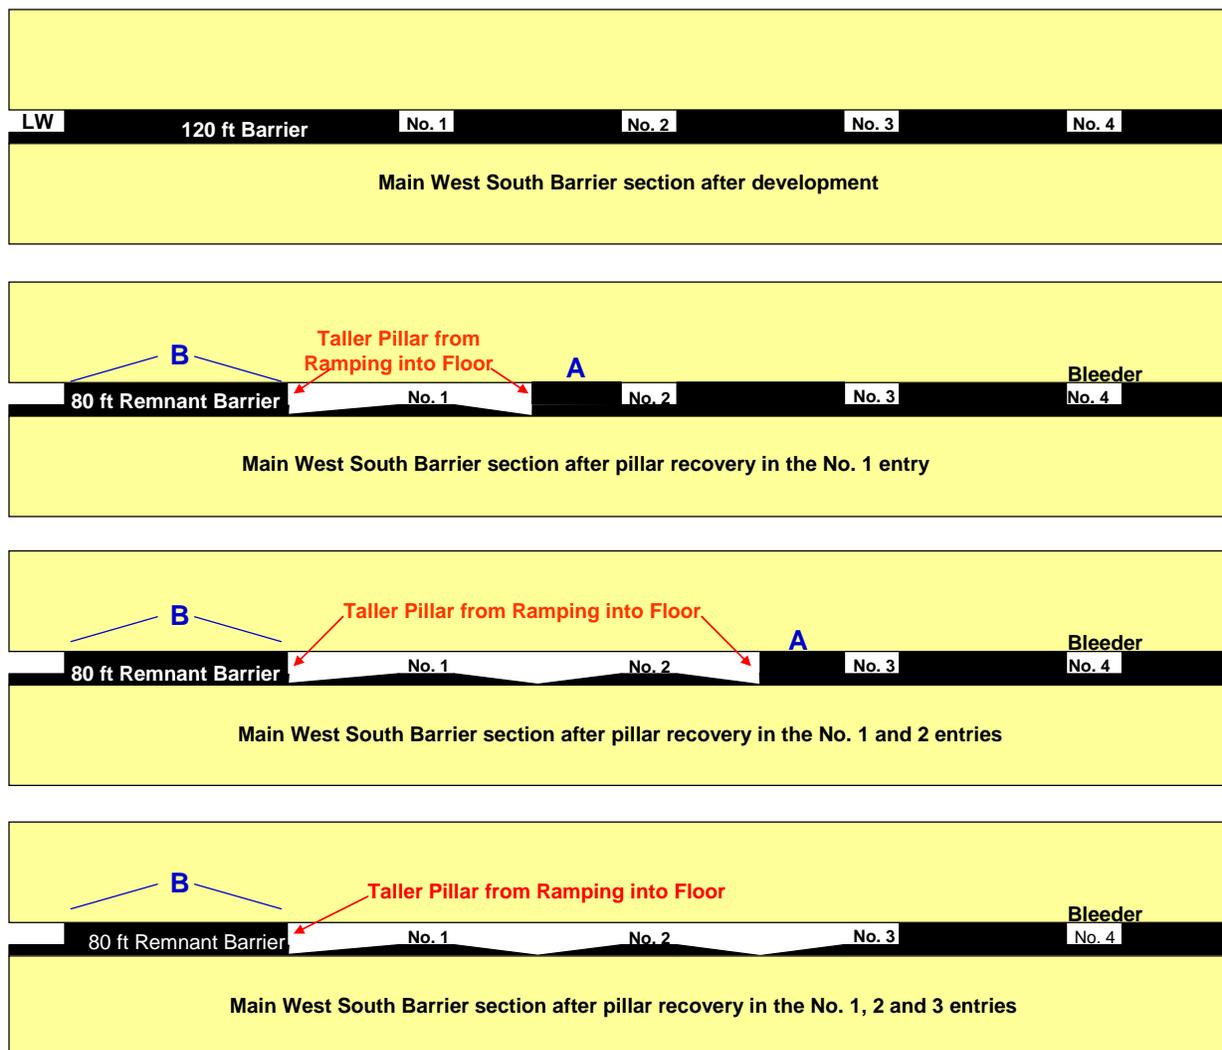
Figure 60 - Cross-Section through South Barrier Section during Pillar Recovery

Bottom mining creates taller pillars, which are generally weaker than shorter pillars of the same length and width. In the South Barrier section, the affected areas were the remnant pillars and the 80-foot wide remnant barrier labeled A and B, respectively, in Figure 60. Bottom mining in the pillars affected pillar stability as mining proceeded within each row. However, once a row

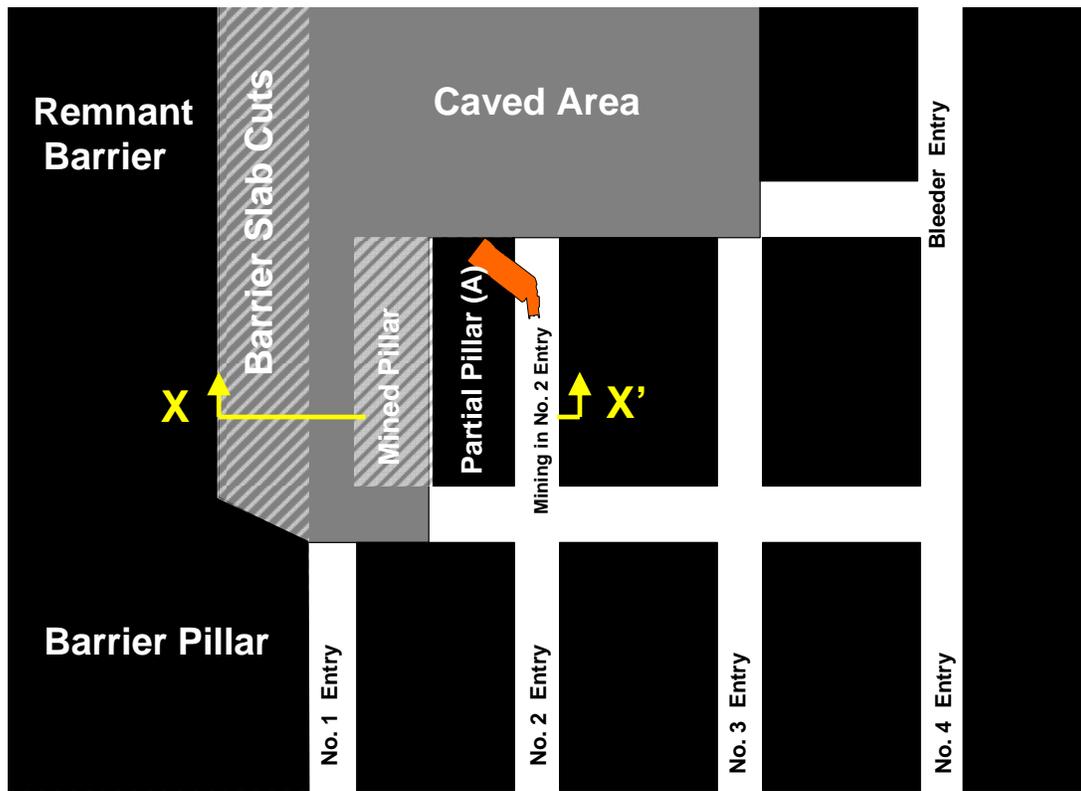
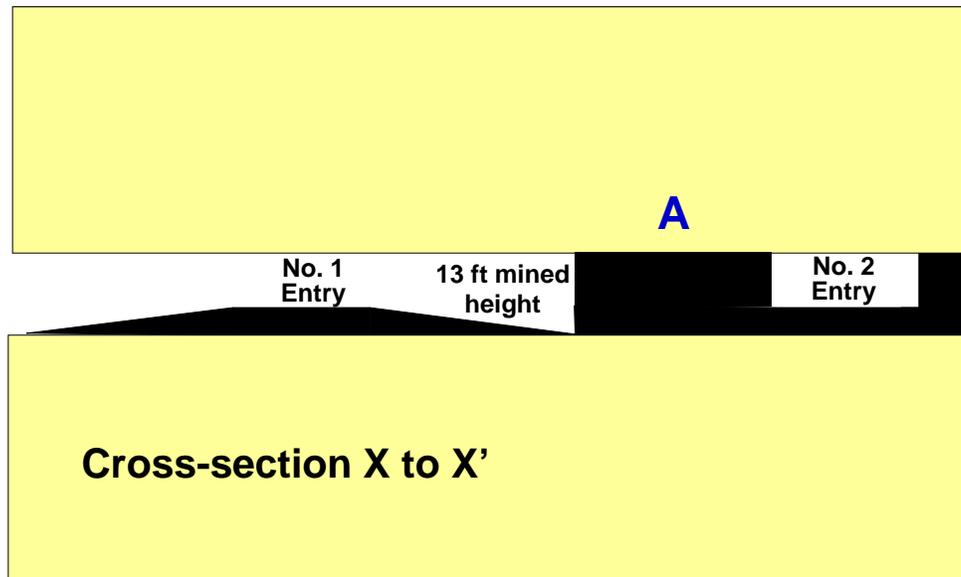
Figure 61 - Effect of Bottom Mining on Pillar Geometry
(e.g. inby crosscut 142)

As illustrated in Figure 61, the partial pillar between No. 1 and No. 2 entry separates the mining crew from the caved area. The stability of the work area relies largely on the stability of the partial pillar, particularly as mining progresses outby to the intersection. Bottom mining on the gob side of this pillar increases the pillar height and effectively reduces its strength. A similar situation occurs when mining moves to the No. 3 entry. Thus, bottom mining can impact local stability even though the pillars are intentionally being reduced in size and the roof is expected to collapse. Also, bottom mining adjacent to the remnant barrier weakened the remnant barrier in the pillar line and contributed to overall instability of the section as it retreated.

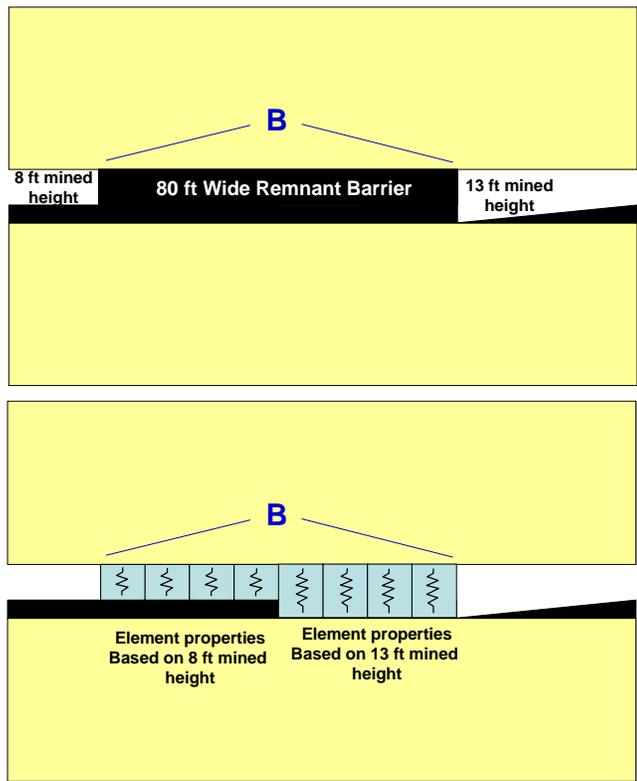
Figure 62 - Model Representation of Bottom Mining in the Remnant Barrier

Dr. Heasley's model was modified to evaluate the impact of bottom mining. As illustrated in Figure 62, one half of the remnant barrier was modeled using coal properties developed for a mining height of 8 feet, while the other half used a weaker coal strength and lower stiffness based on a mining height of 13 feet. Simulations with and without bottom mining were compared to measure the relative impact of the activity.

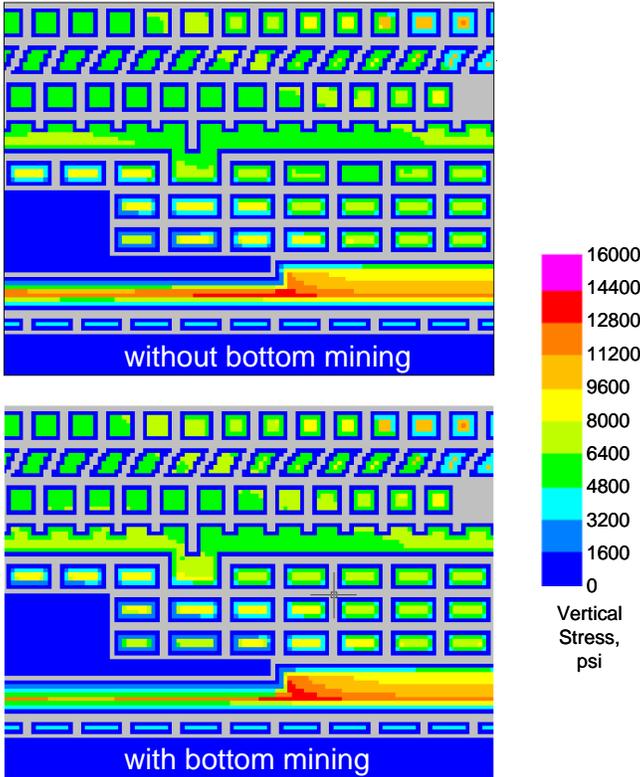
Figure 63 - Distribution of Vertical Stress in the South Barrier Section

The impact of bottom mining in the barrier was evaluated by assessing vertical stress levels and element safety factors in the vicinity of the August 6 mining location. The distributions of vertical stress with and without bottom mining are presented in Figure 63.

Although there are subtle differences over a broad area, the primary impact of bottom mining is seen in the remnant barrier. The core of the 80-foot wide remnant barrier has a higher peak and residual strength (Figure 63 top) when bottom mining is not conducted. With bottom mining, load that otherwise may have been supported by the barrier is redistributed to other elements. Stress redistribution was examined by subtracting model results in the two model grids shown in Figure 63. Negative values reflect stress decreases that result from lower element strength and/or yielding. Positive values represent stress increases. Since no additional mining was simulated, decreases between the models demonstrate the stress redistribution between elements. In effect, Figure 64 shows where stress increased and decreased as a result of bottom mining.

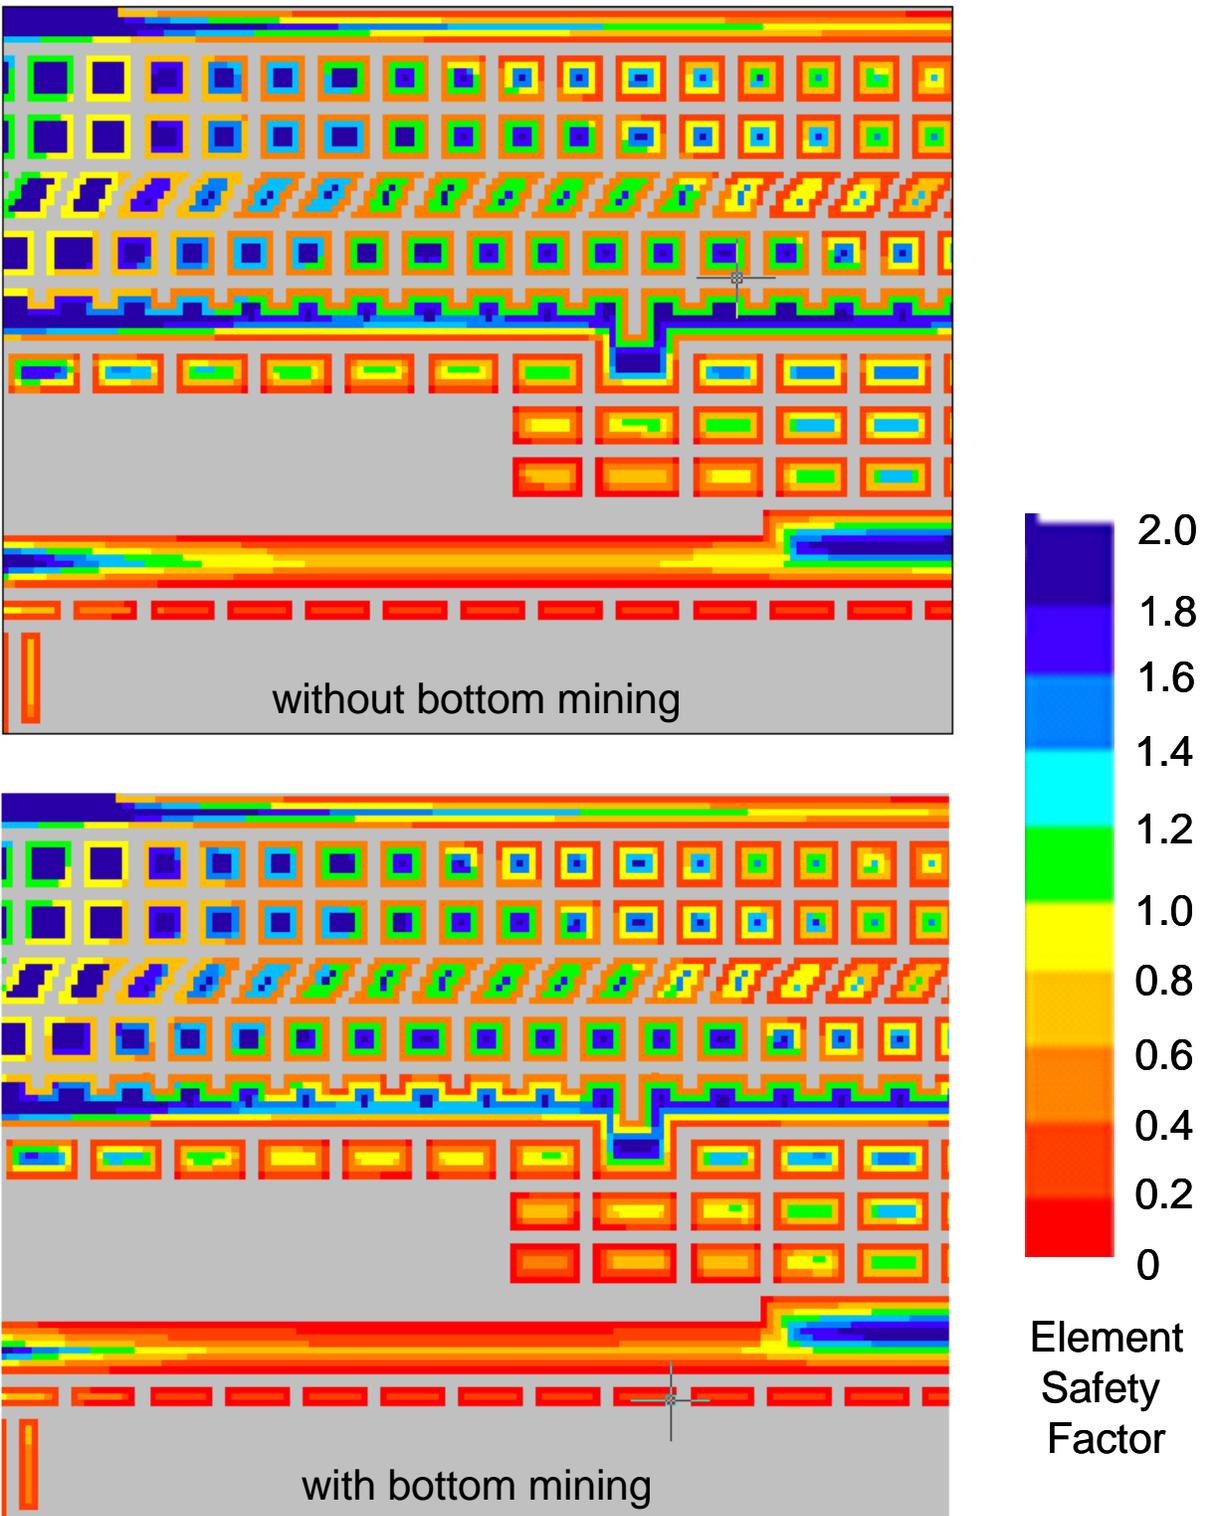
Figure 65 - Element Safety Factors

The element safety factors from the model results indicate that the remnant barrier would have failed even if the bottom coal had not been mined (Figure 65). Element stability factors below 1.0 in Figure 65 indicate that the peak strength of elements was exceeded across the entire width of the barrier even though the modeled mining height was 8 feet. The primary effect of bottom mining in by the pillar line was to weaken an already undersized remnant barrier. Bottom mining in the barrier cuts between crosscuts 139 and 142 weakened the barrier near the last known location of the miners and, consequently, contributed to increased stress levels.

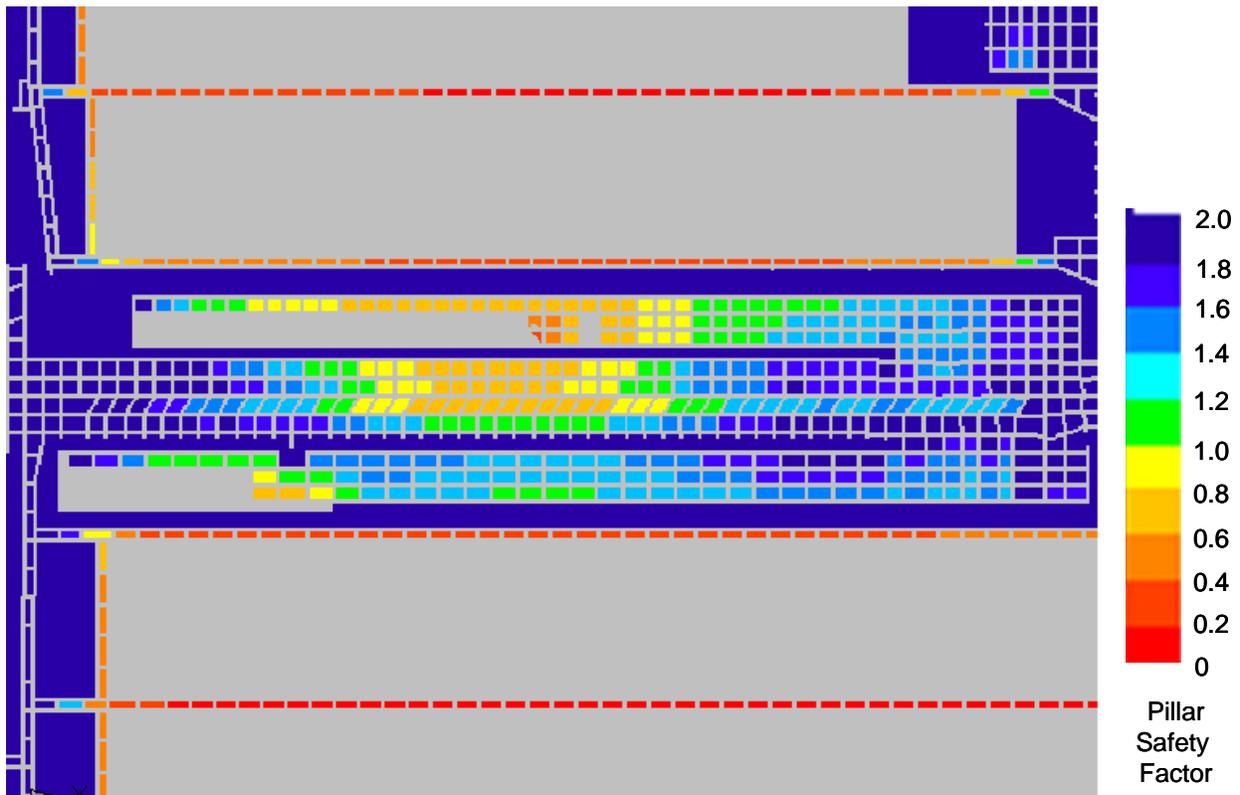
Figure 66 – Pillar Safety Factors Modeled with a 120-foot Southern Barrier

Figure 66 illustrates pillar safety factors calculated for the Main West region as it was actually developed and recovered prior to the August 6 accident. These model results are consistent with Dr. Heasley's results that show some pillar failure in the sealed portion of Main West but stable pillars in the section after development and after the pillar recovery prior to the August 6 accident. Although broad pillar failure can be triggered by one of several mechanisms, the model demonstrates a general reluctance for the Main West failure to propagate south past the

75-foot wide barrier pillar (modeled as 80 feet wide) and into the South Barrier Section. In contrast, when the north side barrier width is reduced to 55 feet (modeled as 60 feet), Main West pillar failure propagates southward into the section during development mining.

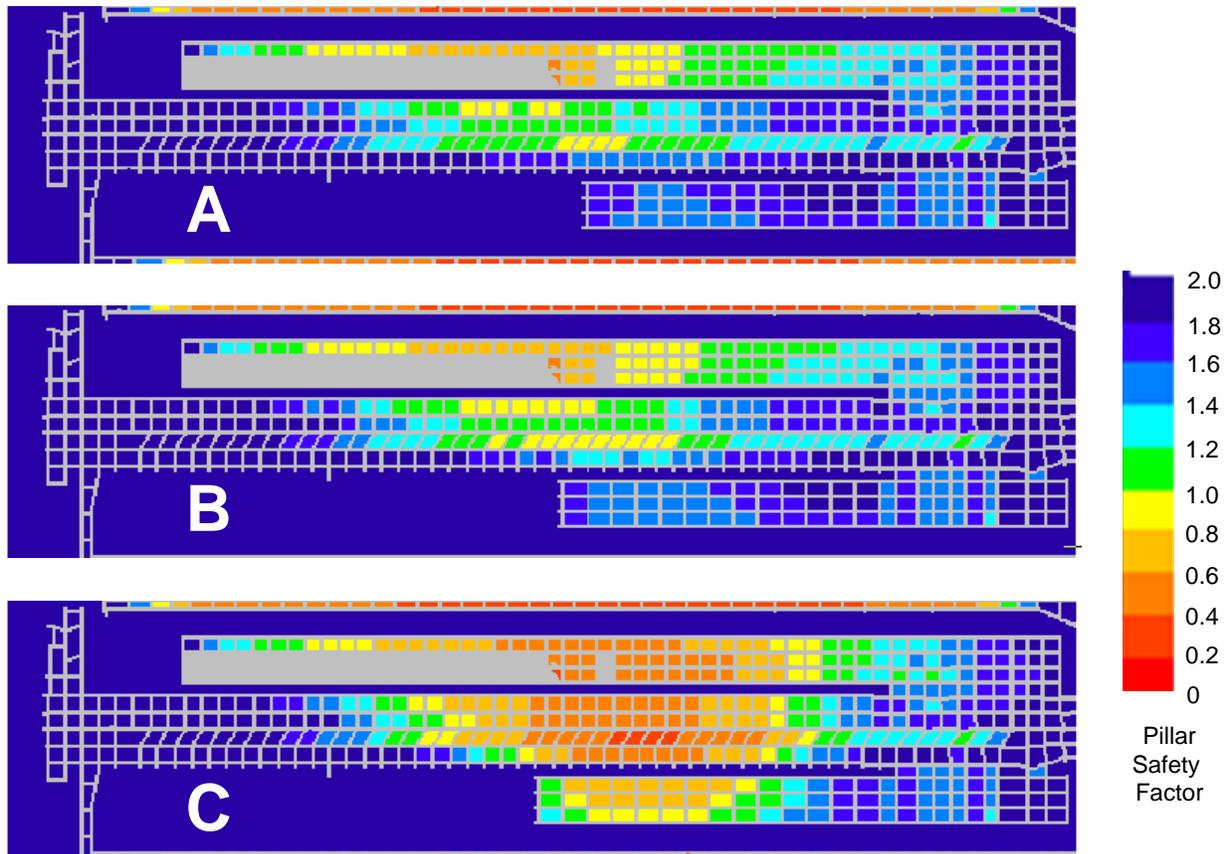
Figure 67 – Pillar Safety Factors Modeled with a 140-foot Southern Barrier for Development Mining

Figure 67 illustrates pillar safety factors for three model steps that represent development mining in the South Barrier section modeled with a 60-foot north side and a 140-foot south side barrier. In Figure 67A, pillars in the South Barrier section are stable as indicated by the blue colors. In Figure 67B, one additional crosscut has been developed. The South Barrier section remains stable but several additional pillar failures are noted in the Main West. In Figure 67C, another crosscut has been developed and failure is widespread throughout the South Barrier section as noted by the yellow and orange colors. A wider barrier south of the section (137-foot versus the 121-foot actually mined) may have decreased the likelihood of failure from Panel 13 longwall extraction abutment stress. However, model results suggest that pillar failure may have occurred in the section during development as a result of the corresponding reduction of barrier width to the north (55 feet initially planned versus 75 feet as mined measured outside the Main West notches).

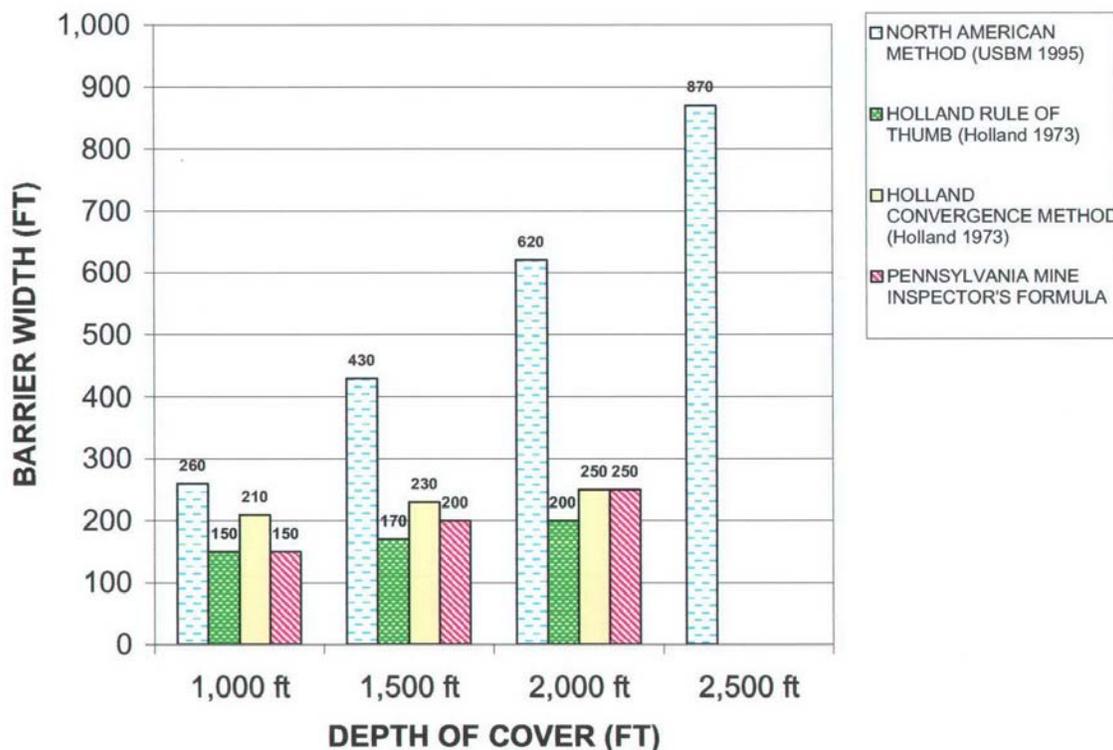
Figure 68 - Barrier Pillar Sizes from Empirical Methods
Figure 4 in AAI's May 5, 2000, Report

As indicated in Figure 68, AAI had previously used the North American method to determine barrier width in overburden depths up to 2,500 feet. This method is the only one of the four that accounts for the width of the adjacent panel in determining the barrier width. AAI's results in Figure 68 were based on using two longwall panel widths (~1,560 feet) and, even at lower depths of cover, this method recommends wider barrier widths than the other three methods. This is a reasonable assumption, given the caving characteristics of strata in the Wasatch Plateau (i.e., maximum subsidence may not be achieved with the extraction of a single panel – see Appendix L). However, if one panel width is used (~800 feet), the calculated barrier widths are much more consistent with the other methods (i.e., 130 feet wide at 1,000 feet of overburden, 210 feet wide at 1,500 feet of overburden, 310 feet wide at 2,000 feet of overburden, and 430 feet wide at 2,500 feet of overburden). As indicated in Table 9, the recommended barrier width using this approach is 357 feet for 2,160 feet of overburden (the depth at which pillar recovery was abandoned in the North Barrier section). Although this approach generates a narrower barrier width than what AAI had calculated in 2000, the recommended width is still nearly three times larger than the 130-foot width determined through numerical modeling in AAI's 2006 studies.

Also, the 130-foot dimension is approximately half the width that the barrier design equations would recommend for a depth of 2,000 feet. This is significant since about 25% of the Main West North and South Barriers have overburden exceeding 2,000 feet. Whereas the numerical model results for barrier design in the May 2000 study were consistent with empirical design equations, the 2006 results were not.

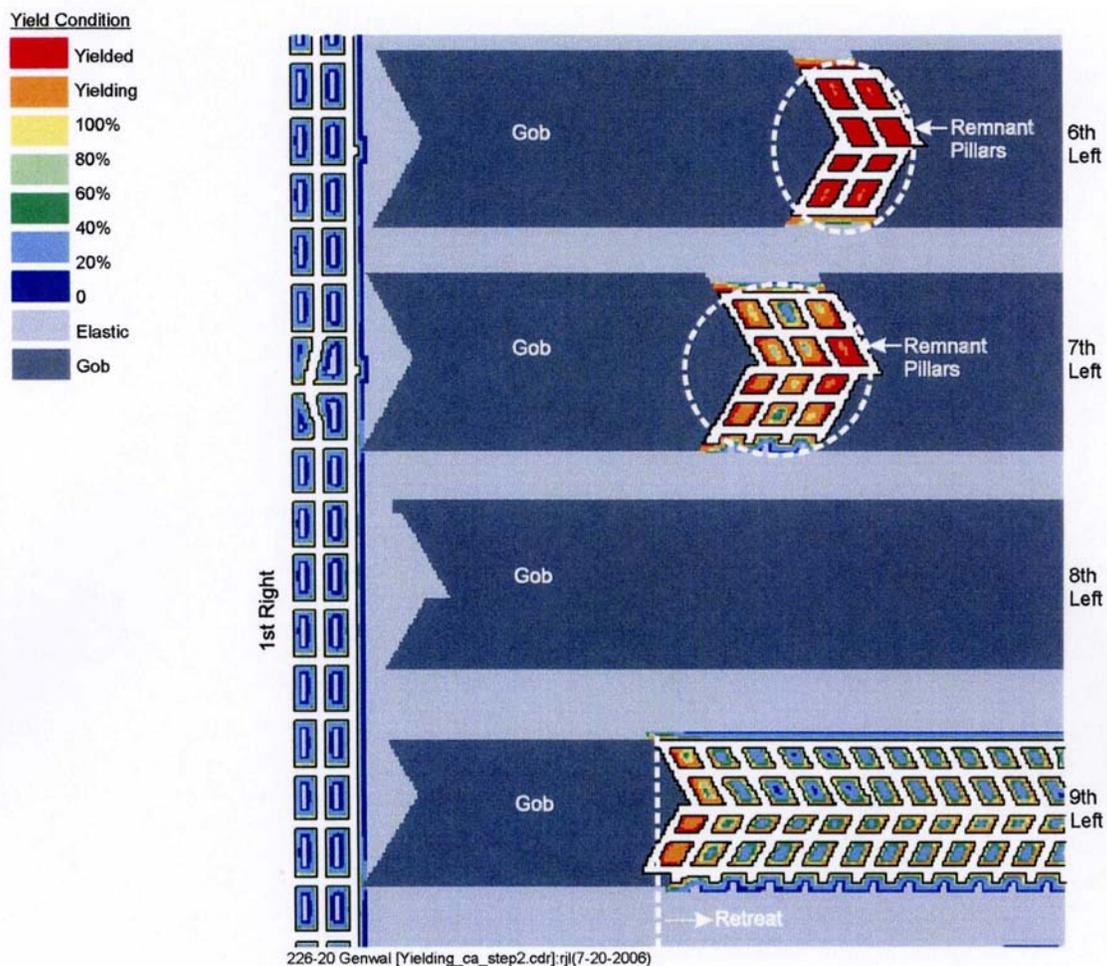
Figure 71 - Modeled Yield Condition - Partial Retreat in 9th Left Panel

AAI claimed that they calibrated the LaModel program using three criteria: vertical stress, convergence, and yielding condition. Lamination thicknesses and coal strength were varied to gauge the sensitivity of model results, reportedly to calibrate to all three input criteria. In their written response to the accident investigation team, AAI indicated that this activity resulted in a calibrated model that simultaneously fit all three criteria. However, interview statements of the AAI engineer that did the modeling reveal that the calibration process relied exclusively on an evaluation of pillar yield condition. Coal strength was adjusted until pillars in the first pillar row of the 1st North, 9th Left Panel (immediately north of Main West crosscut 99) yielded during panel retreat while the outby rows did not (Figure 71).

While mining the 9th Left panel, difficult roof conditions were encountered (i.e., “peeling top coal”) on the pillar line. AAI noted that 2.0 inches or more of convergence was associated with the yielded pillar row in their “calibrated” model. Thus, 2.0 inches of convergence was considered a site-specific indicator of potential roof and rib instability for subsequent predictive models.

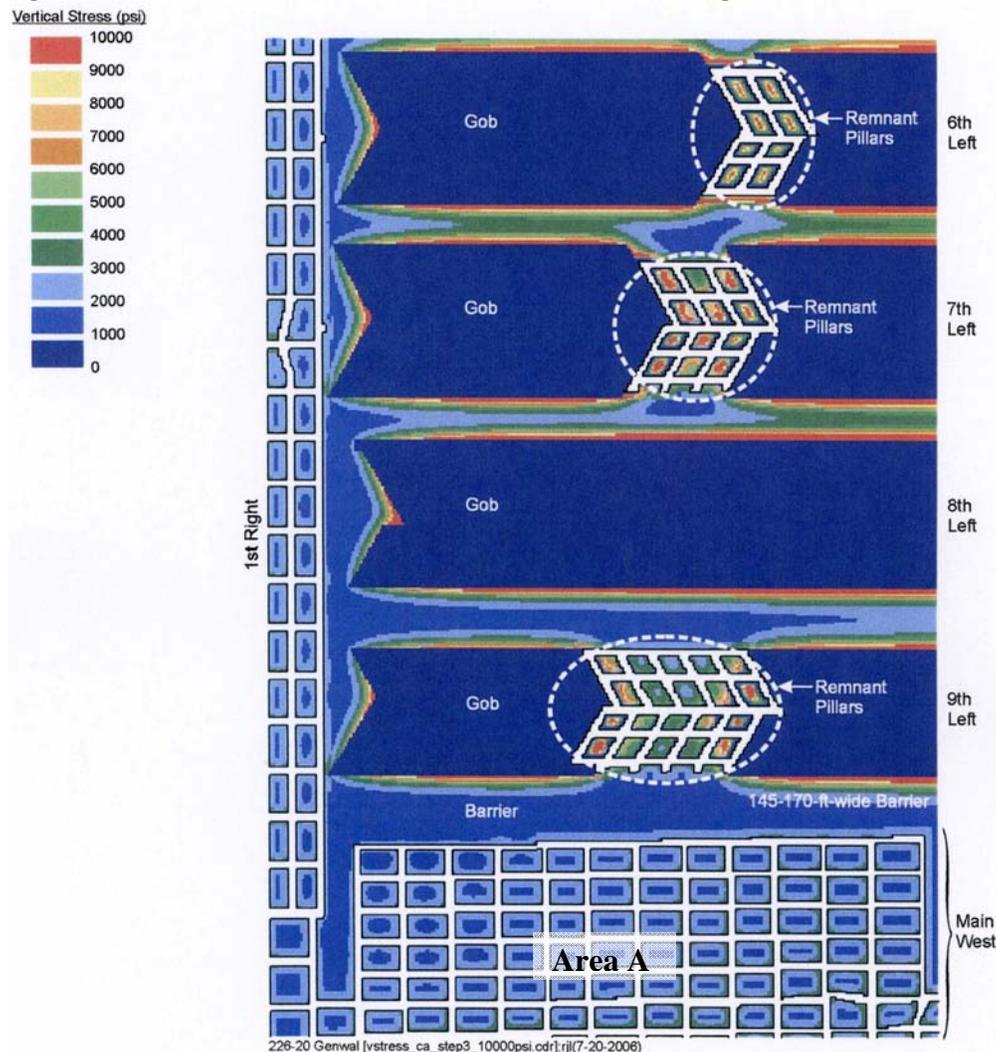
Figure 72 - Modeled Vertical Stress – Retreat Completed in 9th Left Panel

AAI also interpreted abutment stress transfer from their model of the completed 9th Left Panel. As illustrated in Figure 72, AAI's model included mining that was done north of the Main West entries. This northward extension of Main West (labeled "Area A" in Figure 72) was developed intermittently between 2003 and 2005 and approached to within about 145 feet of the 9th Left Panel. AAI interpreted model results to show "no significant side abutment stress override across the barrier on the main pillars, consistent with actual conditions." Since this interpretation appears in a report section titled "1st North Left Panels Back-Analysis," it appears to be intended to support the validity of AAI's model. However, the interpretation actually does little to verify that abutment stress transfer in AAI's model is reasonable.

Underground observations made by the accident investigation team (in Area A, Figure 72) confirmed that there were no significant effects of abutment stress transfer from the adjacent 9th Left Panel. However, this observation does not validate AAI's model results. Given the geometry, substantial abutment stress effects would not be anticipated to occur in Area A. The center of this area is bounded by unrecovered pillars in the 9th Left Panel. One end of the area is bounded by solid coal and the other by a barrier and unmined pillars of the 1st Right Mains. A more appropriate method of validating model behavior is to correlate model results with stress damage (e.g., roof or rib deterioration) rather than a lack of damage.
