REPORT OF INVESTIGATION

Fatal Underground Coal Burst Accidents
August 6 and 16, 2007

Crandall Canyon Mine
Genwal Resources Inc
Huntington, Emery County, Utah
ID No. 42-01715

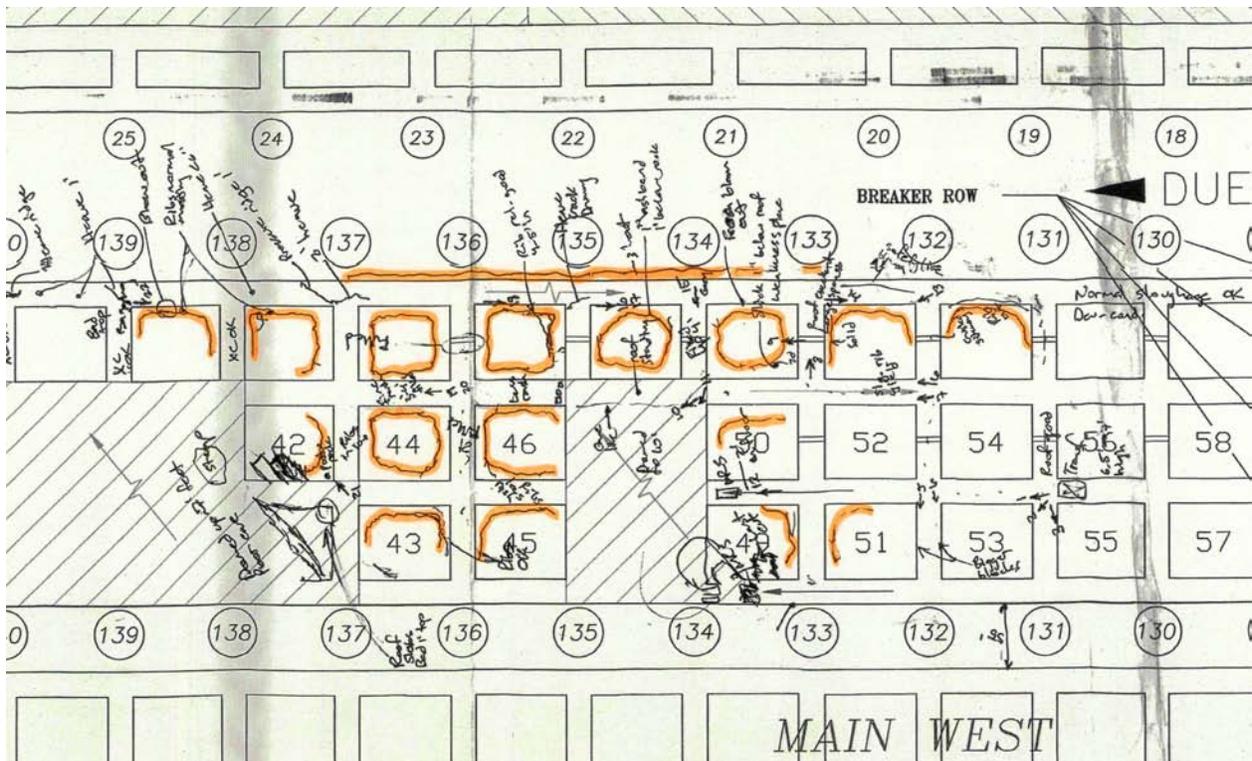
**Figure 73 - Notes Made by AAI on March 16, 2007
(orange lines added for emphasis)**

Photographs, sketches, and interview statements of others indicate that the area affected by the burst was not limited to six or seven pillars and did extend outby. BLM’s Falk noted, for example, that “*Entry ways outby two breaks from the face had extensive rib coal thrown into the entry way. Stress overrides outby the face were very concerning.*” AAI’s field notes also suggest that the damage was more widespread (see Figure 73). The remnants of damaged pillars are sketched inside the original pillar boundaries as indicated by the orange lines in the figure. Photographs taken in this area during AAI’s March 16 visit are included in Appendix O.

AAI attributed the March burst to a lagging cave inby crosscut 138 and the start-up cave between crosscuts 134 and 135 based on their onsite observations. The model grid was changed to reflect this condition. Open entries (as opposed to gob material) were used to represent the areas between crosscuts 134 to 135 and 138 to 139. However, this change had a negligible effect on the model results. Since the gob modulus used in both models was very low, the amount of load transmitted to the gob (rather than transferred to adjacent pillars) was small in either case. Models run by the accident investigation team indicated that peak stress in the gob only increased by approximately 7 psi when the lagging cave was replaced with AAI's low gob modulus.

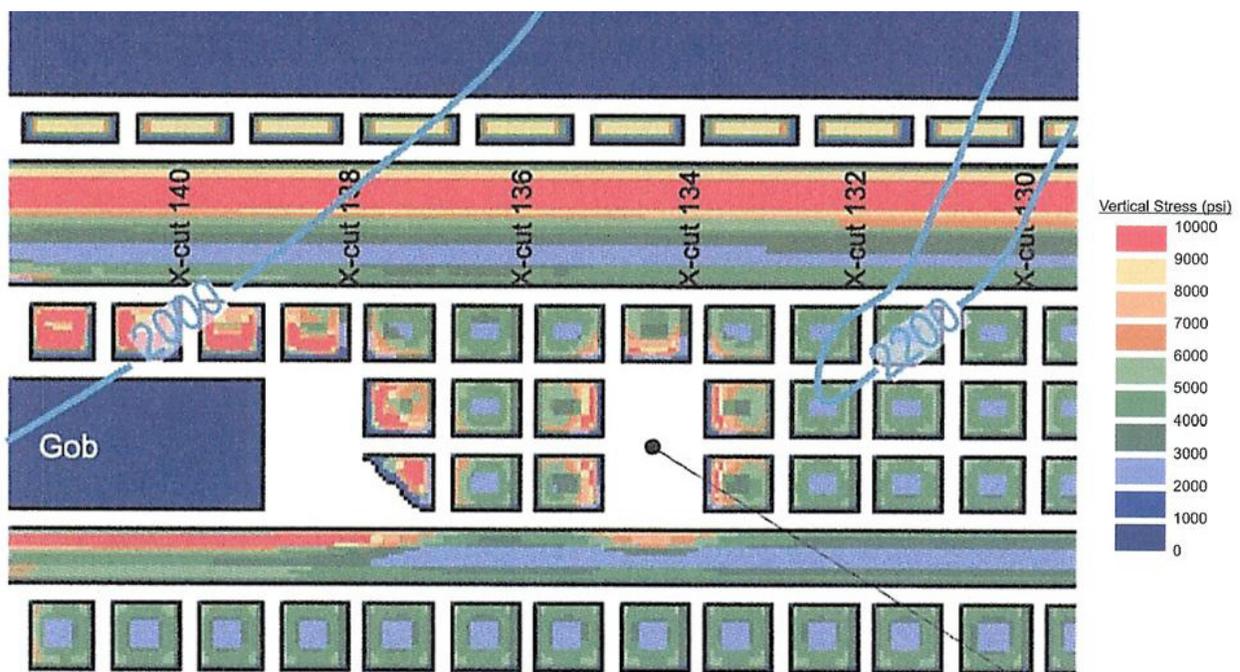
Figure 74 - AAI Model Results of Vertical Stress in March 2007 Burst Area

Models that AAI developed after the March bursts indicated that high stresses were concentrated in the area between these two partially caved or un-caved gobs (see Figure 74). A comparison of Figure 73 and Figure 74 indicates that, even with the lagging cave incorporated into the model, high vertical stresses do not coincide with the extent of damage observed in the mine. Modeled vertical stresses in pillars between crosscuts 136 and 137 appear to be quite similar to stress levels in pillars outby crosscut 133. Furthermore, the pillars outby 133 appear to be largely unaffected by stress transfer from either the longwall gob to the north or the un-caved pillared area between crosscuts 135 and 134. AAI postulated that a dynamic failure (a localized burst) of these pillars could have propagated to pillars over a much wider area.

The changes that AAI made to their numerical model after the March bursts did not constitute a recalibration of the model to the observed ground conditions. Had the disparity between field conditions and model results prompted a careful examination of model input and model recalibration, a properly constructed model would have shown that the South Barrier section mine design was destined to fail. The following section illustrates the output that can be derived by a properly constructed model using AAI's reported parameters.

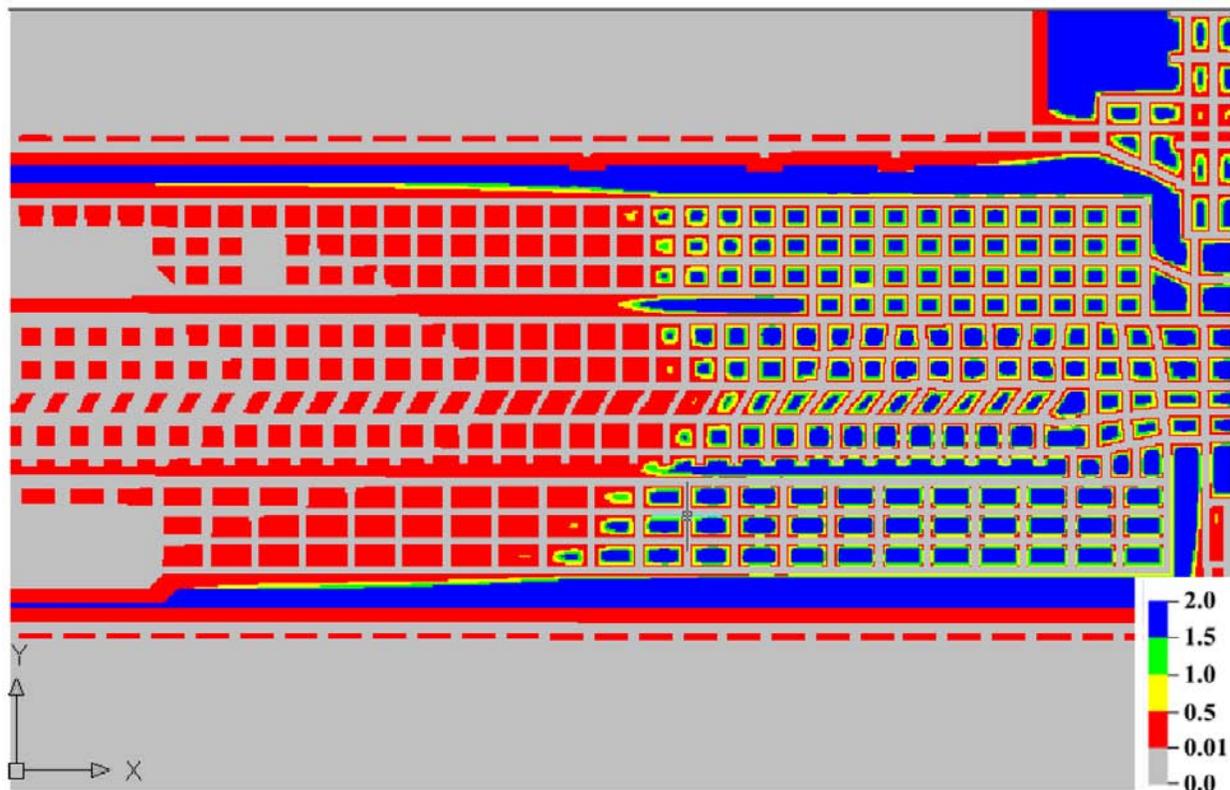
Figure 75 - Element Safety Factors with Coal Properties Distributed as Indicated in AAI Report

BEM Using AAI Model Constructed as Reported. LaModel analyses were conducted with coal properties distributed as outlined in the text of AAI's July 20 report (Appendix F). Results indicate that pillars in the North and South Barrier sections would have failed over a relatively

broad area (Figure 75). In this figure, red and yellow represent elements with a safety factor less than 1 (i.e., the element is considered to have failed).

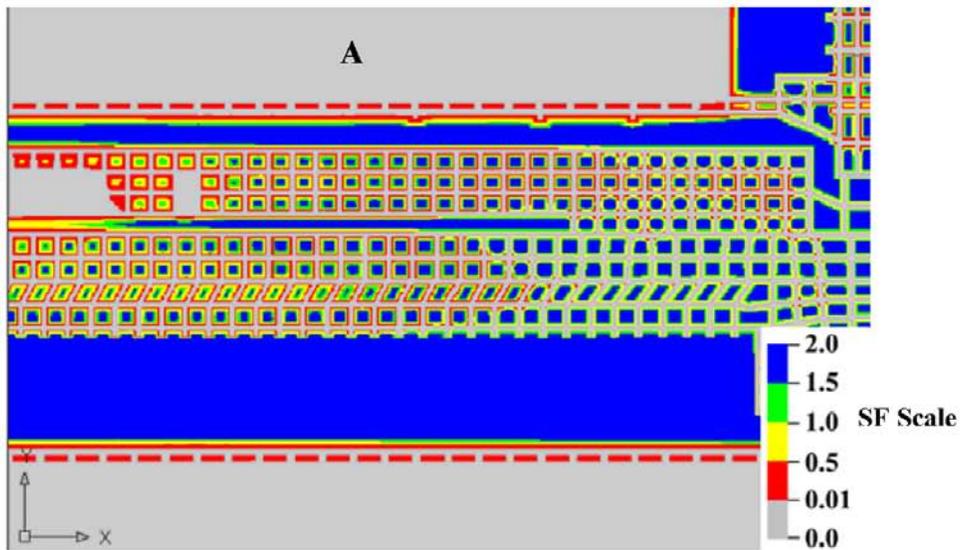
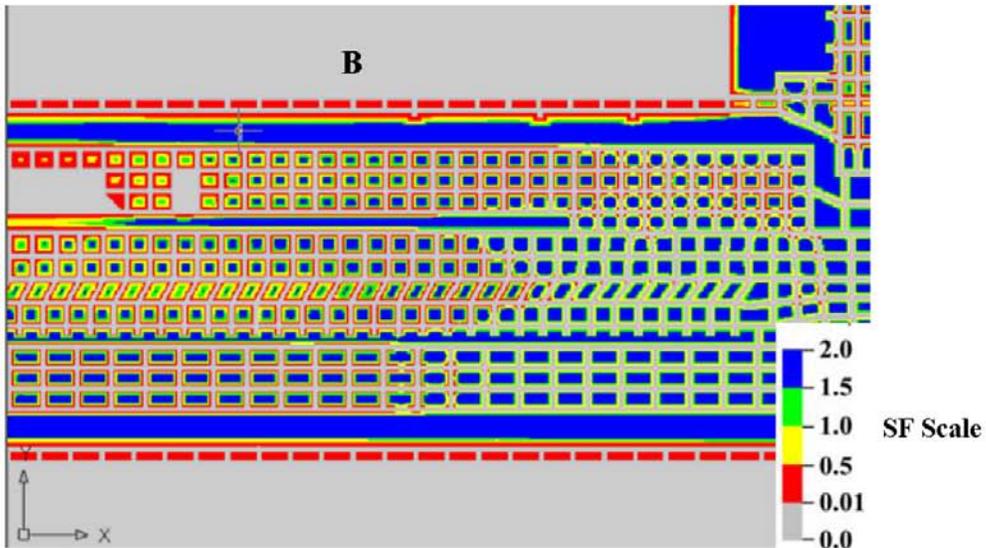
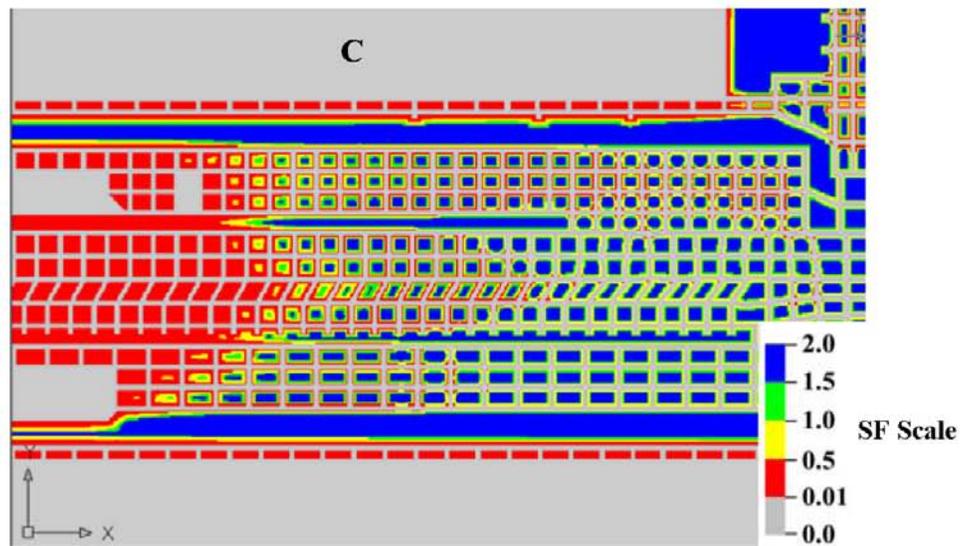
Figure 76 - Element Safety Factors using Modified Coal Strength Property Distribution, Gob Properties, and Lamination Thickness

Figure 76 illustrates element safety factors from a simulation in which AAI's model was further modified to reflect gob properties and lamination thicknesses more consistent with their calibrated EXPAREA model. In this case, a bilinear gob model was used rather than strain hardening and lamination thickness was increased to 115 feet rather than 25 feet. The greater thickness was established using an equation provided by Heasley⁵. Also, rather than modeling a single scenario as AAI had, mining in the North and South Barriers was modeled as three steps: (A) North Barrier pillar recovery to crosscut 133, (B) South Barrier development and (C) South Barrier pillar recovery to about crosscut 131. Results of these model steps are illustrated in Figure 76. Both models (Figure 75 and Figure 76) show widespread pillar failure.

Element safety factors based on the modified model show pillar failure near the site of the March 10 outburst accident (Figure 76 A). Pillar rib elements fail under the deepest cover but pillars remain stable as the South Barrier is developed (Figure 76 B). However, as pillars are recovered in the South Barrier, failure propagates outby the face and extends into the Main West and North Barrier section workings. Although the model does not match the observed damage as well as Dr. Heasley's model, it is generally consistent with the failures that occurred in March and August 2007 at Crandall Canyon Mine. The modeling results illustrate that a properly constructed and calibrated model will depict that the South Barrier section pillar design is unstable and destined to wide spread failure.

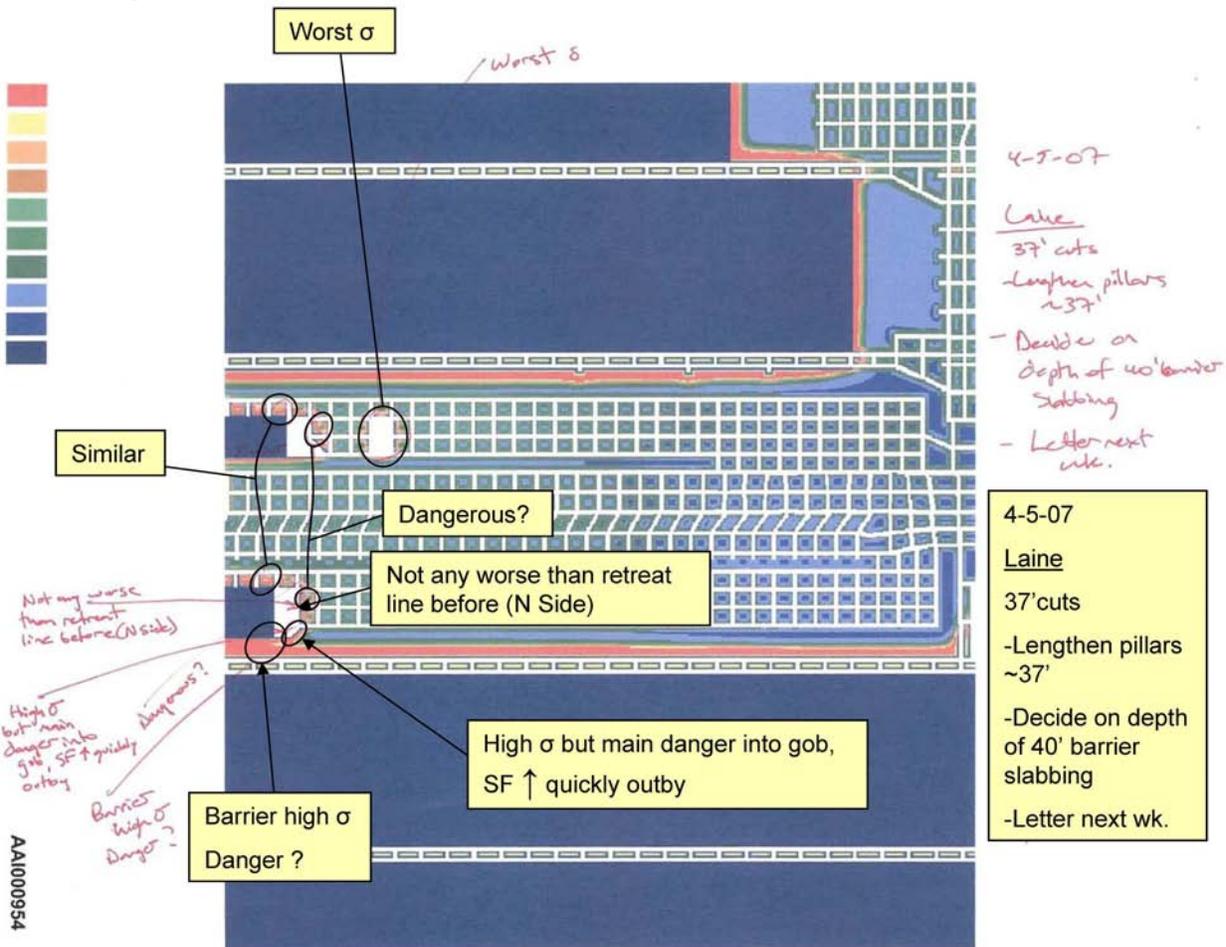
Figure 77 - AAI Notation on Plot of Model Results
Text boxes reflect handwritten notes and were added for clarity.

South Barrier Design. After the March burst, AAI changed their model to reflect a lagging cave but this change had very little impact on model results. The model used to evaluate designs for the South Barrier section was essentially the same as the model used to design the North Barrier section. Proposed design changes including longer crosscut spacing were evaluated. AAI had modeled the effects of longer crosscut spacing early in the Main West Barrier Mining project. Their earlier conclusion was that “increasing crosscut spacing does not significantly improve conditions.” Increased pillar length (reported as a 20-foot increase, but modeled as a 10-foot increase from 70 to 80 feet) “only incrementally reduces rib yielding, corresponding to a modest decrease in entry convergence.” In the South Barrier section models, however, pillar length was increased by 37 feet (72 to 109 feet). AAI noted that modeled stresses in the projected South Barrier workings were similar to those experienced at the March burst site when crosscuts of similar length were used (see handwritten notes, Figure 77). However, AAI concluded that the longer crosscut spacing “increases the size and strength of the pillars’ confined cores, which helps to isolate bumps to the face and reduce the risk of larger bumps overrunning crews in outby locations.”

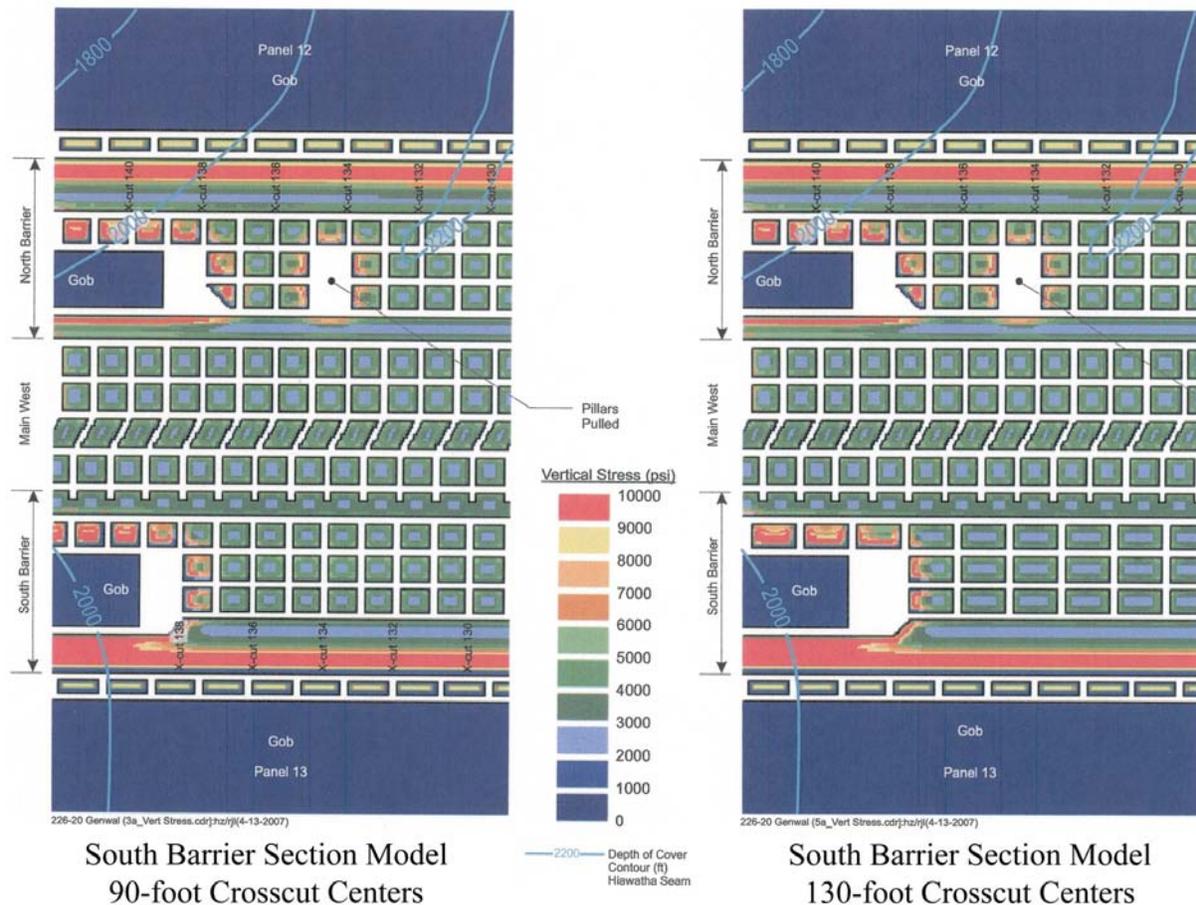
Figure 78 – AAI Modeled Vertical Stress Results Comparing Effects of Crosscut Spacing

AAI’s model results with two different crosscut spacing distances are shown in Figure 78. The images are similar in the sense that high stresses are concentrated in pillar ribs adjacent to the expanding gob area. With longer pillars, the concentration appears to be reduced in the vicinity of the outby intersection. It is important to note, however, that the models did not evaluate pillar recovery on a cut-by-cut basis. When pillar cuts remove coal from the inby ends, the pillars in

the active mining area are reduced in size. Consequently, some of the benefit of longer pillars in the active mining area is diminished as pillar recovery proceeds. The stress concentration will migrate towards the outby intersection as the pillar in the active mining area is reduced. Although the larger (i.e., longer) pillars used in the South Barrier were stronger than those used in the North Barrier, they were not sufficient to ensure the stability of these workings during pillar recovery. Given the aforementioned deficiencies, the models provided no insight into the “risk of larger bumps overrunning crews in outby locations.”

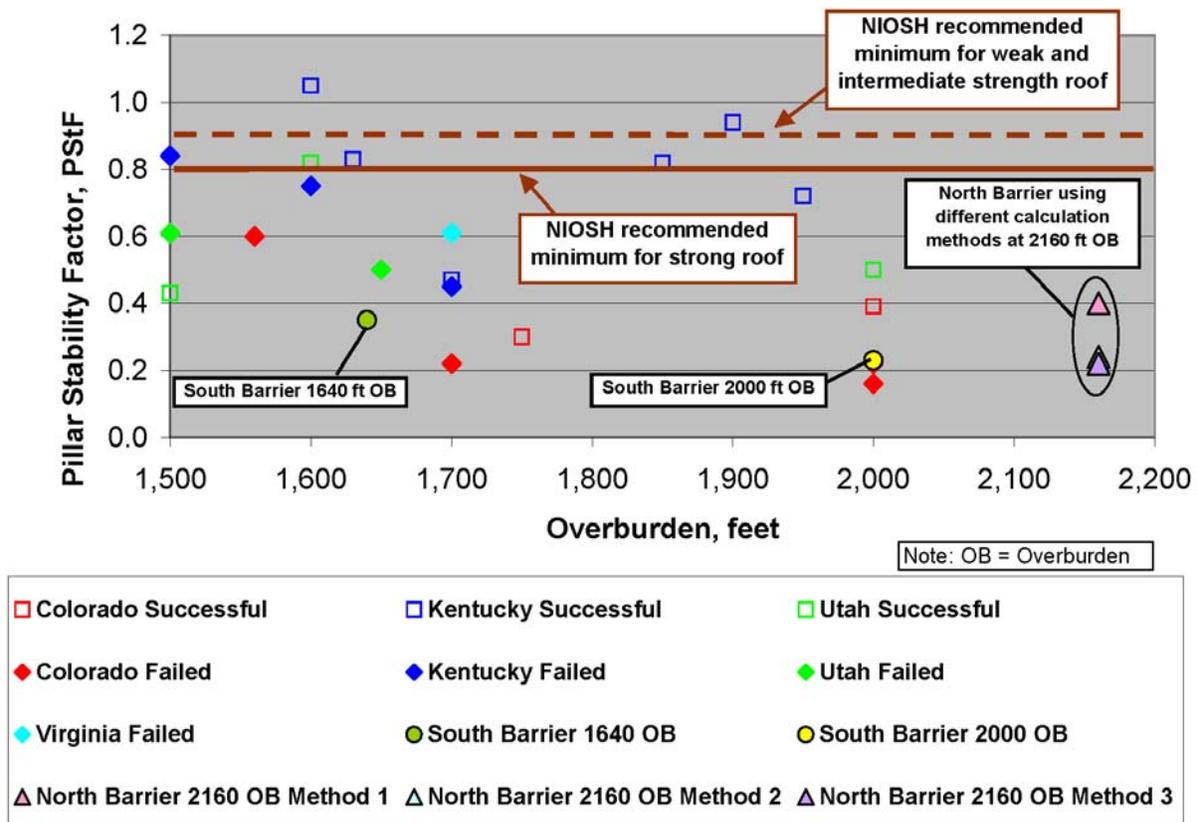
Figure 80 - Pillar Stability Factors from NIOSH ARMPS Database for Depths Over 1,500'
NOTE: NIOSH ARMPS Database only contains case histories at or below 2,000' overburden.

This observation is accurate. Eleven of 21 cases at depths greater than 1500 feet were deemed to be satisfactory designs. Difficult ground conditions were attributed to the remaining ten. Similarly, five of ten cases with PStF’s less than 0.53 (i.e., the PStF value they determined for the proposed North Barrier section) were satisfactory and the other five experienced difficulties (see Figure 80). It is noteworthy that in all of the “failed” cases, NIOSH indicated some degree of pillar “bumping” was involved.

AAI recognized that the North Barrier section pillar stability factors they had calculated were below the NIOSH recommended minimum. AAI reasoned that since the 1st North Left block panels had been mined successfully with a PStF of 0.37, the North Barrier section with a PStF of 0.53 should be acceptable:

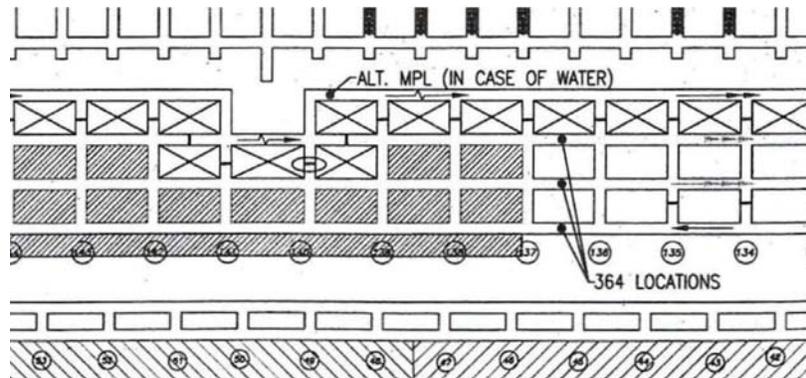
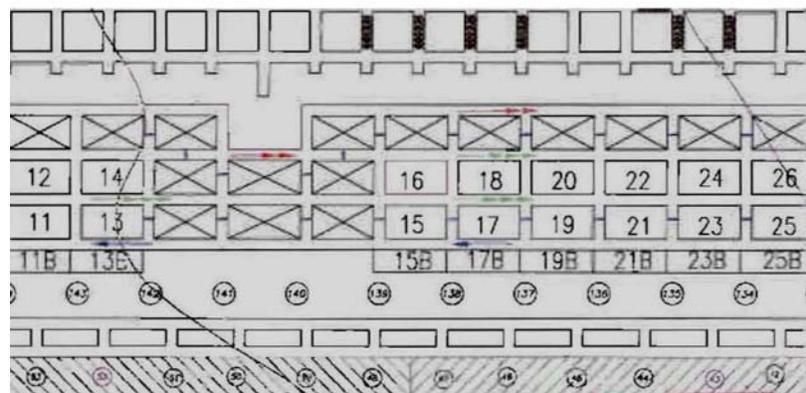
Figure 82 - Comparison of South Barrier Roof Control and Ventilation Plans

The revised roof control plan for pillar recovery of the South Barrier section was approved on June 15, 2007 (see Appendix J). Measurements from the scaled map included with this roof control plan addendum indicated that the pillars were to be mined on 80 x 130-foot centers. The plan also showed the sequence of removing pillars from west to east and specified where coal was to be left unmined. The rows of pillars were to be extracted from south to north. To protect the No. 4 bleeder entry, the northern-most pillars were not recovered.

A 55-foot barrier between the South Barrier section No. 4 entry and the sealed Main West notches was also required to be left unmined. The roof control plan permitted a maximum 40-foot cut from the last row of roof bolts into the barrier south of the No. 1 entry. A double row of roof-to-floor support (timbers) was also required to be installed at the entrance to crosscuts in the No. 4 entry for additional bleeder protection. These timbers were required to be set a maximum of four feet apart with a minimum of four per row.

Portion of mine map from ventilation plan approved June 1, 2007 showing pillar and barrier mining from crosscuts 139 to 142 allowed.

Portion of mine map from roof control plan approved June 15, 2007 showing pillar and barrier mining from crosscuts 139 to 142 not permitted.

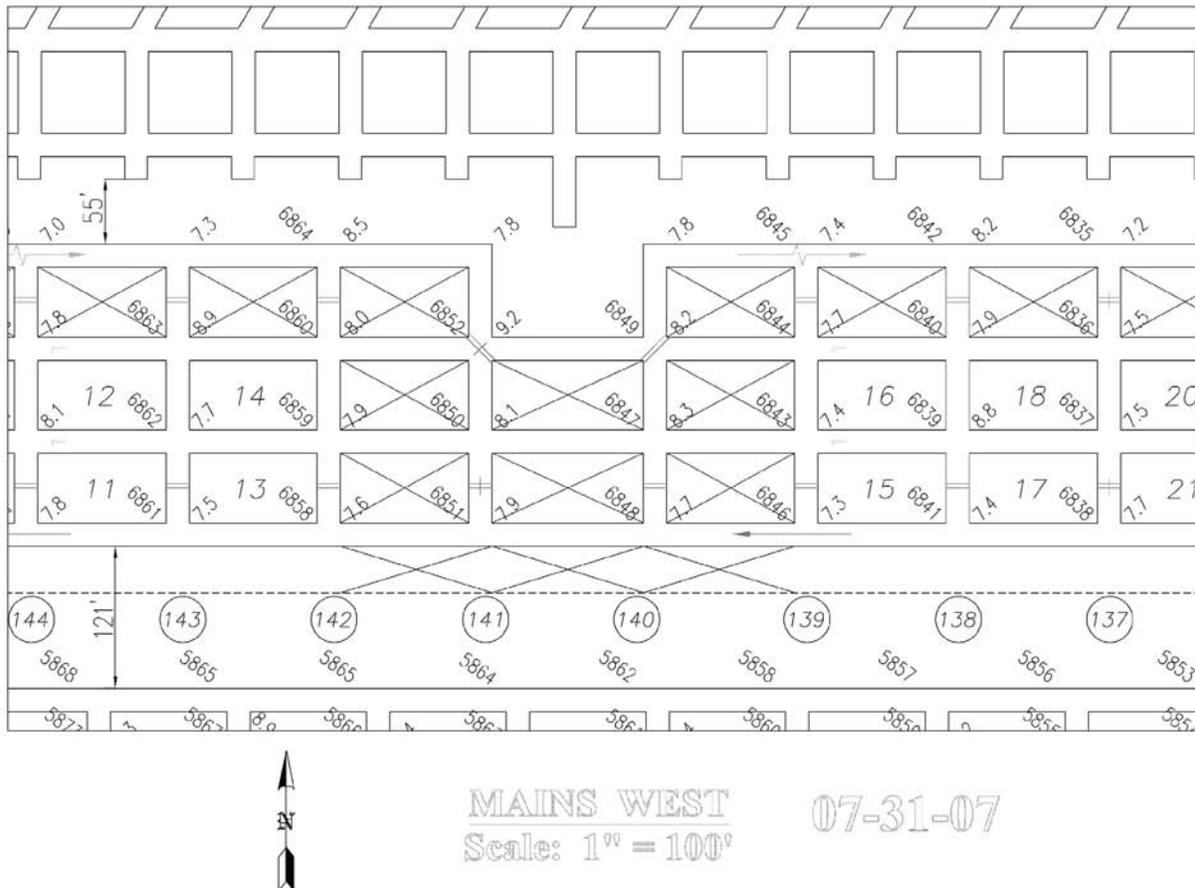
Figure 83 - Mark Up Map Provided to Mine Management on July 31, 2007

The initial South Barrier section mark up map showed the pillar recovery sequence from crosscut 149 to crosscut 142. On July 31, 2007, as pillar recovery approached crosscut 143, Gary Peacock emailed David Hibbs (manager of engineering), "We need an updated mark up map at Crandall showing the pillars that will be left in the area were there is only 3 entries." Hibbs replied, "Gary, I feel we need to leave all rows in the area of 3 entries and also delete the barrier. Do you have any thoughts?" Peacock answered, "I think we should take the barrier." Hibbs responded to Peacock: "Gary, This is the drawing in approved Roof Control Plan for that

area.” Hibbs attached a copy of the pillar extraction map from the approved roof control plan and included Shane Vasten (surveyor) in his email response to Peacock. Later that evening, Vasten emailed Peacock and Hibbs: “Gary, Here is a mark up map for you to look at based on the latest approvals forwarded to me from Dave. If you have any questions/concerns, get with Mr. Hibbs. Ace and I will be there tomorrow doing month end. I will check with you then to see if any changes need to be made. I will also plot more maps for you then. I just wanted to send you this one so you can be looking it over.” Between crosscuts 142 and 139, the attached mark up map (see Figure 83) correctly showed that no pillars were to be recovered and the barrier was to remain unmined south of the No. 1 entry (as indicated by the standard symbol X in the pillars) in accordance with the approved roof control plan. Interview statements, belt scale records, shift foremen’s reports, and production records revealed that the barrier south of the No. 1 entry between crosscuts 139 and 142 was, nonetheless, mined.

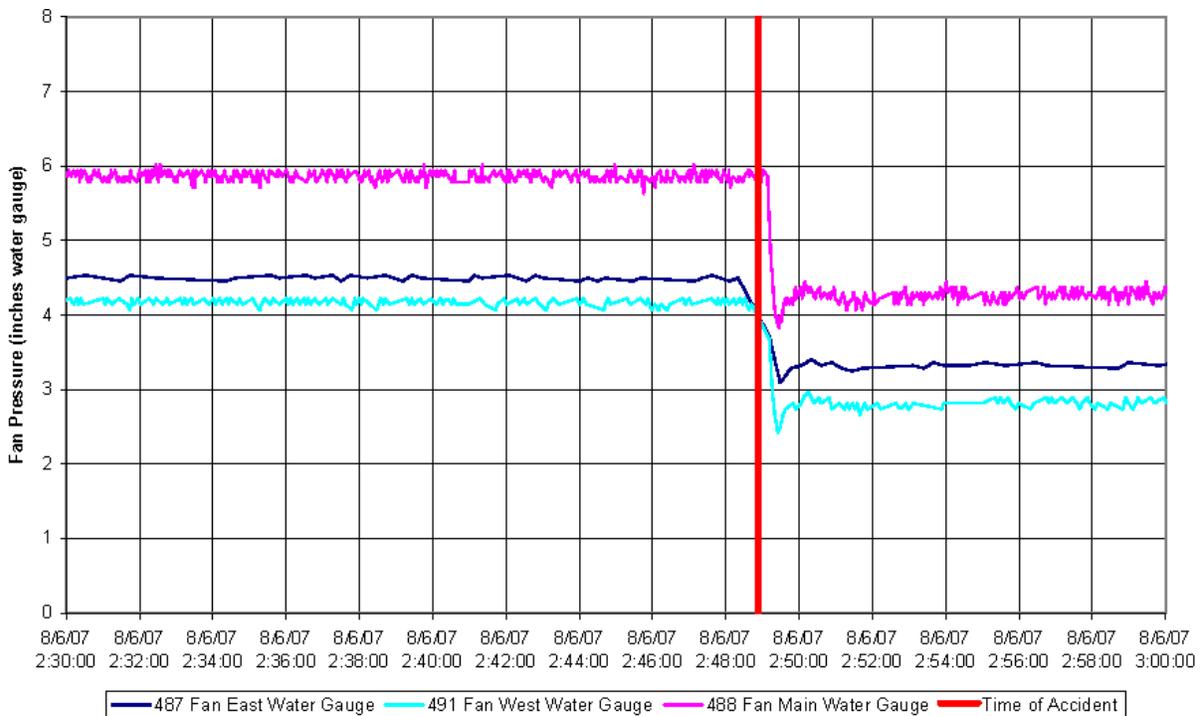
Figure 85 - Fan Pressure at the Time of the August 6 Accident

The effect of the August 6, 2007, accident on the mine ventilation system was significant. The initial air blast and burst coal pillars destroyed or damaged stoppings from the accident site outby to crosscut 93 and the overcasts at crosscut 90 and 91. The damage short-circuited ventilation inby that point.

The short circuiting of air affected the main fan pressure. Figure 85 shows the fan pressure recorded by the mine monitoring system for the time period immediately before and after the accident. Also, the daily fan examination record book indicated 6.5 inches of water gauge (w.g.) for fans 1 and 2 and 6.25 inches w.g. for fans 3 and 4 on the previous day. A pressure of 5.25 inches w.g. for fans 1 and 2 and 5.5 inches w.g. for fans 3 and 4 was recorded after the accident. This was an average decrease of 1.0 inches w.g. after the accident.

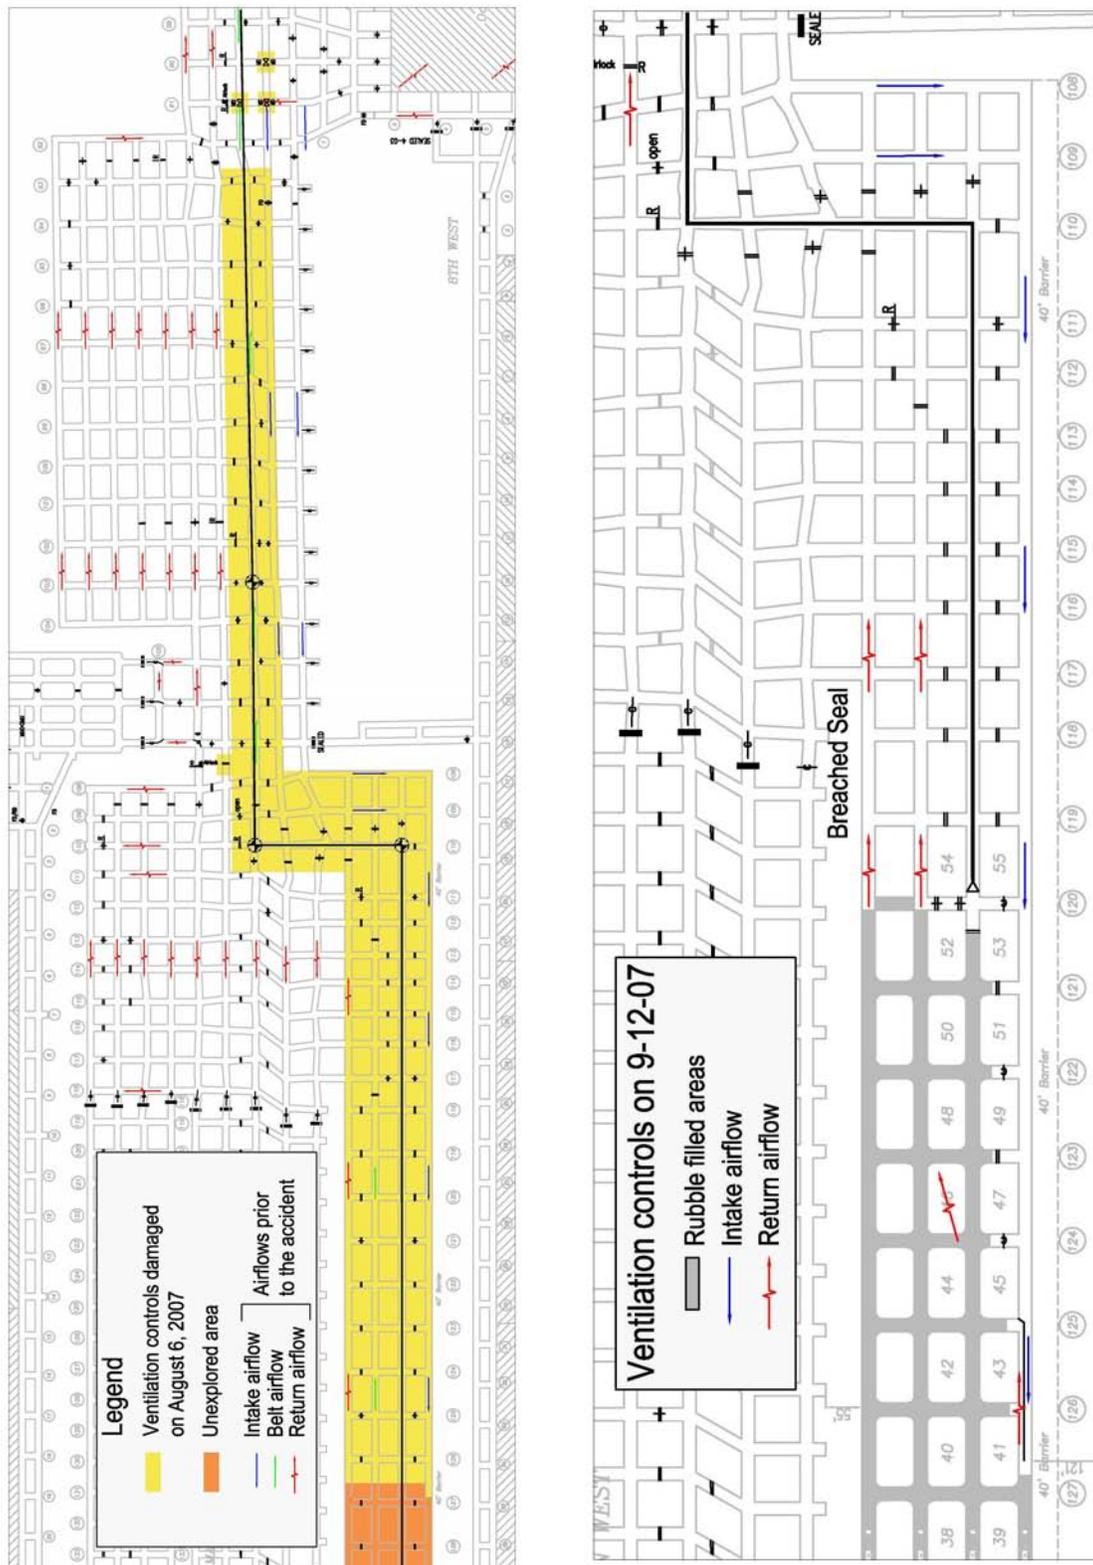
Figure 86 - Ventilation Controls after Accidents

August 7 damaged many of these temporary ventilation controls. The temporary controls were then replaced with permanent stoppings. These permanent stoppings were completed prior to resuming rescue efforts. Figure 86 shows the locations of stoppings damaged in the August 6 accident and the stopping configuration after the August 16 accident.

Originally, the South Barrier section No. 3 entry was in common with the belt entry. As ventilation controls were reestablished, the No. 3 entry was utilized as a return air course. Stoppings were erected between the No. 2 and 3 entries. A feeder was set in the No. 2 entry between crosscuts 119 and 120. The stoppings between the intake and belt entries (No. 1 and No. 2) were reestablished up to crosscut 120. Crosscut 120 was left open to serve as the haul road to the feeder. A stopping was built across the No. 2 entry inby crosscut 120. Inby that point, the No. 1 entry served as the intake and the Nos. 2, 3, and 4 entries served as returns.

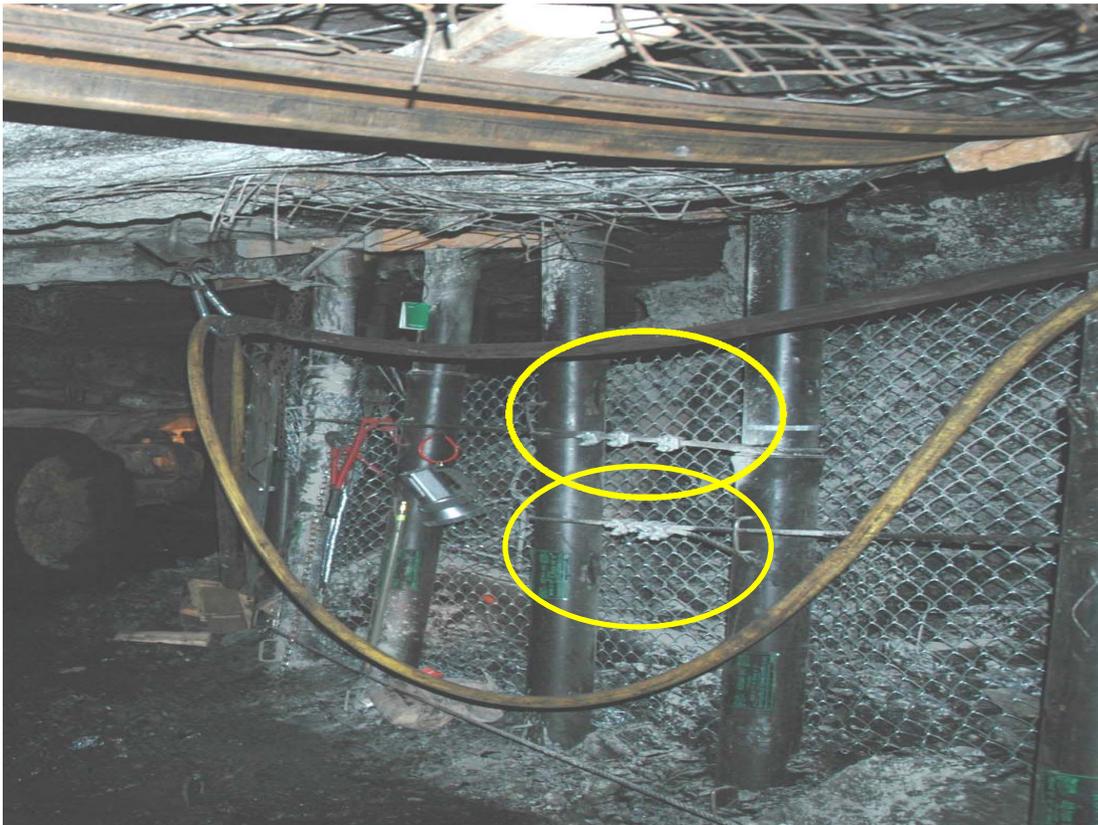
After a series of RocProps was installed, chain-link fencing was installed on the rib side of the RocProps to contain sloughed or burst coal. Periodically, 5/8-inch diameter steel cables were installed on the travelway side of the RocProps to contain the RocProps and fencing in the event of a larger burst event. Three cables were installed on the travelway side of the RocProps at the top, middle, and bottom. Each cable connection or loop was secured with three cable clamps. The cable was wrapped around one RocProp every 40 feet and connected to itself. Each cable was anchored to a separate RocProp (Figure 88). The RocProps and associated chain-link fence and steel cables were advanced behind the continuous mining machine.

Figure 88 – Steel Cables Connected to RocProps

On the evening of August 16, a large burst originated from the north side of the No. 1 entry. The burst dislodged the installed RocProps, steel cables, and chain-link fencing, violently throwing the debris and the support system from one side of the entry to the other. It happened at a time in the rescue work cycle where the maximum number of personnel was in the area. This accident resulted in six injuries and three fatalities.

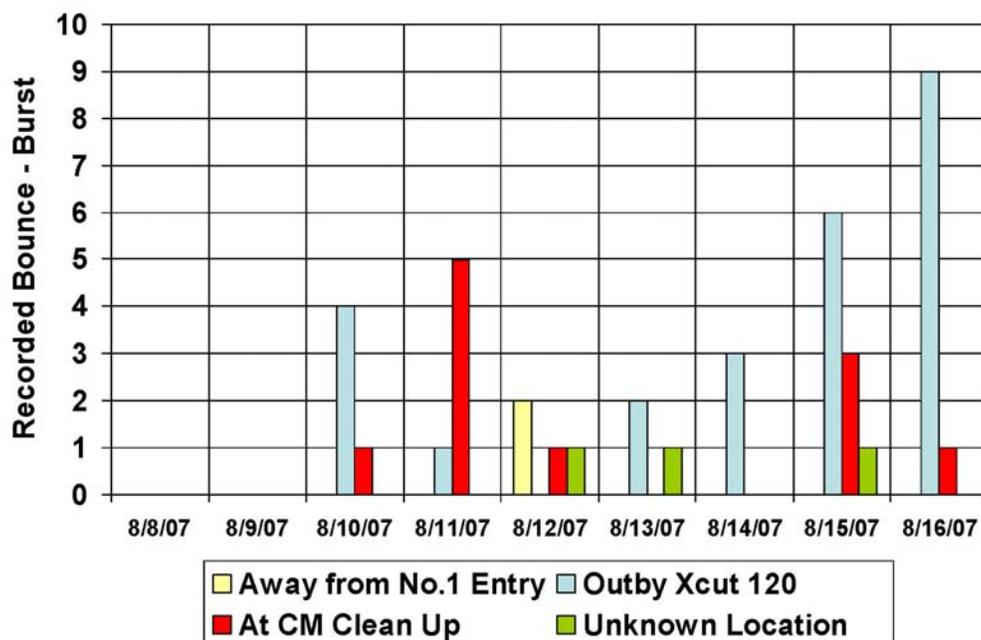
Forty-one events were reported by underground personnel during rescue work in the No. 1 entry prior to the August 16 accident. All bounce activity, which included bursts, originated from the section pillars to the north of the No. 1 entry. None was associated with the barrier to the south. The majority of these bounces or bursts were outby crosscut 120 (see Figure 93). This area was outby the crosscut leading to the feeder, away from the clean-up operation in the No. 1 entry (see Figure 3). The rescue work area was protected with RocProps or wood posts with Jackpots. Rib deterioration and bursts that occurred outby the clean-up area were contained by the support system.

Figure 93 – Bounce or Burst Activity Recorded in Command Center Log Book August 8 to August 16, Prior to August 16 Accident

Prior to the August 16 accident, eleven burst/bounce events were reported to have originated from the north side (right side) section pillars inby crosscut 120 (see Figure 93). These events occurred at the remote-controlled continuous mining machine where the material was being loaded, inby the area of the advancing RocProp system. The approved clean-up plan included procedures that minimized exposure of rescue workers in this area. It was thought that if a significant pillar burst were to occur, it most likely would be in the area where material was being removed. The command center log book noted that events in the clean-up area varied in size with two large pillar bursts in this area recorded prior to the August 16 accident. Prior to August 16, no significant bounces or bursts were recorded within the RocProp support system inby crosscut 120. One burst event was noted outby crosscut 120. Material piled behind the chain-link fencing inby crosscut 120 resulted from unreported bounces or bursts, or from rib sloughage.

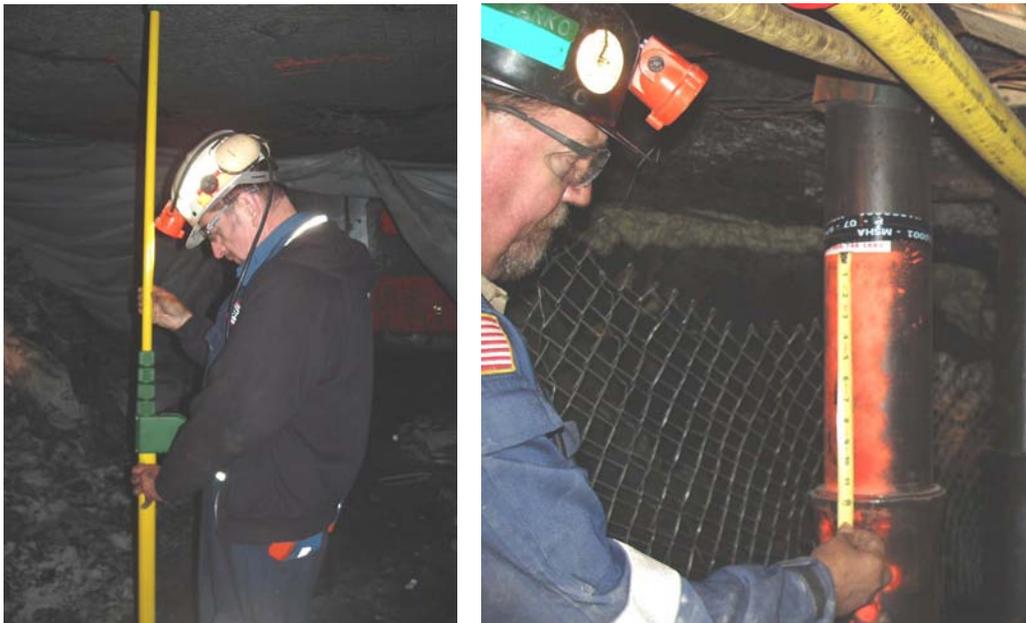
Between August 12 and 15, clean-up progressed steadily but there was an increasing number of reports of rock noise emanating from locations outby crosscut 119 and roof cracks were observed between crosscuts 115 and 119. These observations raised concerns that a roof fall could occur outby the rescue workers and that additional pillar failure could be responsible for the changing conditions. MSHA installed 10 roof-to-floor convergence stations (at crosscuts 111, 113, 115, 117, and 119 in the No. 2 and No. 4 entries) to assess ground behavior.

Figure 95 - Convergence Measurements
Left: Roof-to-floor convergence station. Right: RocProp convergence station.

The convergence stations were monitored to determine the magnitude, rate, and distribution of roof-to-floor closure. Historically, measurements of this type have been useful in monitoring changing and potentially hazardous ground conditions. Initial (baseline) measurements were taken on August 15 and the stations were measured twice on August 16 prior to the accident. Measurements in this time frame indicated that ground conditions were stable; three of ten stations showed closures of 0.04 inches but this amount of displacement is within the precision of the measuring instrument.

Sixteen monitoring locations were established using RocProps in the No. 1 entry. As shown in the photograph on the right side of Figure 95, these monitoring locations were established by painting a line on installed RocProps, 12 inches above the locking ring. Entry convergence could be monitored at these locations simply by measuring the distance between the lock ring and paint line using a tape measure. Although not as exact as a convergence rod, these measurements were intended to provide a convenient method for determining convergence between the mine roof and floor that anyone with a tape measure could perform.

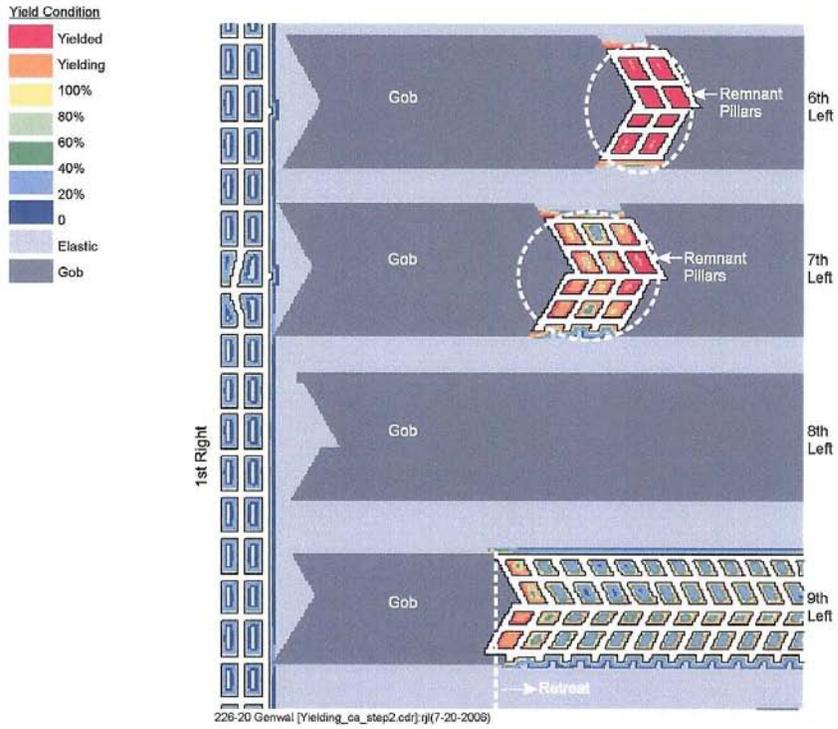
Figure 6. Modeled Coal Yielding—Partial Retreat in Panel 9th Left—1st North

At the second mining stage, pillars next to the gob at the retreat line are shown to be yielded (Figure 6) and converged more than 2.0 inches (Figure 7) in response to abutment stresses. Based on the experience in the panel with peeling top coal, 2.0 inches of convergence is considered an indicator of potential roof and rib instability in the model.

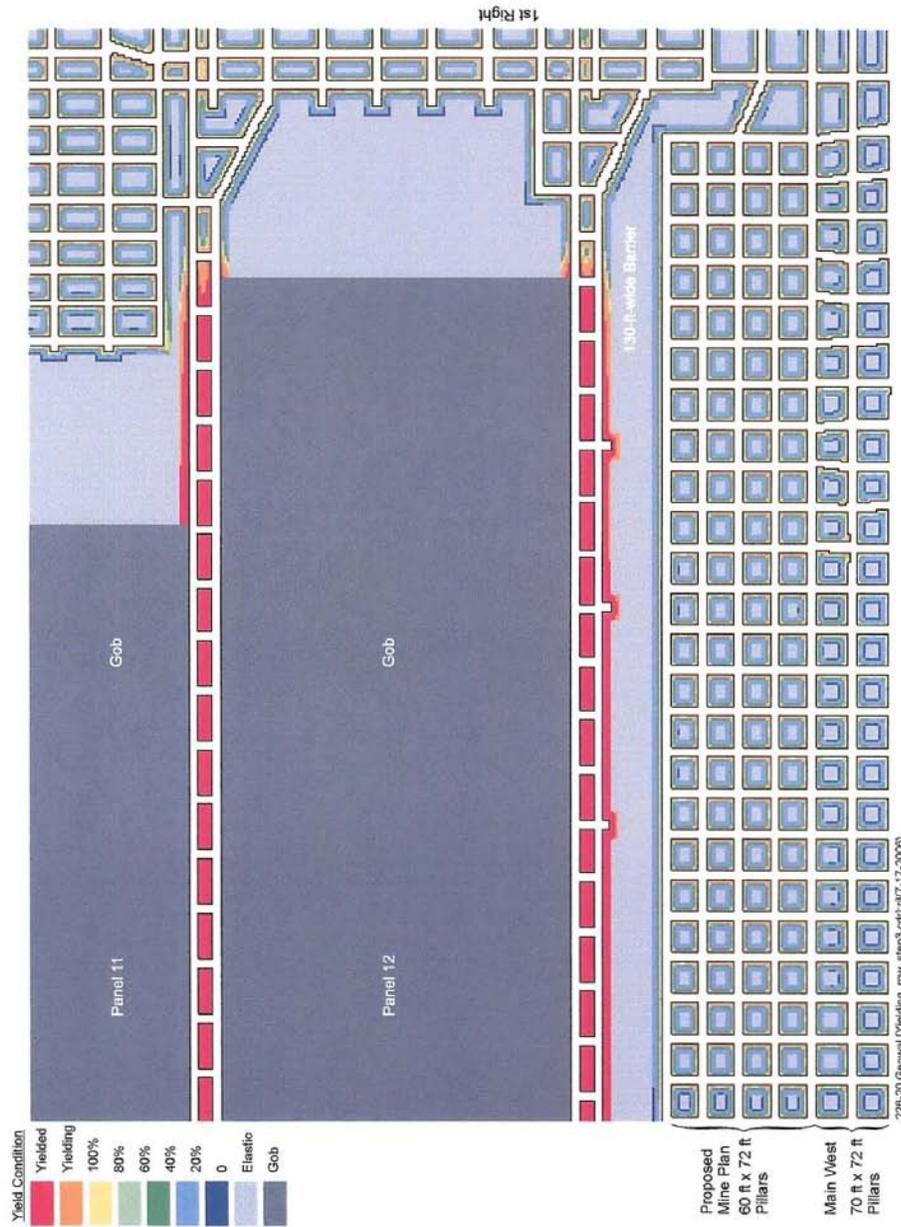
Figure 18. Modeled Coal Yielding—Mining Completed in Main West Barrier

This reduced strength translates to slightly increased rib yielding (sloughage) and increased roof convergence. Figure 18 shows rib yielding predicted by the model. In the figure, rib yielding is limited to the corners of the existing 70-ft by 72-ft pillars (bottom two rows of pillars). In the proposed smaller pillars (top four rows of pillars), yielding occurs in the skin all the way around the pillar. However, the pillar cores are shown to remain competent in all locations, indicating acceptable pillar performance.

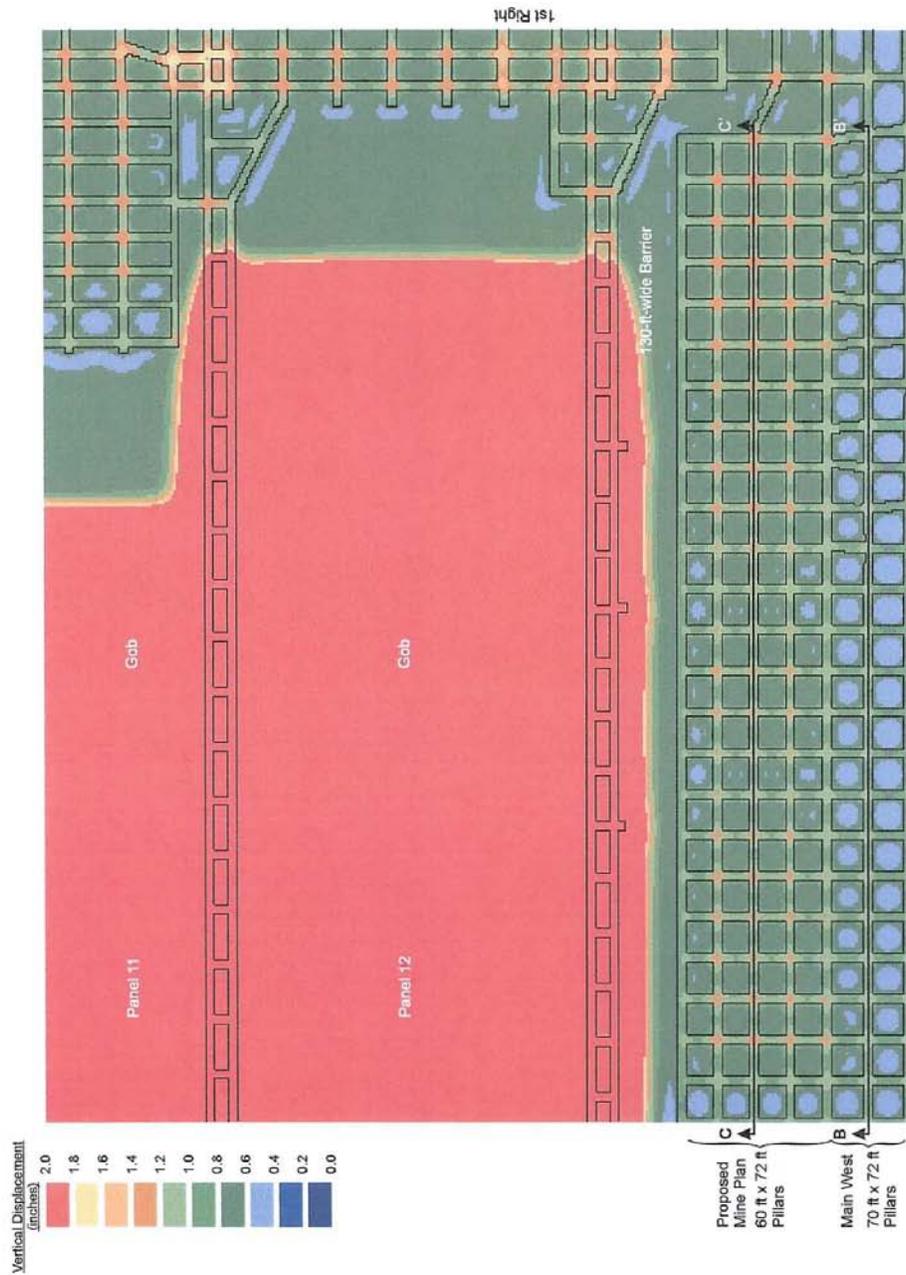
Figure 19. Modeled Roof-to-Floor Convergence—Mining Completed in Main West Barrier

Figure 19 shows predicted roof convergence. Figure 21 compares centerline convergence along an entry in the existing mains (Profile B-B') with an entry central to the new mining (Profile C-C'). Profile locations are shown in Figure 19. The figures show that the proposed smaller pillars result in up to a 0.15 inch increase in roof convergence in the intersections, or about a 15% increase, compared to historical conditions in Main West. This reflects the increased rib yielding around the smaller pillars.
