REPORT OF INVESTIGATION

Fatal Underground Coal Burst Accidents
August 6 and 16, 2007

Crandall Canyon Mine
Genwal Resources Inc
Huntington, Emery County, Utah
ID No. 42-01715

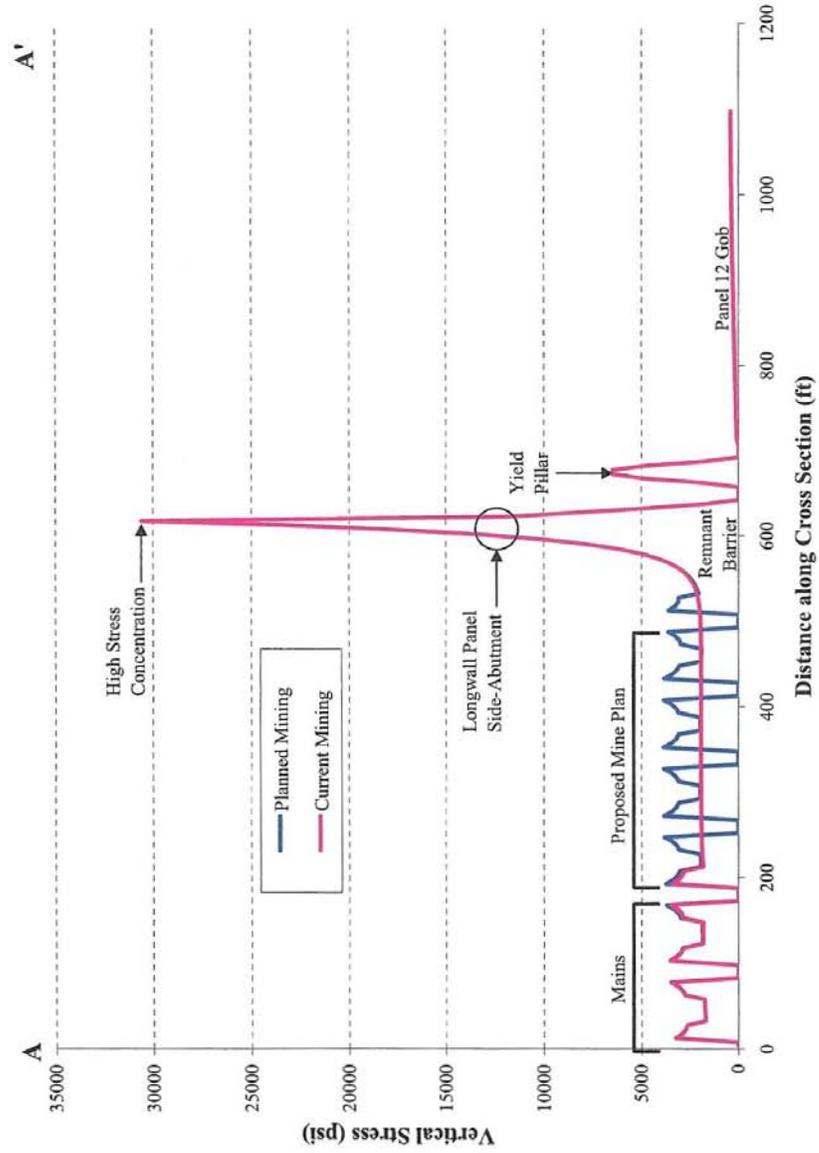
Figure 20. Modeled Vertical Stress Profiles Across Main West Barrier—Profile A-A' (profile location shown in Figure 14)

For the current geometry, the model shows side-abutment stresses reaching as high as 30,000 psi in the northern interior of the existing 450-ft-wide barrier. Figure 20 shows two stress profiles (A-A') through the barrier, one for the current geometry (magenta) and a second with planned mining in the barrier (blue). The location of Profile A-A' is shown in Figure 14. For the current geometry, stress levels taper to near pre-mining (in situ) stress levels approximately 100 ft into the barrier, indicating that the proposed 130-ft-wide barrier will limit exposure of the

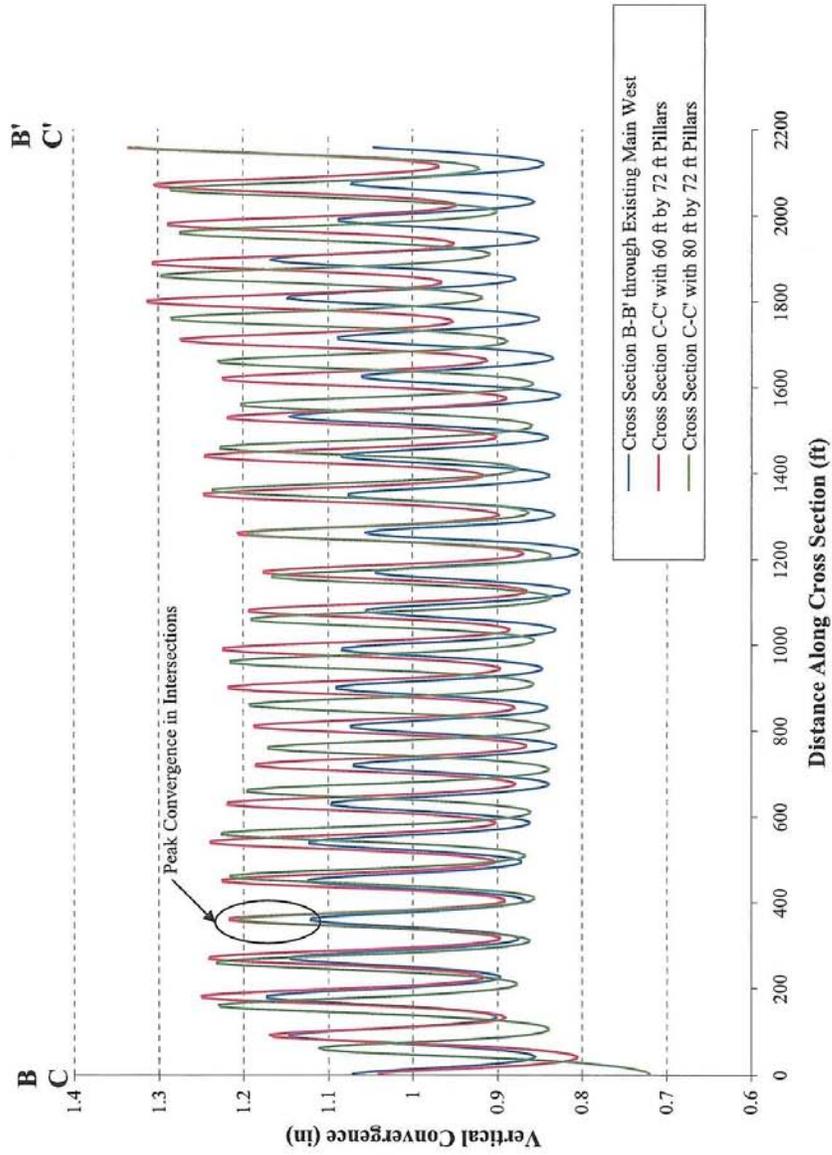
Figure 21. Modeled Roof-to-Floor Convergence Profiles Along Main West Entries—Profiles B-B' and C-C' (profile locations shown in Figure 19)

Figure 19 shows predicted roof convergence. Figure 21 compares centerline convergence along an entry in the existing mains (Profile B-B') with an entry central to the new mining (Profile C-C'). Profile locations are shown in Figure 19. The figures show that the proposed smaller pillars result in up to a 0.15 inch increase in roof convergence in the intersections, or about a 15% increase, compared to historical conditions in Main West. This reflects the increased rib yielding around the smaller pillars.

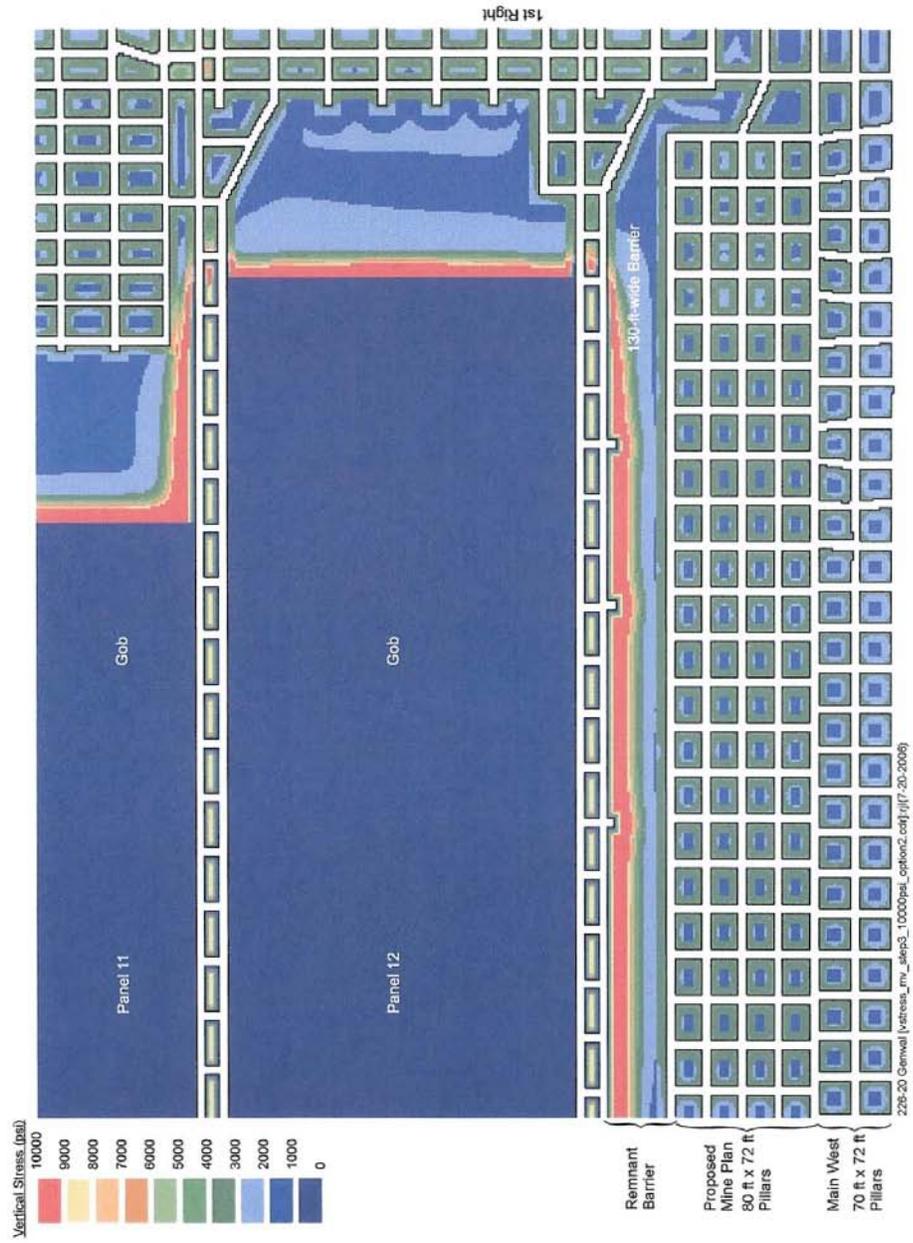
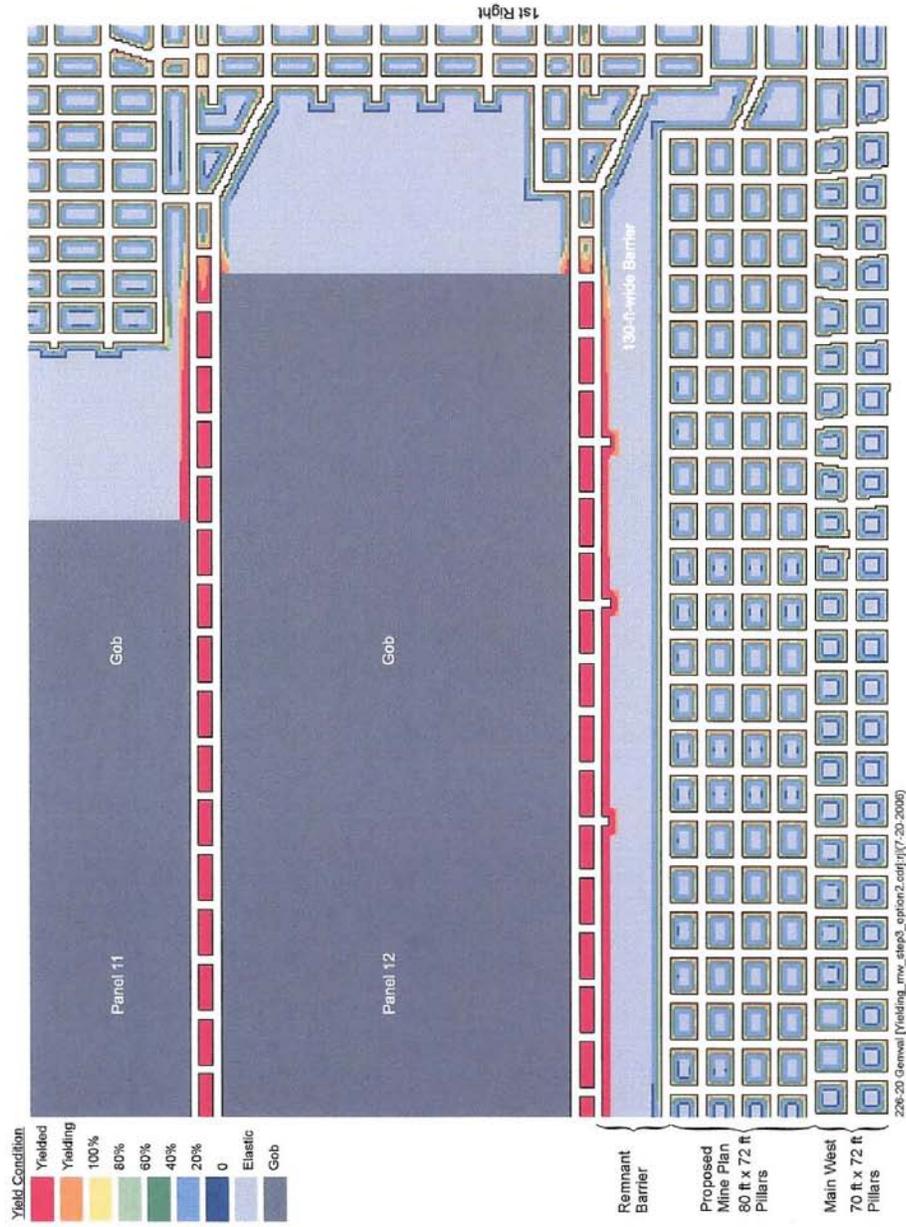
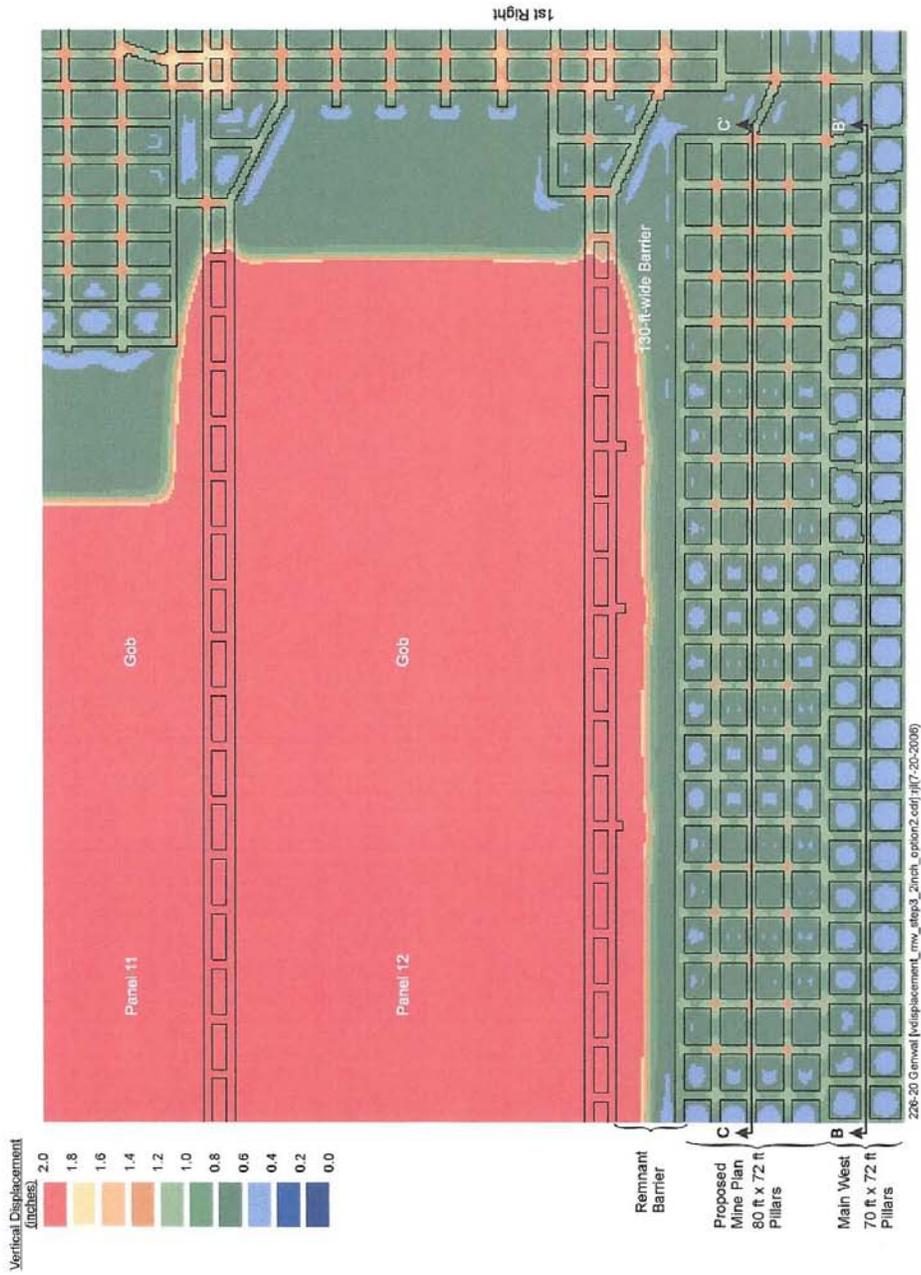
Model results indicate that increasing crosscut spacing does not significantly improve conditions. Figures 22 through 24 show stress, yielding, and convergence for a 60-ft by 80-ft pillar, representing about a 20-ft increase in pillar length (between crosscuts) over the proposed design. The increased length only incrementally reduces rib yielding, corresponding to a modest decrease in entry convergence of about 2% to 4%, as shown by comparison of convergence profiles in Figure 21.

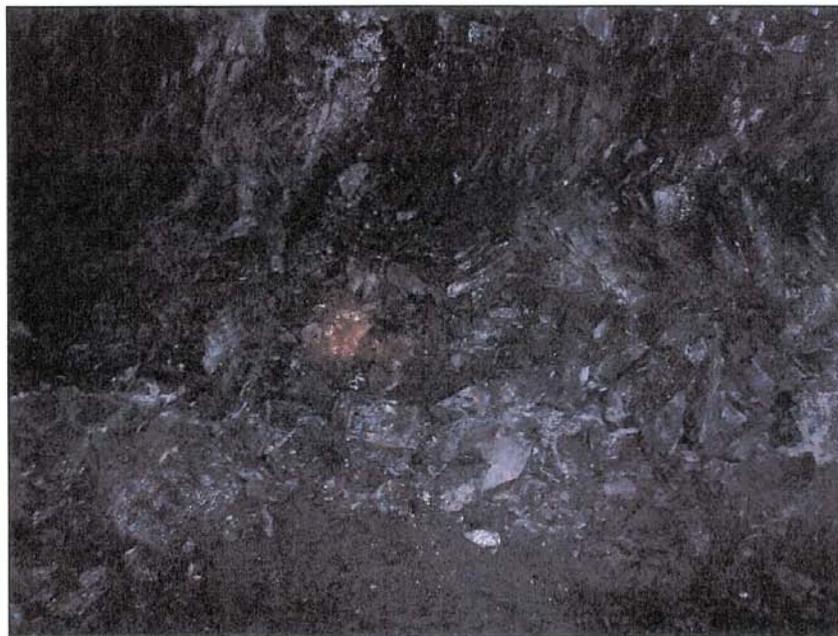
West Main barrier. Photo 1 shows only minor rib sloughing at Crosscut 123 in the entry immediately north of the West Mains. Photo 2 shows the second entry below longwall Panel 12 with minor sloughing at the rib between Crosscut 122 and Crosscut 121. The conditions of ribs along the north remnant barriers were good and consistent as shown in Photo 3. The rib was mildly yielded, but showed no evidence of blowouts, indicating that the 130-ft-wide remnant barrier pillar is wide enough to accommodate the load transfer from Panel 12 for short-term mining. The abutment load is expected to have alleviated since the time that Panel 12 was retreated in 1999 due to ground settlement and subsidence.

Photo 1. Rib Sloughing Near Crosscut 123 in the Entry North to the South Remnant Barrier Pillar

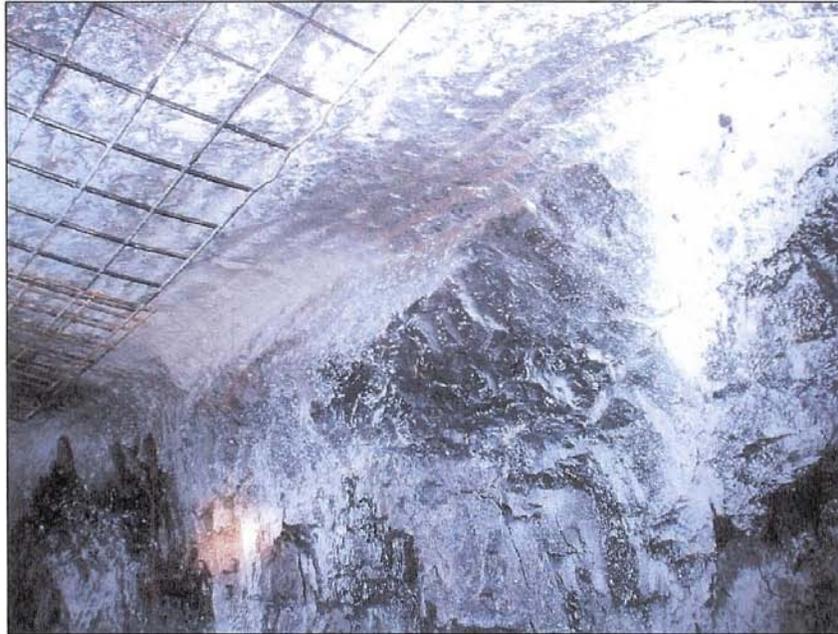
Photo 2. Minor Rib Sloughing at Crosscut 122 in the Second Entry from North Remnant Pillar

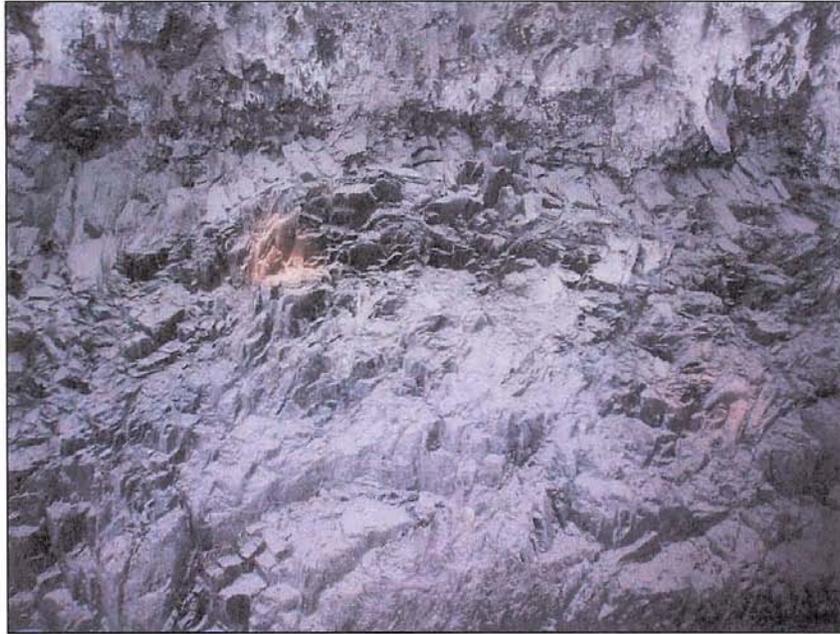
Photo 3. North Remnant Barrier Pillar Rib Condition Between Crosscuts 120 and 119

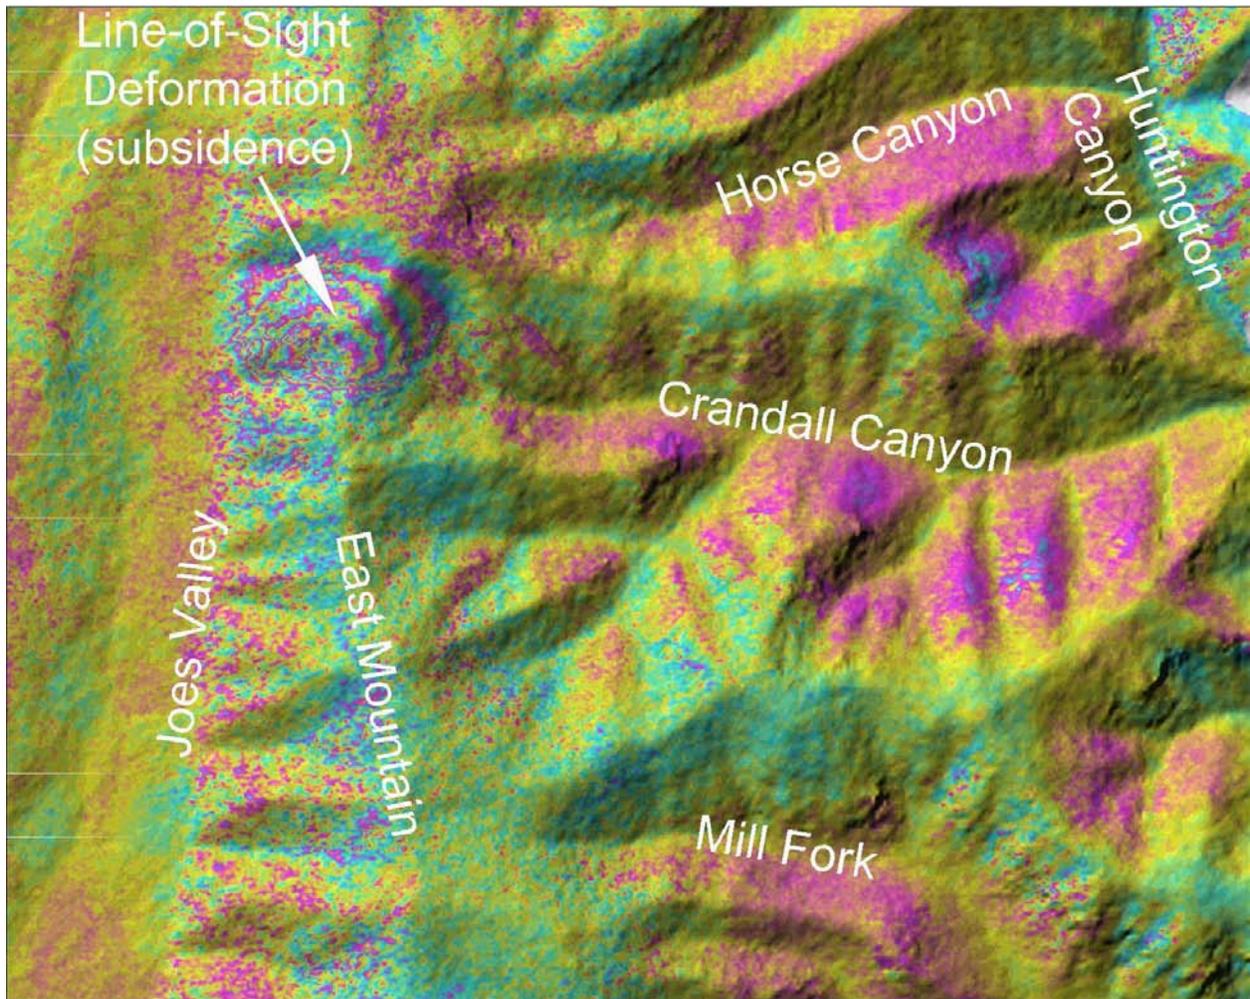
Figure 98 - USGS InSAR Image of Subsidence above the Accident Site.
The surface deformation depicted occurred between June 8, 2007, and September 8, 2007.

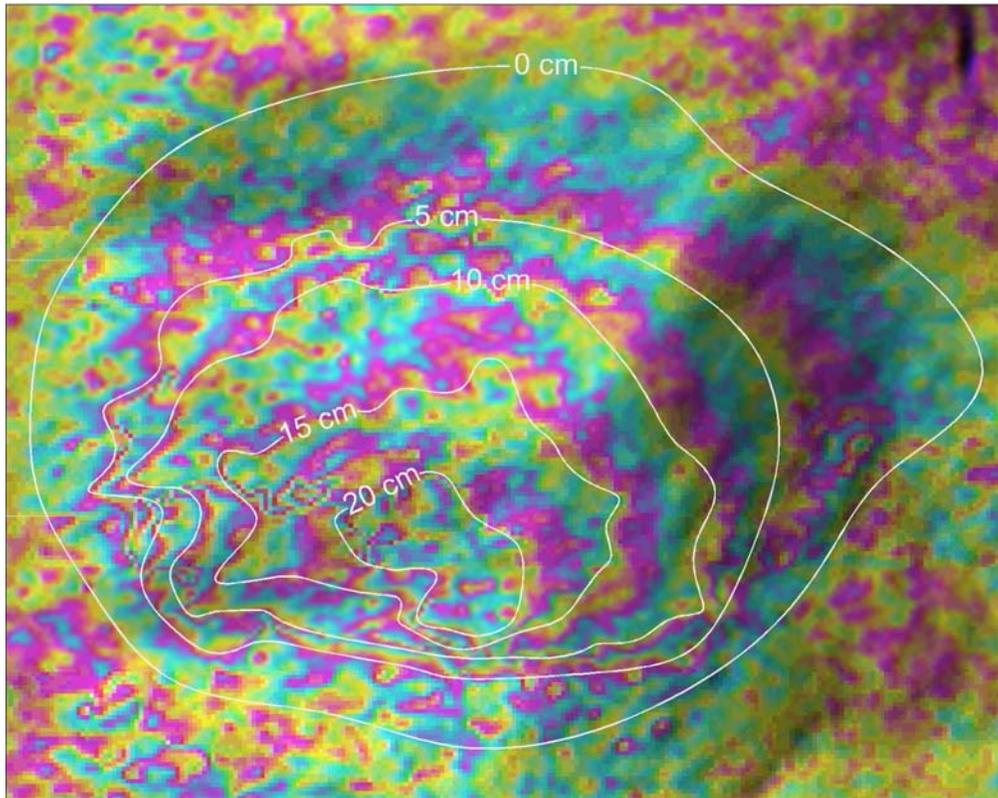
The displacement contour values are Line-of-Sight (LOS) from the satellite. In Figure 99, maximum LOS subsidence contour is 20 cm (approximately 8 inches LOS). Each repetition of the color band (i.e., sequence of rainbow colors) represents 5 cm of LOS deformation with the repetitive color banding indicating successive 5 cm increments of movement. Mining subsidence is typically vertical; therefore, LOS subsidence values are multiplied by 1.29 ($1/\cos 39.7^\circ$) to determine vertical deformation. Consequently, the 20 cm LOS deformation contour converts to approximately 25 cm (approximately 10 inches) vertical surface subsidence. The movement is significant but, at a magnitude that cannot be detected visually on the mountainside.

Figure 99 - Surface Deformation from USGS InSAR

Color banding contoured to delineate Line-of-Sight successive 5 cm subsidence movement. Maximum LOS movement of 20 cm (~8 inches) contoured.

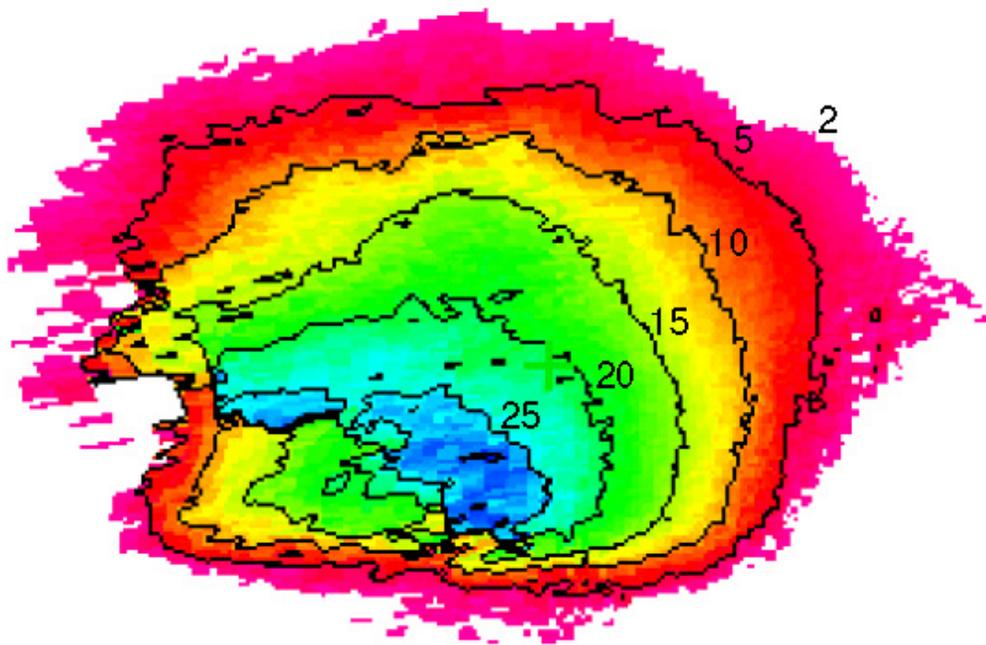
Figure 100 - InSAR Vertical Subsidence Contours (cm) from Neva Ridge

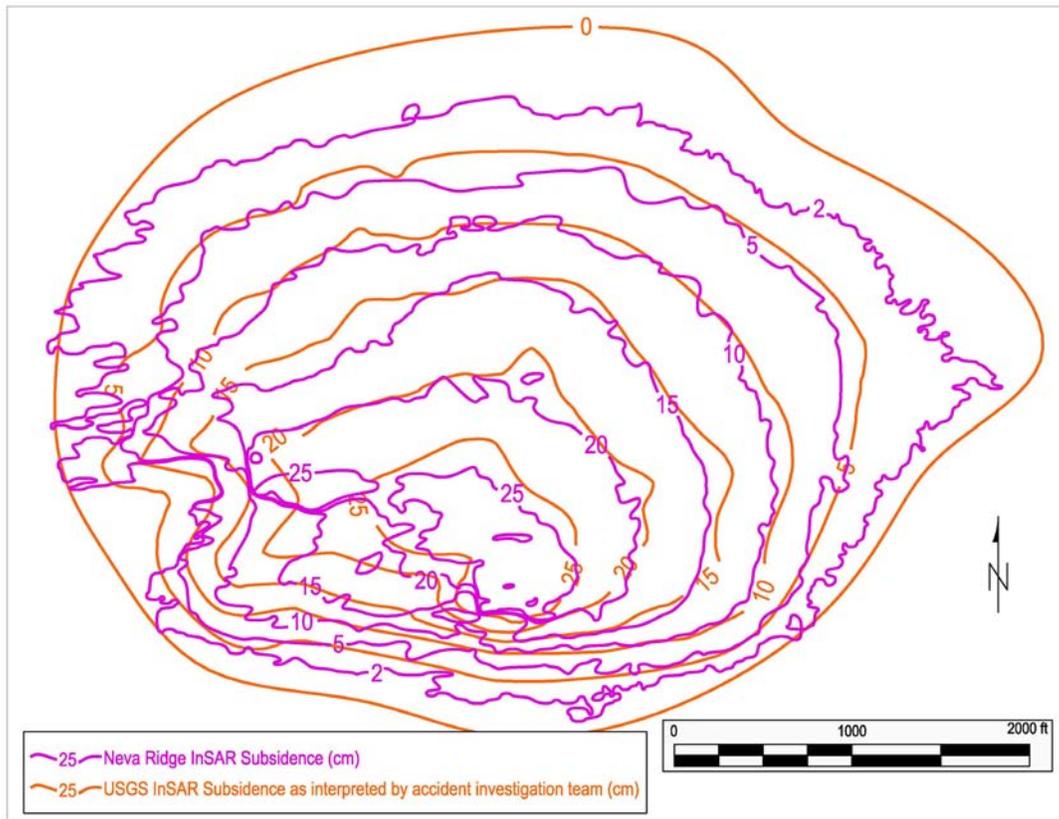
The contours on the USGS results were converted to vertical values and overlain on the Neva Ridge results for comparison. All measurements less than 2 cm were considered noise by Neva Ridge and removed from the map. The comparison of the two results is shown in Figure 101. The results are very similar except for the south-west portion of the depression. Tracing the contours of the USGS image was very difficult in this area due to the rapid rate of change, making it challenging to follow the color banding in Figure 99. The uncertainty in this area was a factor in retaining an independent analysis. The Neva Ridge contours developed by experts in InSAR analysis were therefore used throughout this report. The Neva Ridge InSAR surface subsidence contours were overlain onto the mine workings and identify a wide spread subsidence basin with the 25 cm (10-inch) vertical subsidence contour centered within the South Barrier section, roughly between crosscuts 133 and 139 (see Figure 31).

Figure 101 - Comparison of Vertical Subsidence from Interpreted USGS and Neva Ridge InSAR Results

The geometry of the InSAR surface subsidence depression indicates that the Main West and North and South Barrier sections have undergone extensive pillar failure. The knowledge that surface deformations radiate around collapse regions was used to extrapolate the extent of damage into adjoining regions that could not be traveled or investigated. Subsidence principles suggest that the extent of the collapse at seam level would be less laterally but greater vertically than the surface expression implies. The development of bed separations and other openings within the overburden can cause surface subsidence to be less than the full height of closure at mine level. Conversely, the collapse at mine level will draw the overburden downward with subsidence deformations radiating outward and laterally over an area greater than the collapsed area. Although subsidence research has primarily focused on full extraction mining, it is reasonable to expect that strata will respond similarly to a pillar collapse.

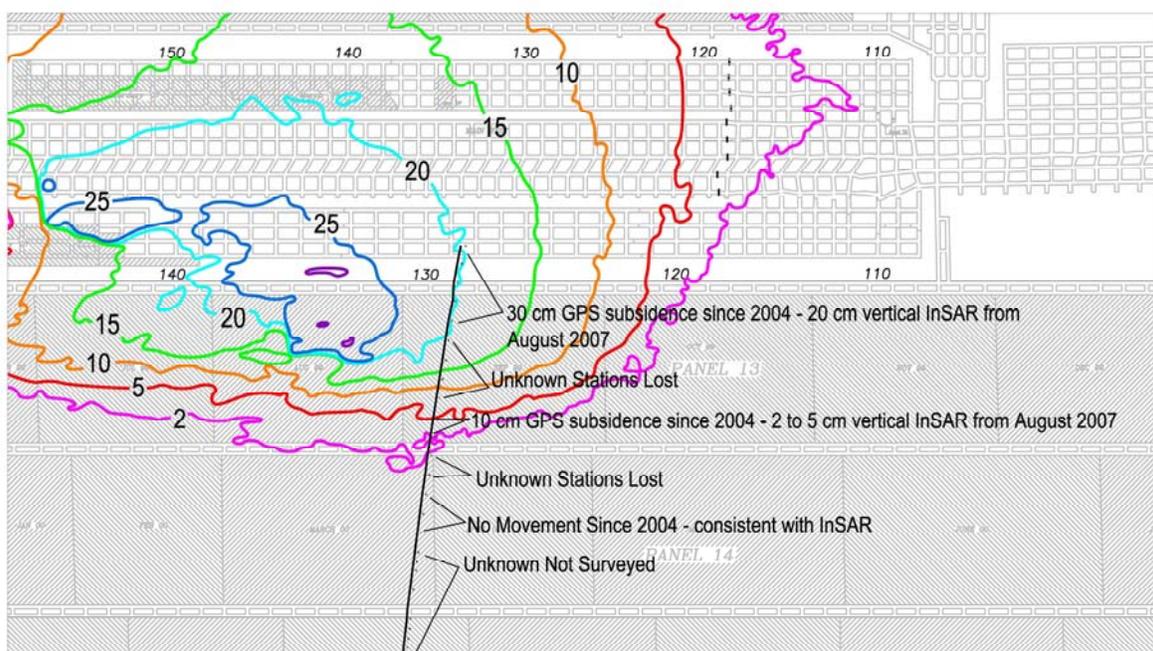
Surface monuments were resurveyed on August 17, 2007, along the portion of the line from the center of Panel 14 to just north of Panel 13. These GPS subsidence measurements are the only reliable information available for comparison with the InSAR analyses. On August 17, six of 16 survey stations had been destroyed in the area of interest. However, some of the remaining monuments lie within the deformation crater identified using InSAR. The northern end of the survey line terminates along the 20 cm (8-inch vertical) deformation contour. The southern portion of the line lies outside of the 2 cm vertical subsidence contour (see Figure 102).

Figure 102 - InSAR Vertical Subsidence Contours & GPS Subsidence Line Data

Three stations near the southern end of the survey line showed no movement since 2004; this observation is consistent with the InSAR analysis in this area (see Figure 102). Two survey stations which showed approximately 10 cm of vertical movement (since 2004) were located within the 2 to 5 cm InSAR vertical deformation contours. Five stations at the northern end of the survey line showed 30 cm of vertical movement (since 2004) although they were located along the 20 cm InSAR vertical deformation contour.

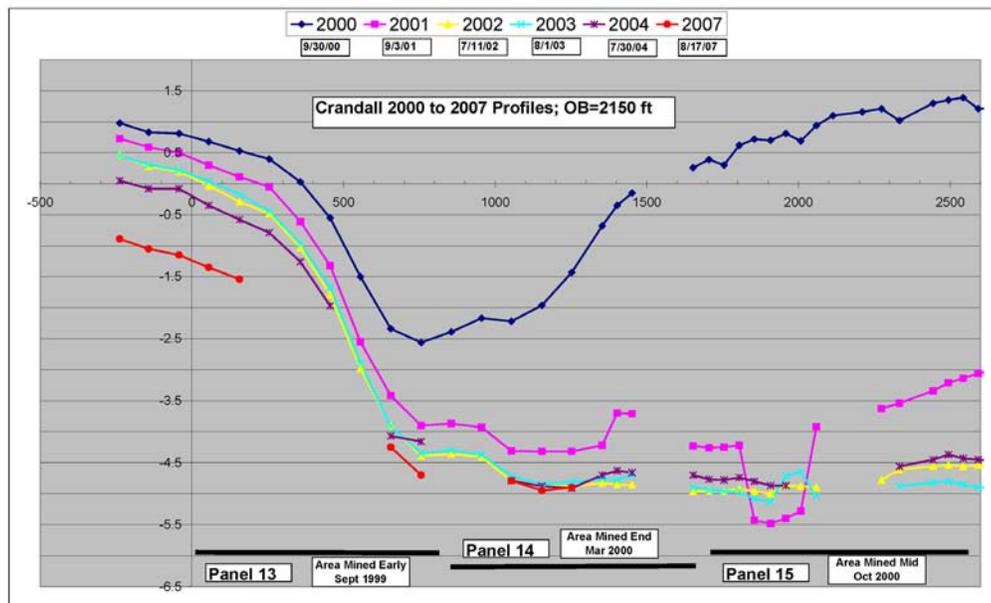
Data from the subsidence surveys show the development of the subsidence trough with the extraction of successive longwall panels. As illustrated in Figure 103 surface profiles do not begin to show the formation of a critical subsidence basin²² (i.e., when subsidence reaches the maximum possible value) until 2001 when the third successive panel (Panel 15) was extracted. This delayed subsidence behavior is typical of the Wasatch Plateau where strong, thick strata in the overburden control caving characteristics. Similarly, these strong units can resist caving and form cantilevers at panel boundaries (as indicated by the absence of subsidence over more than half the width of Panel 13). Subsidence data collected elsewhere in the region indicates that the amount or extent of cantilevered strata at panel boundaries varies. These strata can be responsible for high abutment stresses and long abutment stress transfer distances.

Figure 103 - Longwall Panels 13 to 15 GPS Surveyed Subsidence Profiles

Early measurements (2000 to 2002) show a surface elevation increase above the baseline from about the middle of Panel 13 to the barrier south of Main West. Cantilevered strata may be responsible for this movement. The data also suggest that the strata gradually subsided in this area over time.

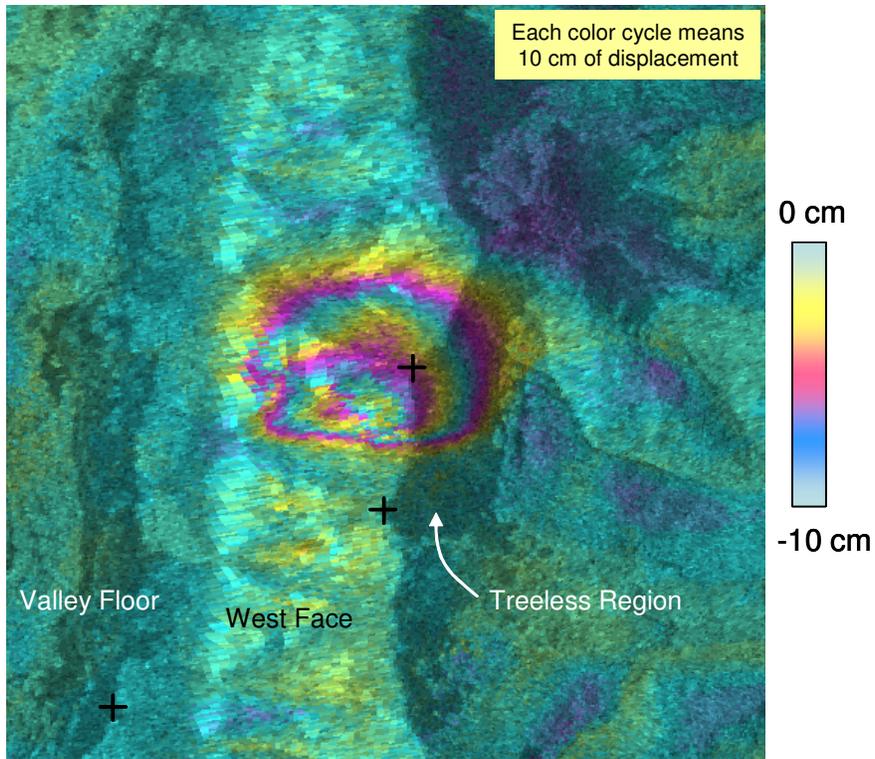
Figure 2. Color contours superimposed on the corresponding SAR image. A peak displacement of 24 cm (along the line-of-site, away from the radar) is measured.

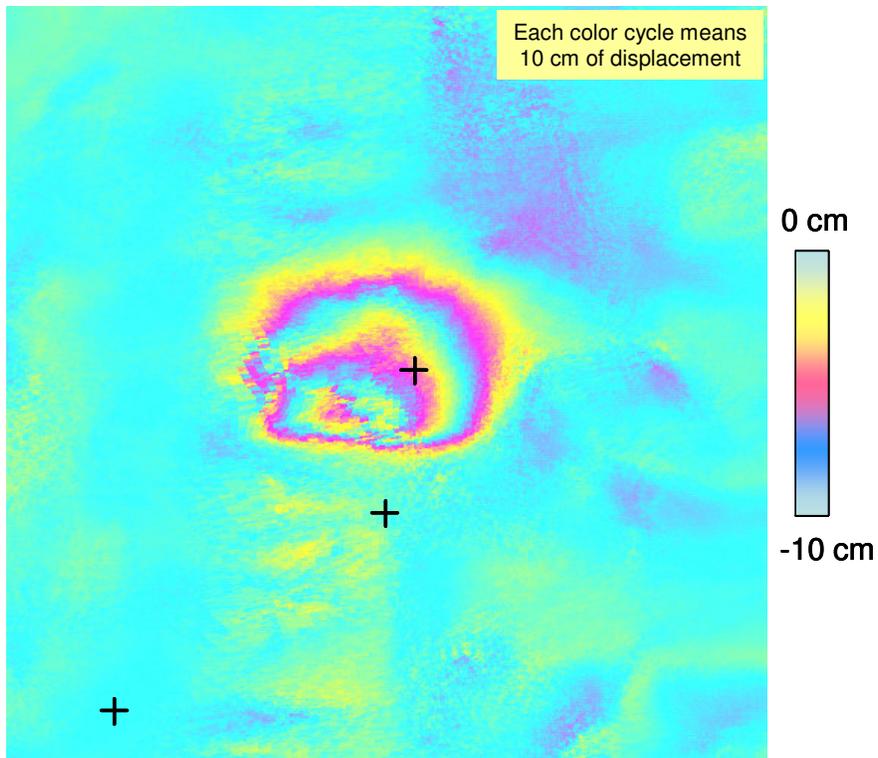
Figure 3. Color contour with no SAR image background layer. A peak displacement of 24 cm (along the line-of-site, away from the radar) is measured.

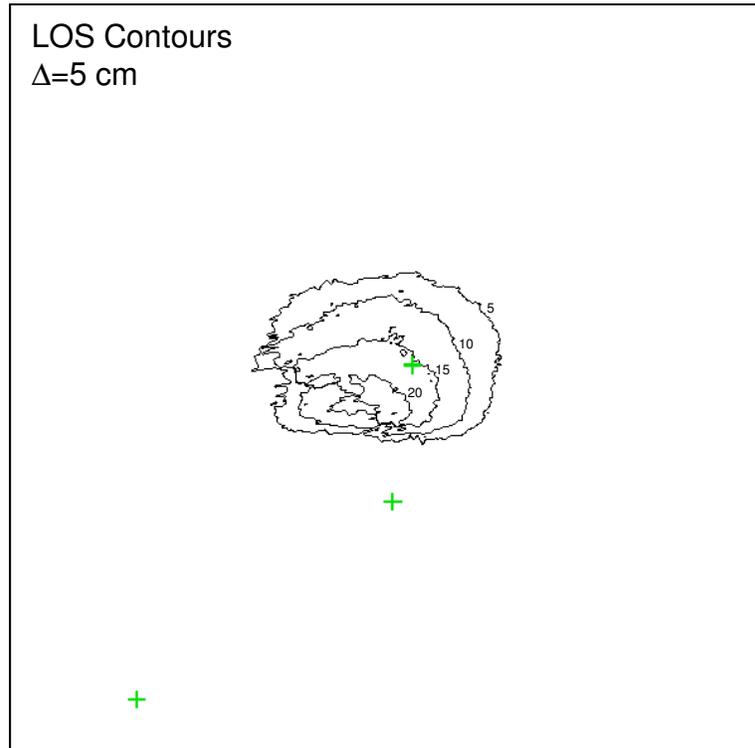
The line-of-site deformation contours are produced at 5 cm intervals and are shown in Figure 4. It is not uncommon in InSAR measurements to contain atmospheric effects that are on the order of 1-2 cm. These are produced by moisture (dielectric) variations in the atmosphere that produce noise due to variable phase delays of the radar signal. Using an initial contour of 5 cm mitigates visual interference due to this low-level noise.

Figure 4. Line-of-site deformation contours with intervals of 5 cm. Motion is away from the radar.

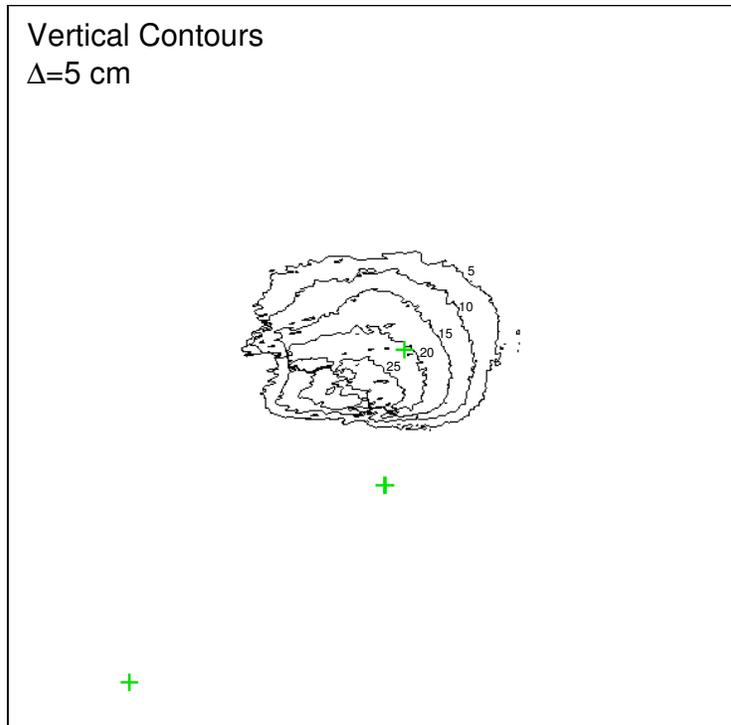
Figure 5. Vertical contours. A peak displacement of 30 cm (vertical, downward) is measured.

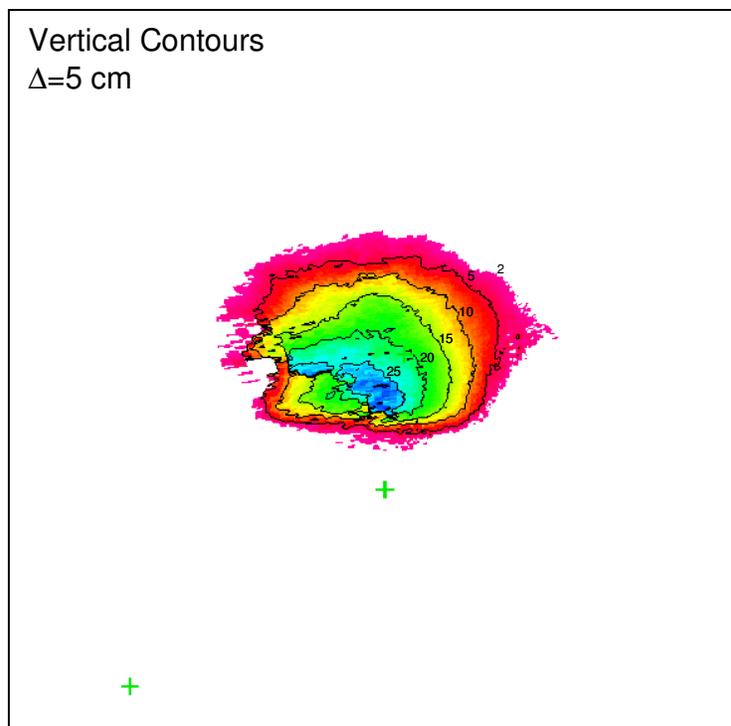
Figure 6. Vertical contours are combined with a color scale. For visual clarity, measurements outside the main feature, with values of 2 cm or less, have been removed.

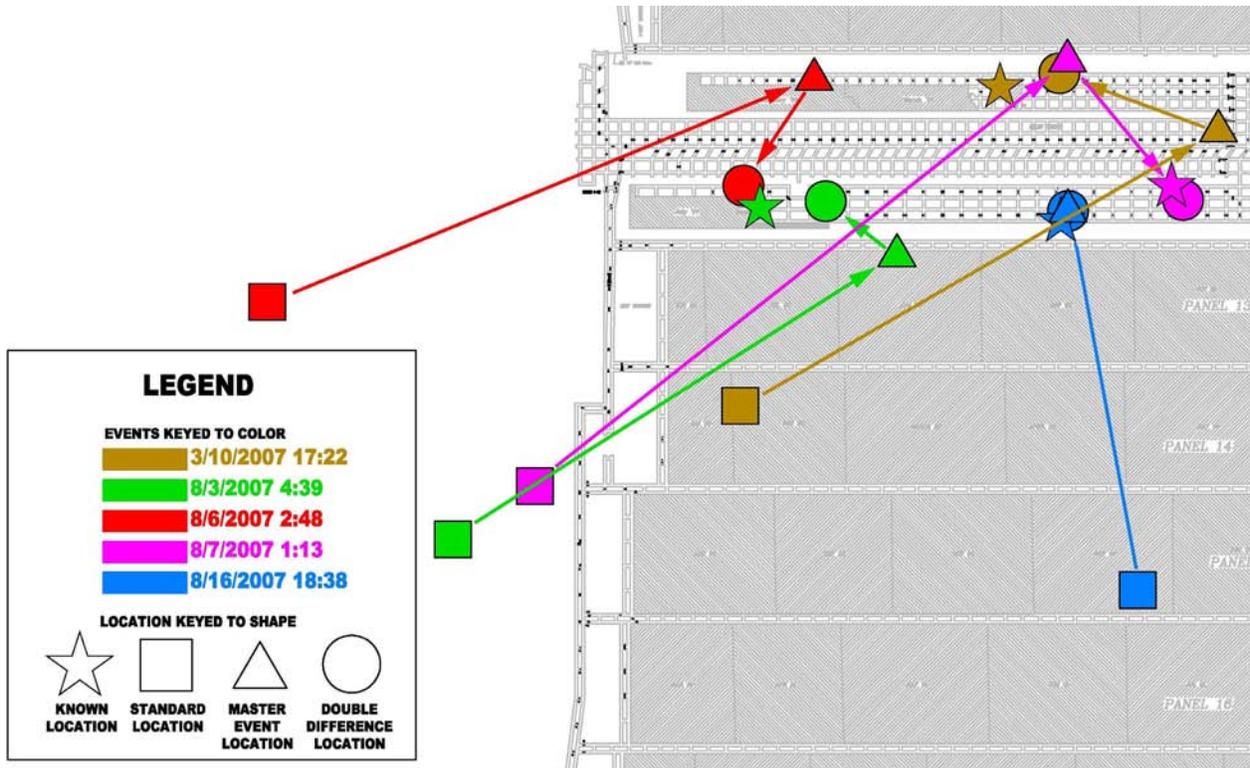
master event method, and the locations as revised by the double difference method. As shown on the figure, the double difference locations match the known locations most closely. The location for the August 6 accident is given at the No. 3 entry of the South Barrier section between crosscuts 143 and 144. The August 6 accident was known to extend over a wide area. Because locations of seismic events are determined by the first arrival of the seismic waves, only the location of the initiation of the August 6 accident can be calculated. Therefore, the location shown indicates where the event began, not the center of the event.

Figure 106 – Locations of Selected Events showing Progressive Refinements Using Three Methods

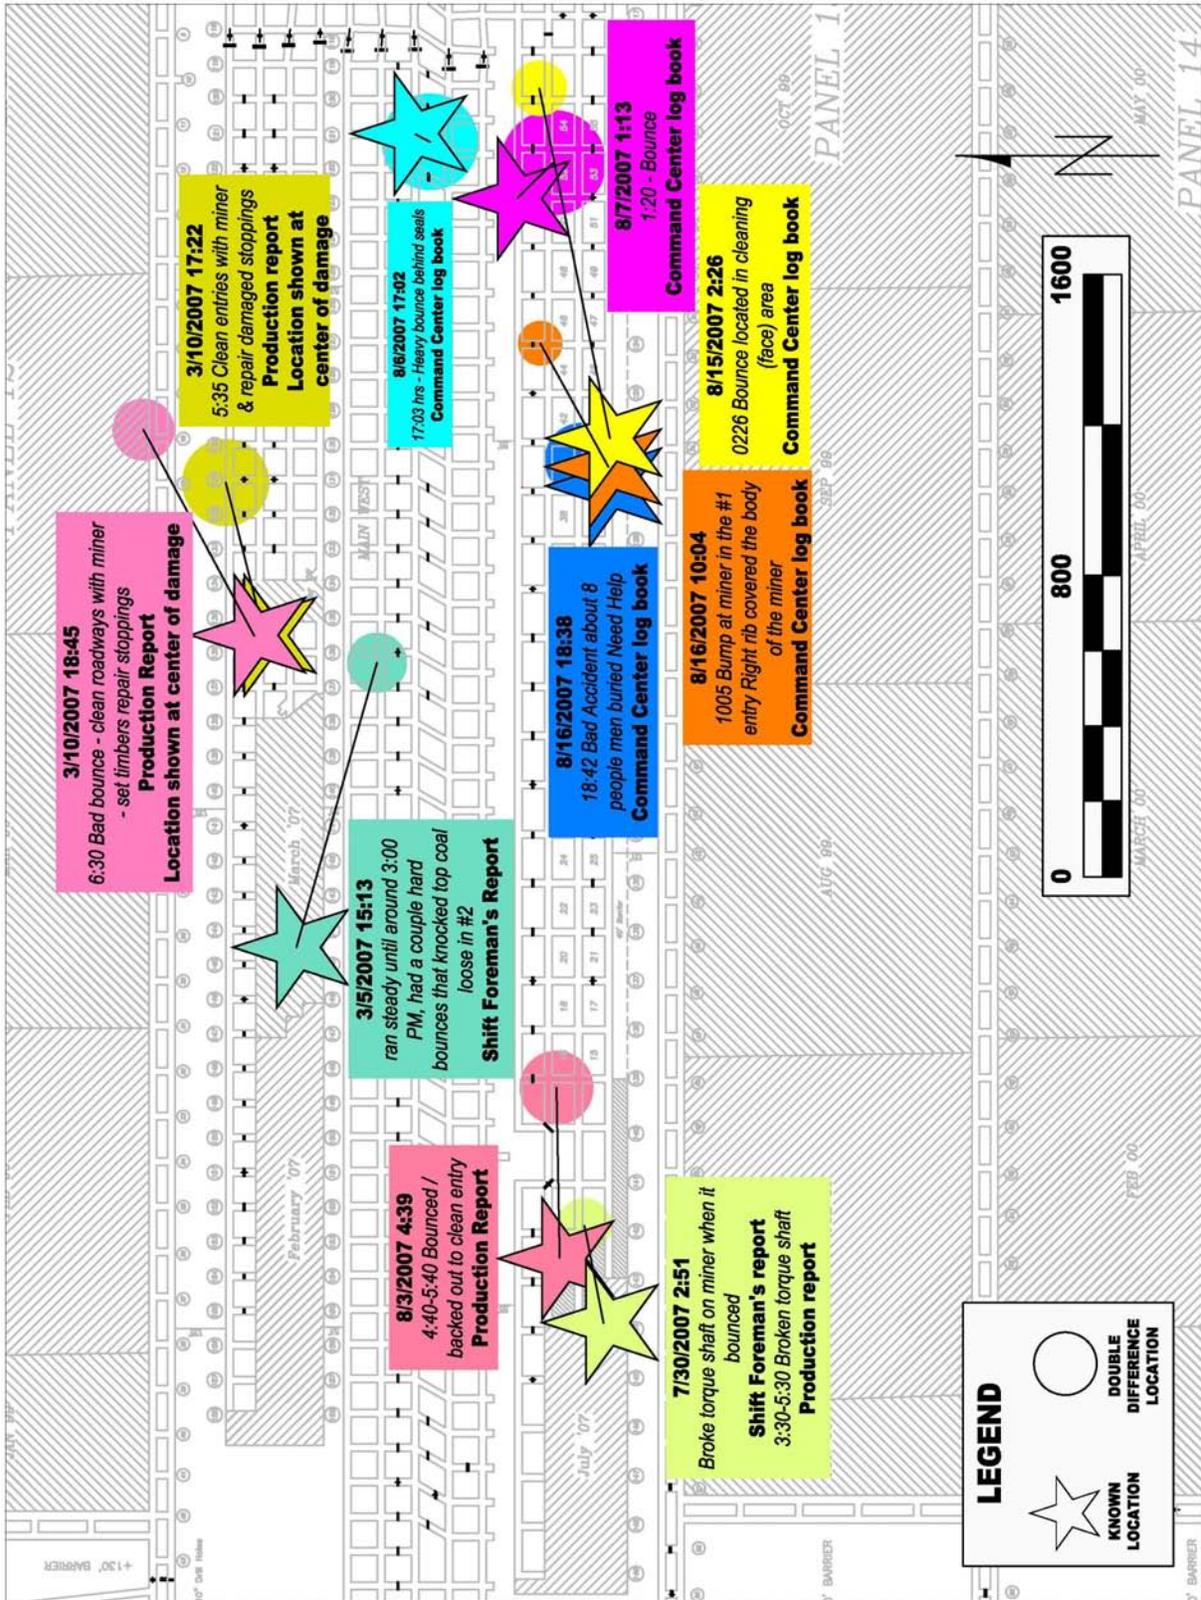
A review of mine records and records from the rescue and recovery operations revealed that ten events were both noted underground and recorded by the USS. Figure 107 shows the high degree of correlation with the underground locations and the double difference locations calculated by the USS. This provides some measure of the accuracy of the locations. Only the location of the August 16, 2007, accident had been provided to the USS. Excluding the August 16 accident event that was used for calibration, the mean distance between the reported locations and calculated locations was 450 feet. The median distance was 421 feet.

Figure 107 - Observed and Calculated Locations for Events
