REPORT OF INVESTIGATION

Fatal Underground Coal Burst Accidents
August 6 and 16, 2007

Crandall Canyon Mine
Genwal Resources Inc
Huntington, Emery County, Utah
ID No. 42-01715

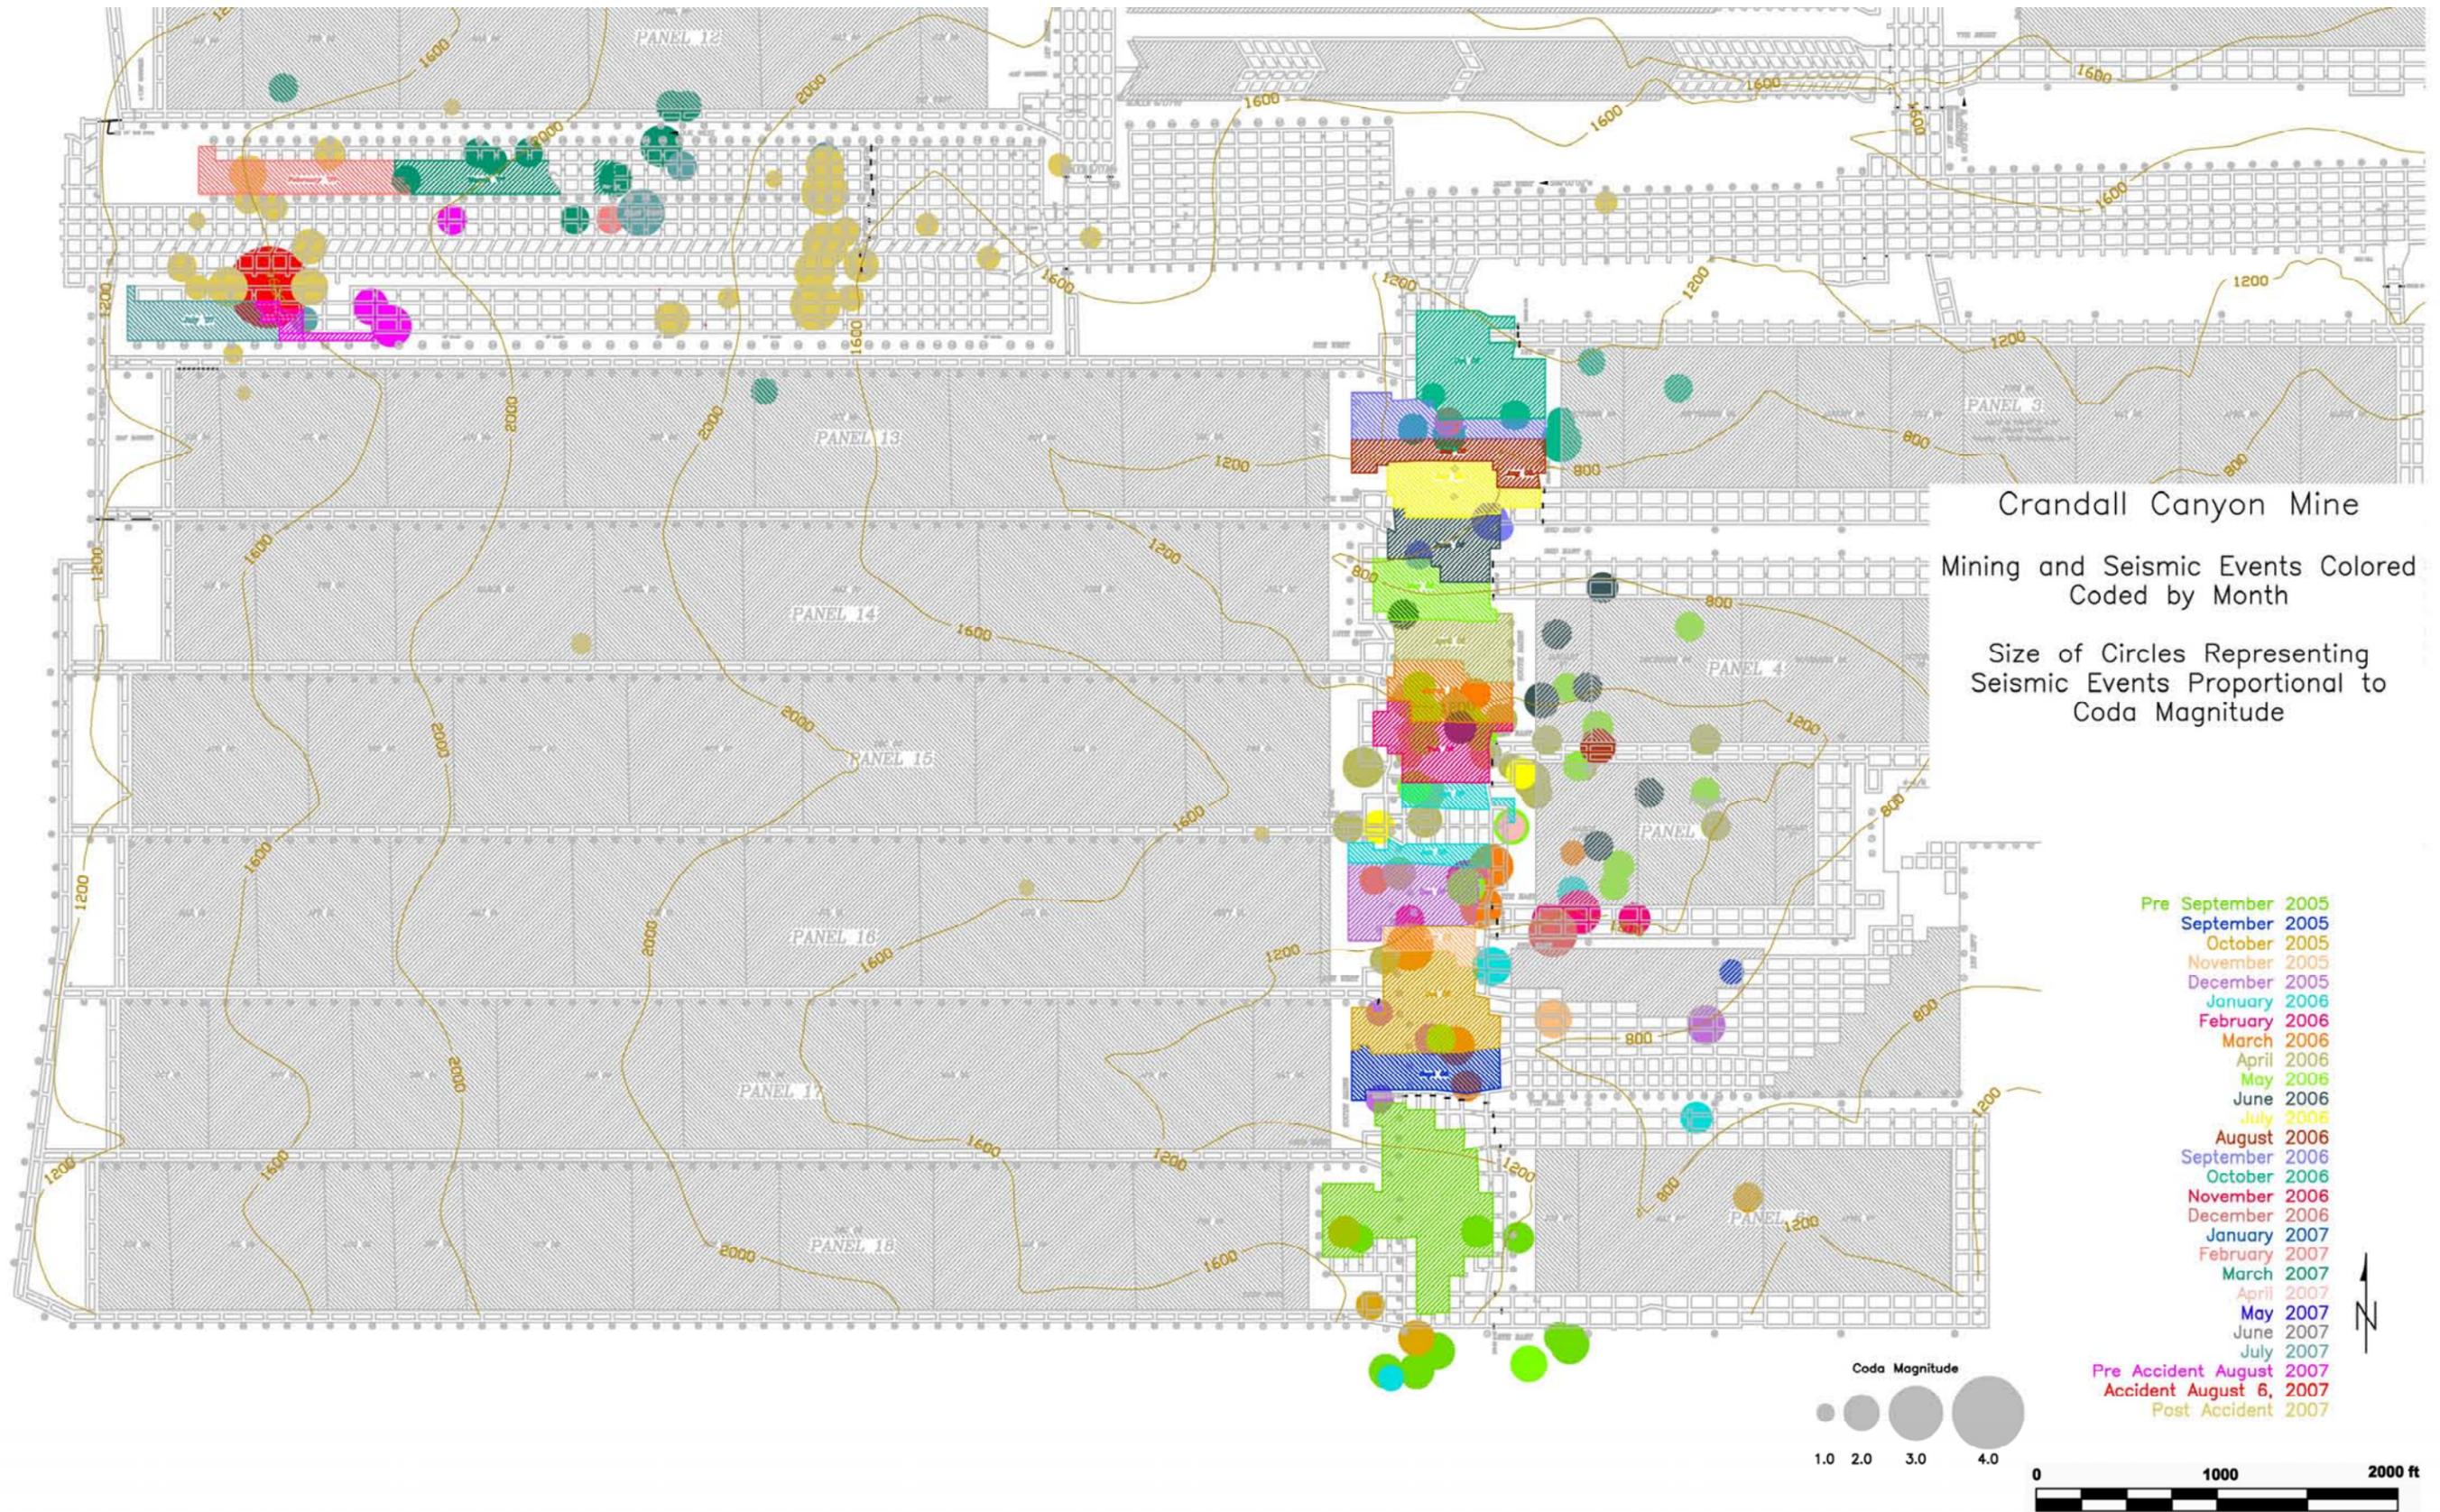
Figure 108 - Calculated Double Difference Locations and the Location of Mining Color Coded by Month

Figure 108 shows all of the calculated double difference locations and the location of mining activity color coded by month. The symbols are sized according to the coda magnitude of the events. The double difference locations show a high degree of correlation with pillar recovery mining in South Mains and the Main West barriers.

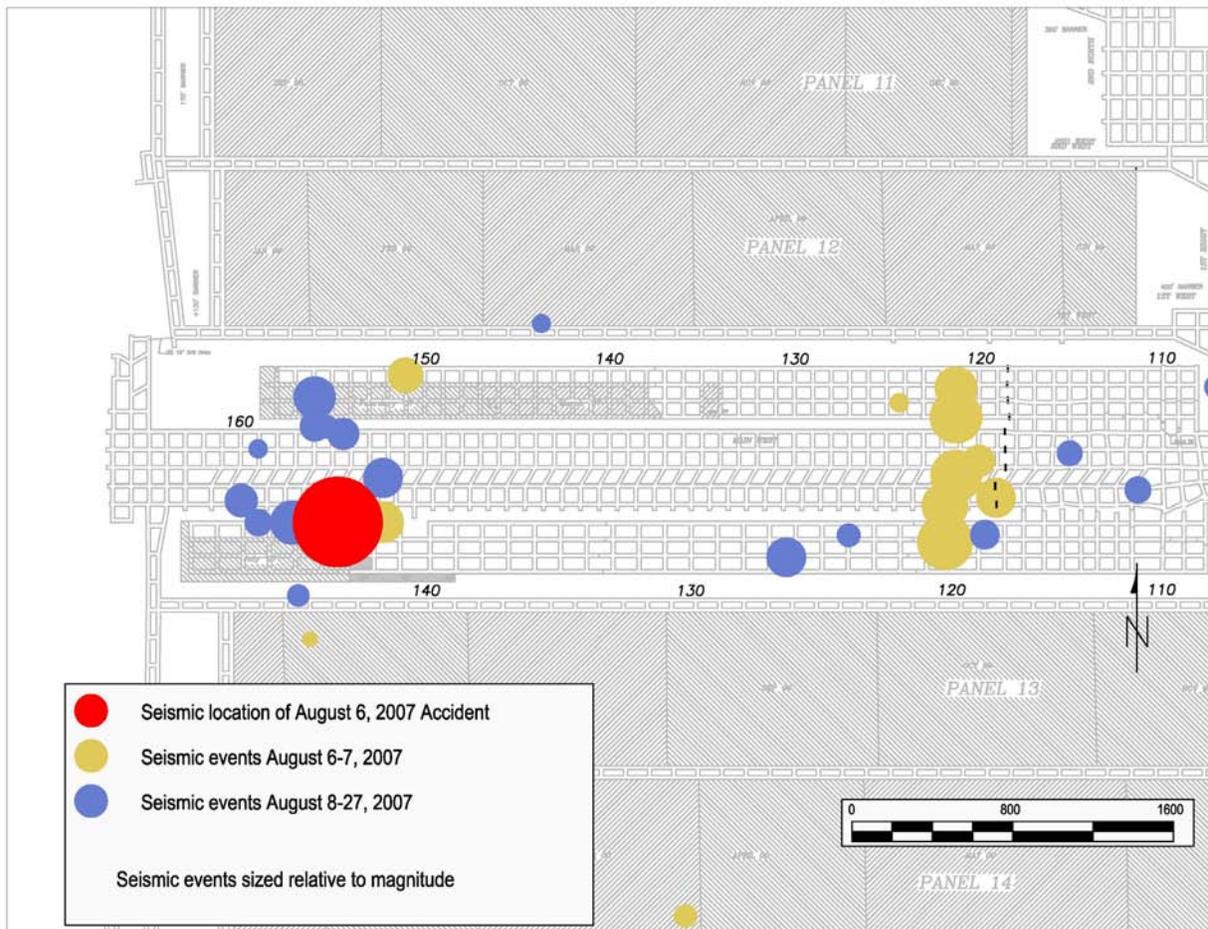
Figure 109 shows the seismic location of the August 6, 2007, accident in red. The events occurring after the accident on August 6 and 7 are shown in tan. Events occurring on August 8 to 27 inclusive are shown in blue. The locations of seismic events occurring on August 6 and 7 are notably clustered along a north to south line near crosscut 120 of the South Barrier section. The location corresponds with the outby extent of the collapse in the South Barrier section as determined by underground observation in the South Barrier section entries and Main West inby the breached seal. The seismic events extend from the South Barrier to the North Barrier. The initiation point for the collapse is located at the western boundary of the area. The collapse would have progressed to the east. The continuing events may have been the result of residual stress at the edge of the collapsed area. The events colored in blue occurred later and may represent settling at the west end of the collapse area.

Figure 109 – Seismic Location of the August 6 Accident and Following Events

Given that the event initiated at the west edge of the collapse area and seismic events occurred in the following 37 hours at the east edge of the collapse area (see Figure 109), the most likely explanation is that the event began at the western edge of the area and progressed eastward. The eastern edge, where the collapsed stopped, would have resulted in residual stress at the cantilevered edge and continued seismic activity.

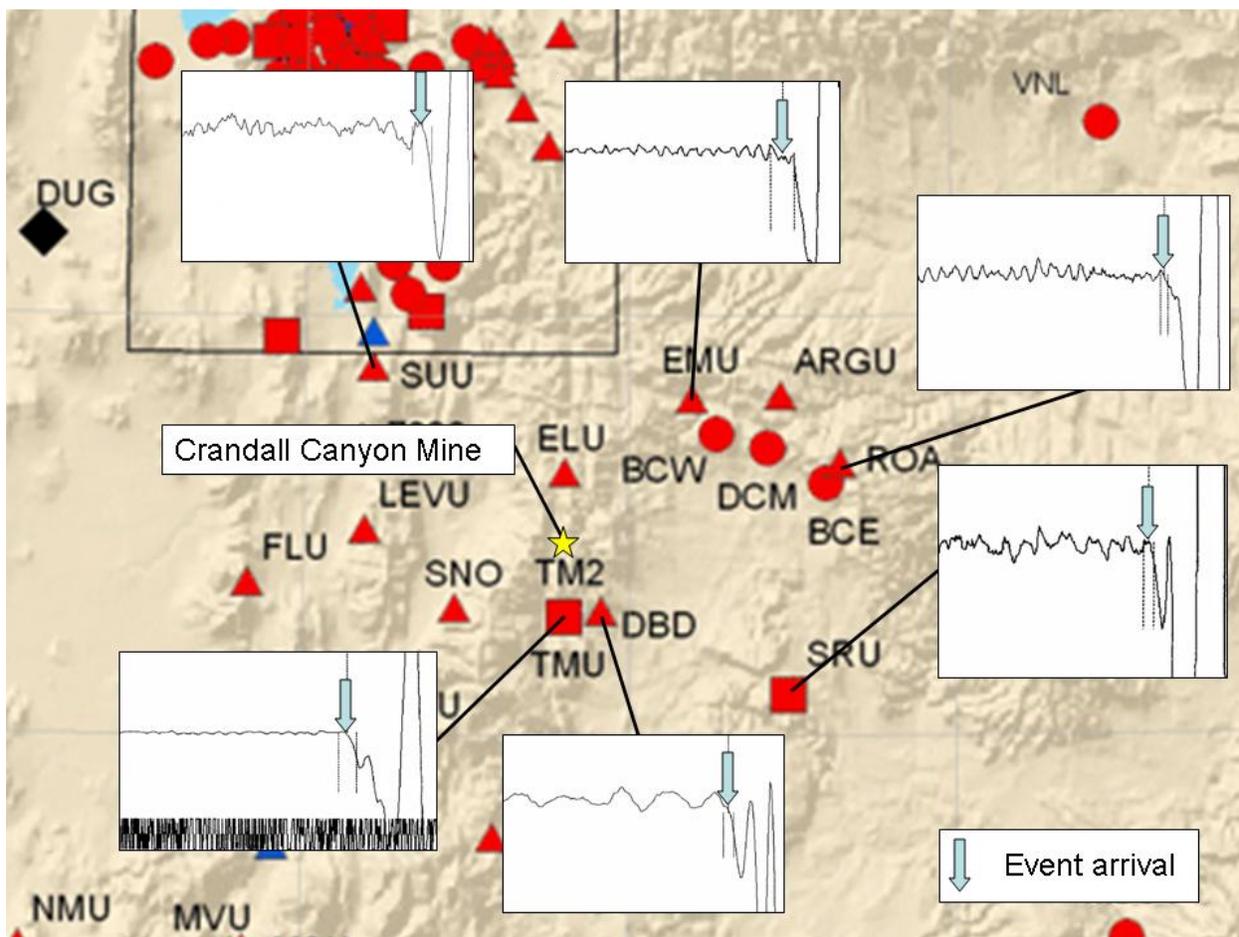
An analysis of the seismograph recordings from the August 6, 2007, event indicated that the initial or first motion recorded on a vertical component seismograph was downward in all cases (Pechmann 2008)². This is characteristic of a collapse or implosion. Coal mining-related events are commonly collapse type events where caving or a coal burst has sudden roof-to-floor convergence. The lack of compressional or upward first motions is highly suggestive of a collapse but not conclusive. It may be possible that some upward first motions may have been missed. Figure 110 is a simplified diagram illustrating the types of motions expected for mine collapse and normal-faulting earthquakes.

Figure 111 - Vertical Component Waveform Data for August 6, 2007 Event

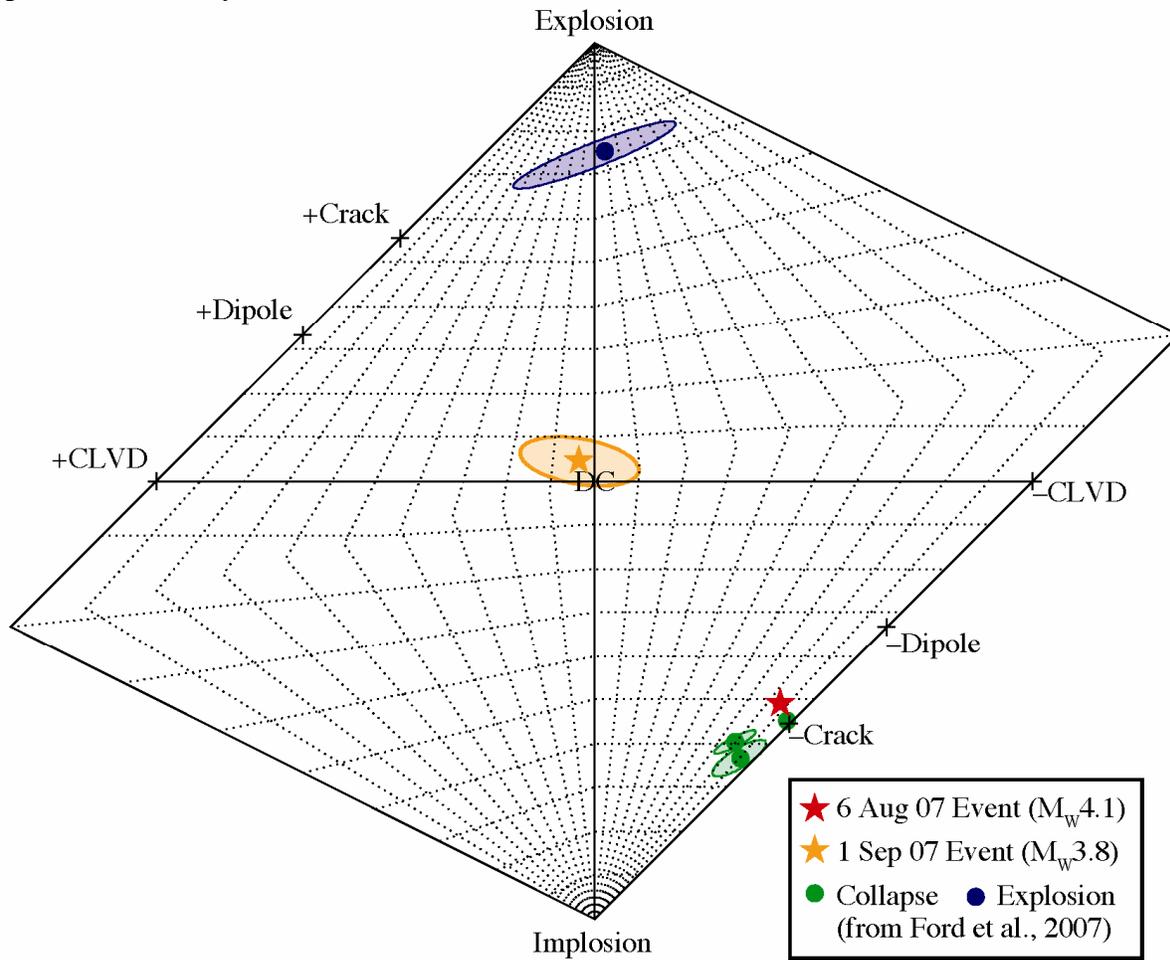
As early as August 9, 2007, scientists at the University of California at Berkeley Seismological Laboratory and the Lawrence Livermore National Laboratories studied the data and prepared a report titled “*Seismic Moment Tensor Report for the 06 Aug 2007, M3.9 Seismic event in central Utah*” that was made available on the UUSS website. A paper based on this analysis titled “*Source Characterization of the August 6, 2007 Crandall Canyon Mine Seismic Event in Central Utah*” also has been prepared³. The techniques employed in this analysis are beyond the scope of this report. However, the results can be summarized by Figure 112, reproduced from their paper, which shows seismic events plotted according to their source mechanism. The term DC refers to a double couple of forces or opposing forces which create shear or slip type movement resulting in natural earthquakes with no change in volume. The data for the August 6, 2007 event is shown as the red star. Its location characterizes it as an anti-crack or closing crack. This

would be consistent with an underground collapse. Natural or tectonic earthquakes plot near the center of this diagram. The orange star represents a natural tectonic earthquake of similar size that occurred on September 1, 2007 near Tremonton, Utah. The August 6 event is clearly outside this area. The explosion plotted in the figure was a nuclear test explosion. The three other collapses plotted were two trona mine collapses in Wyoming and a collapse of an explosion test cavity.

Figure 112 - Source Type Plot from Ford et al. (2008).

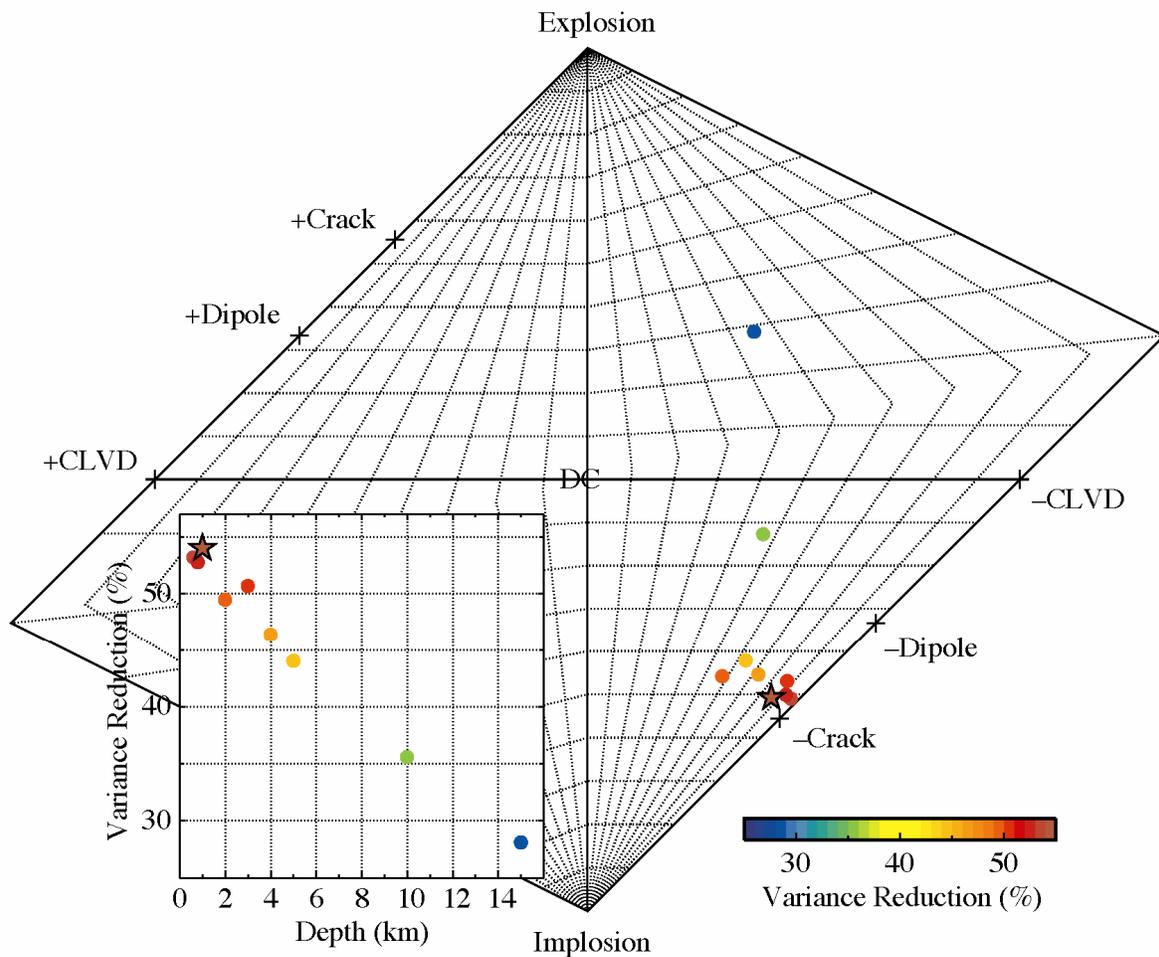
An analysis of the source depth for the August 6 event was conducted by Ford et al. (2008). Different depths for the event were assumed and the source type and variance reduction were calculated. Variance reduction is a measure of fit; the greater the reduction, the better the fit. Figure 113 shows the variance reduction results from the analyses in the inset box and the source type for the different assumed depths. As indicated, the shallowest depths (shown in red) result in the best fit. Even at depths up to 5 km, the source type remains as a closing crack and does not indicate the double-couple mechanism typical of natural tectonic earthquakes.

Figure 113 – Depth Analysis of August 6, 2007 event from Ford et al 2008.

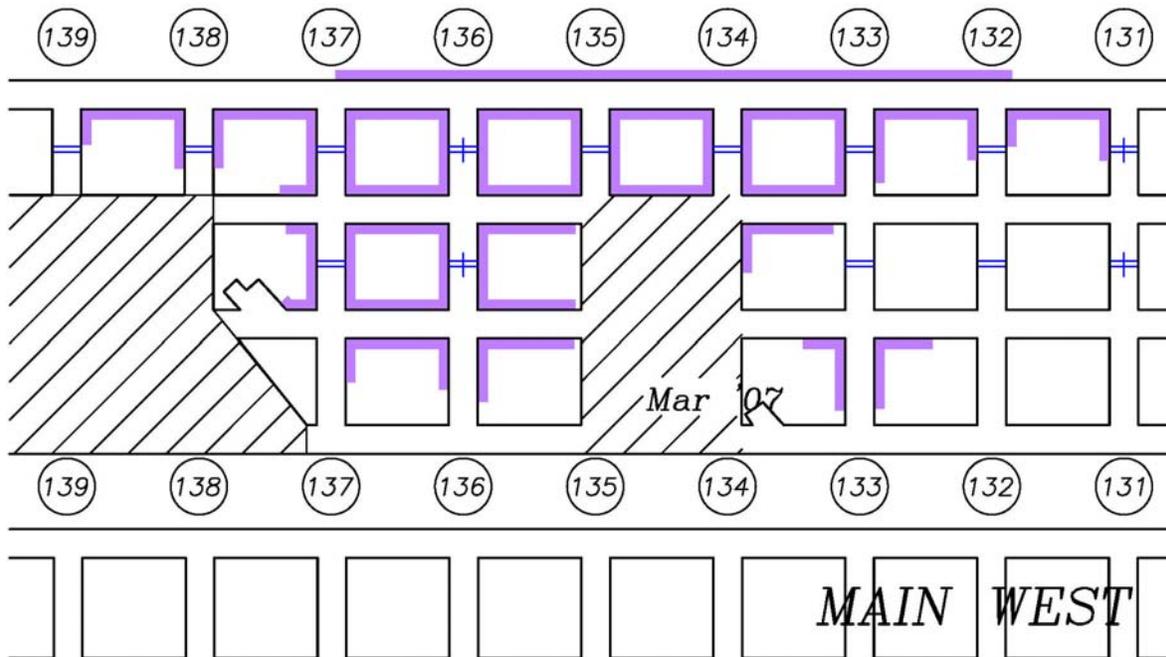
North Barrier Section after March 2007 Coal Outburst Accident

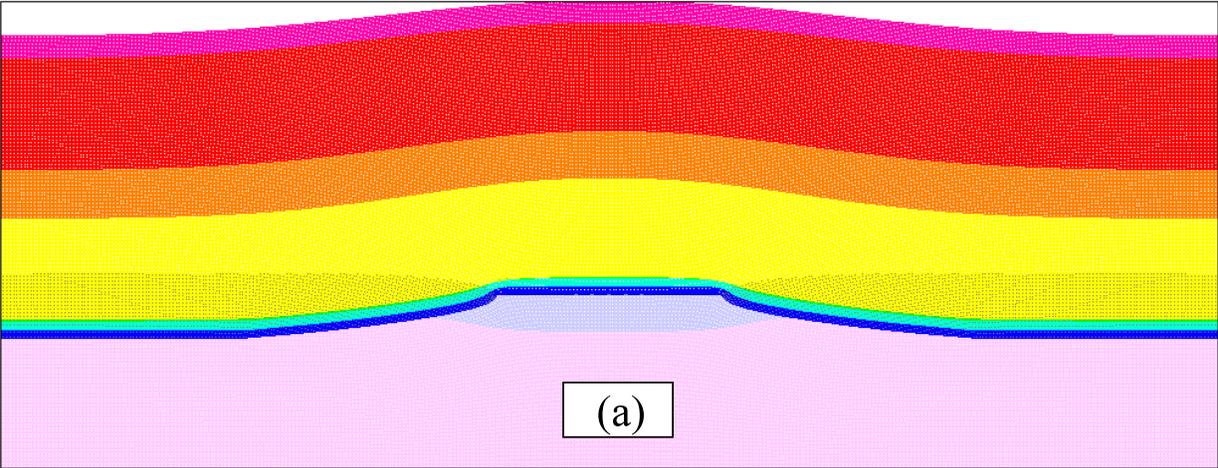
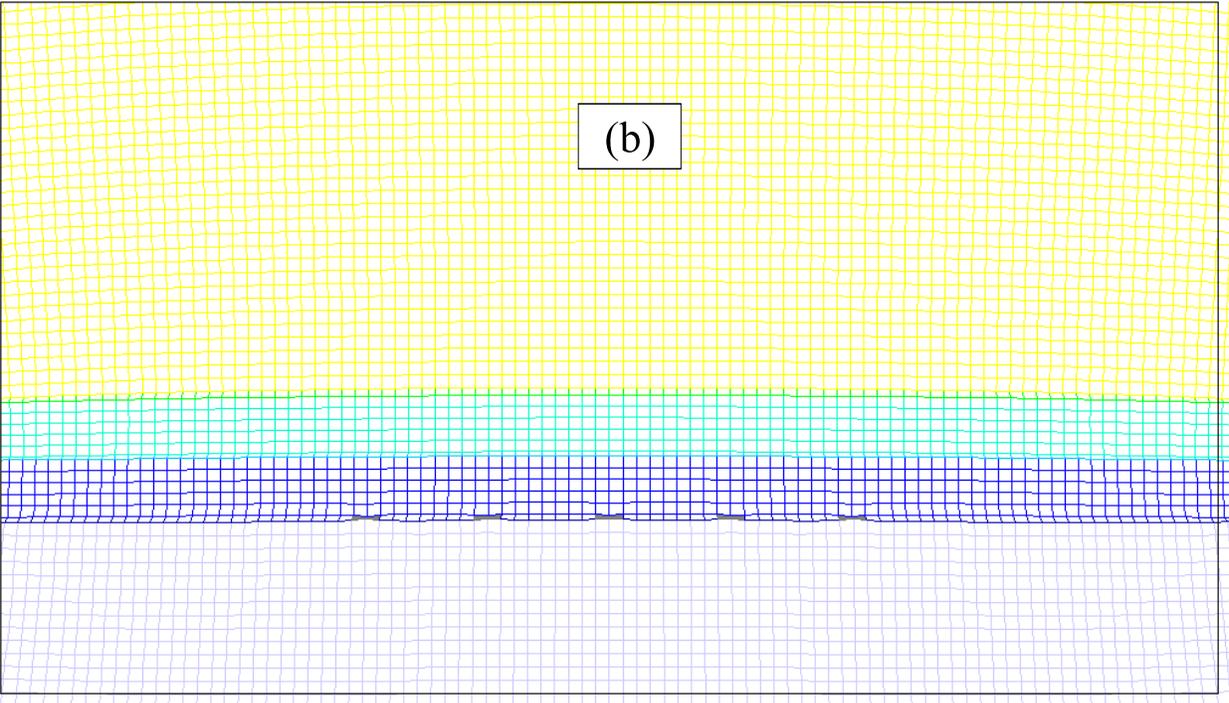
Figure 8a shows displacements in the form of a deformed mesh after a second attempt at panel mining. The displacement scale is exaggerated relative to the distance scale in order to visualize the overall displacement pattern. Maximum displacement of 63 inches or about 5 ft (160 cm or about 1.5 m) occurs at the mesh sides, that is, over the centers of panel mining. Interestingly, 18 inches (46 cm) of subsidence occurs over the center of the main entries. Floor heave (upward displacement) is also maximum at the mesh sides but diminishes with distance to the main entries. At 130 ft (39 m) from the outside barrier pillar ribs, floor heave diminishes to zero. With further distance from the mesh sides towards the mesh center and center of the main entries, floor displacement is downwards indicating that the barrier pillars and entry pillars depress the floor under the weight transferred from panel mining. Figure 8b is a close up view of the deformed mesh about the main entries and only hints at entry roof sag and floor rise. The rough agreement between maximum subsidence obtained from finite element analysis and that observed in actual subsidence profiles, although indirectly imposed through seam closure, suggests the finite element model of panel mining is reasonable.

Figure 8. Displacements after panel and entry mining. (a) overall, (b) entries.

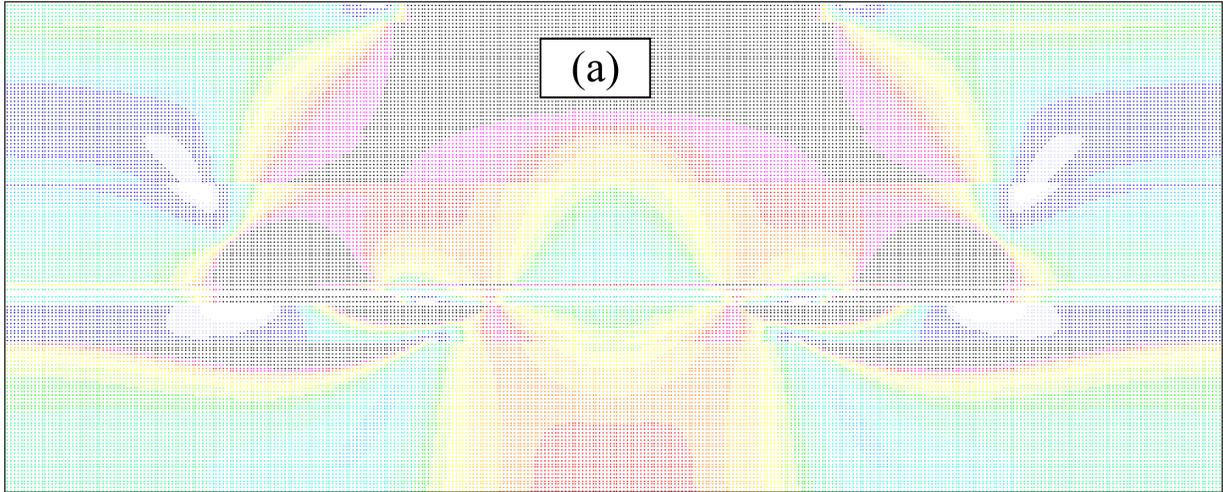
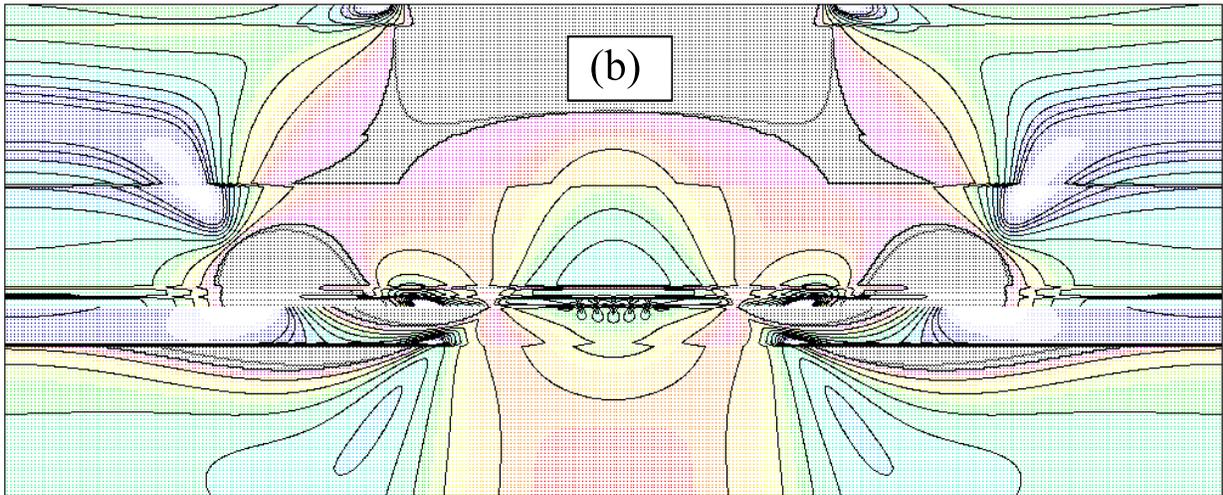
Figure 9 shows the overall distribution of element safety factors in two ways, one without contours that supplement the color coding and one with contours. The seemingly faded color is a result of the plot density that brings white element borders into close proximity and allows only a tiny area for coloring. The jumps in contours occur across strata interfaces where discontinuities in material properties occur. Disruption of contours occurs at seam level across portions of the seam that have been excavated (panels and entries). Symmetry of the contour pattern is apparent and as the pattern should be. The dark (black) regions of yielding are extensive. Near the surface above the main entries strata flexure leads to tensile failure. Much of the roof and floor yield is also tensile.

Figure 9. Whole mesh element safety factor distributions. (a) without line contours, (b) with.

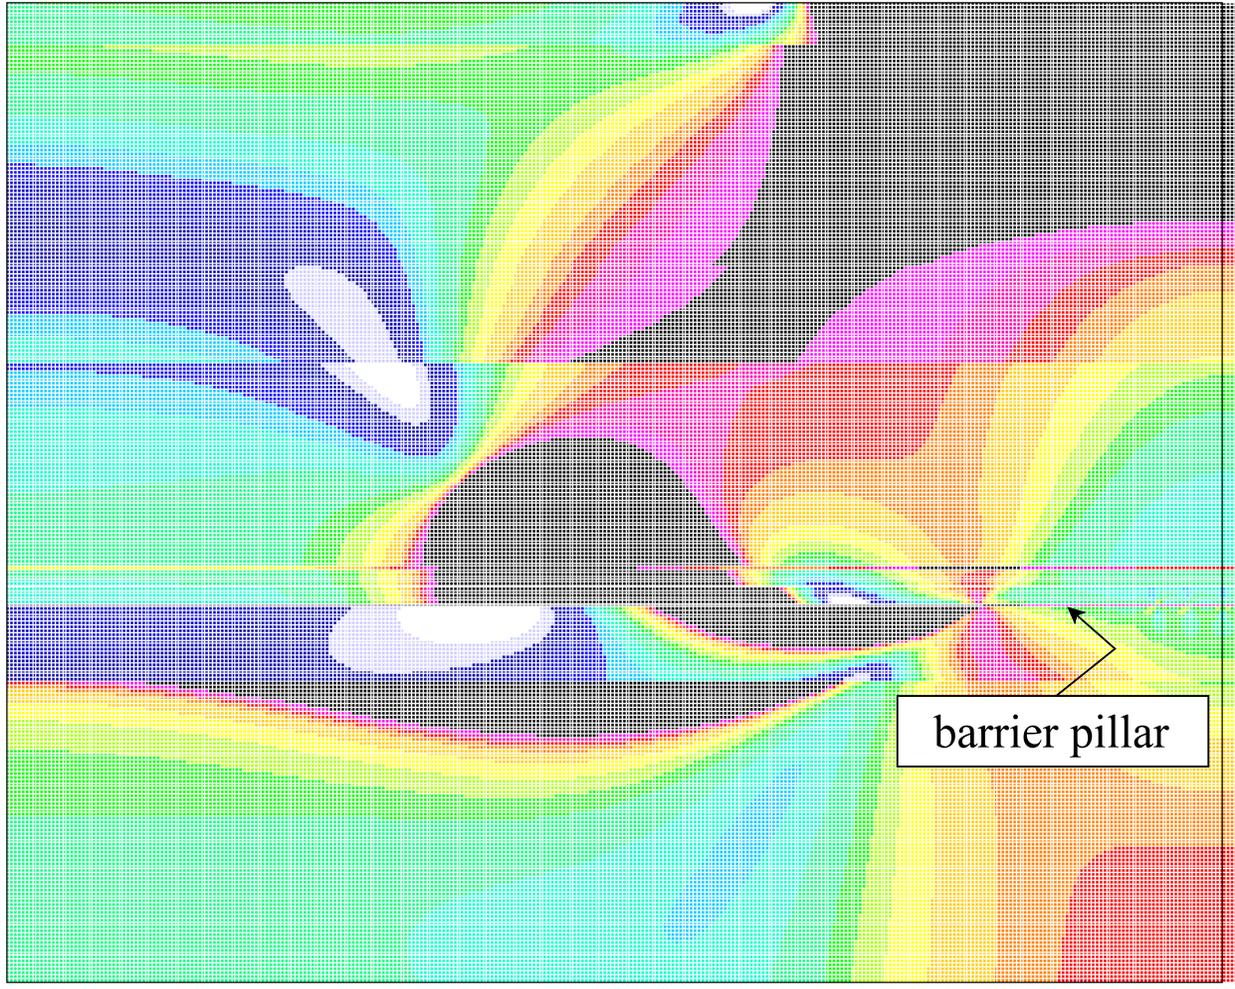
An expanded half-mesh view is shown in Figure 10 where the yield zones are more clearly seen. Strata flexure in tension and failure is indicated near seam level in the roof outside the barrier pillar rib. Floor failure below is also evident in Figure 10. Interestingly, yielding is small in the immediate sandstone floor, but is extensive in the Masuk shale below.

Figure 10. A half-mesh view of element safety factors showing dark (black) zones of yielding mainly in horizontal tension associated with strata flexure.

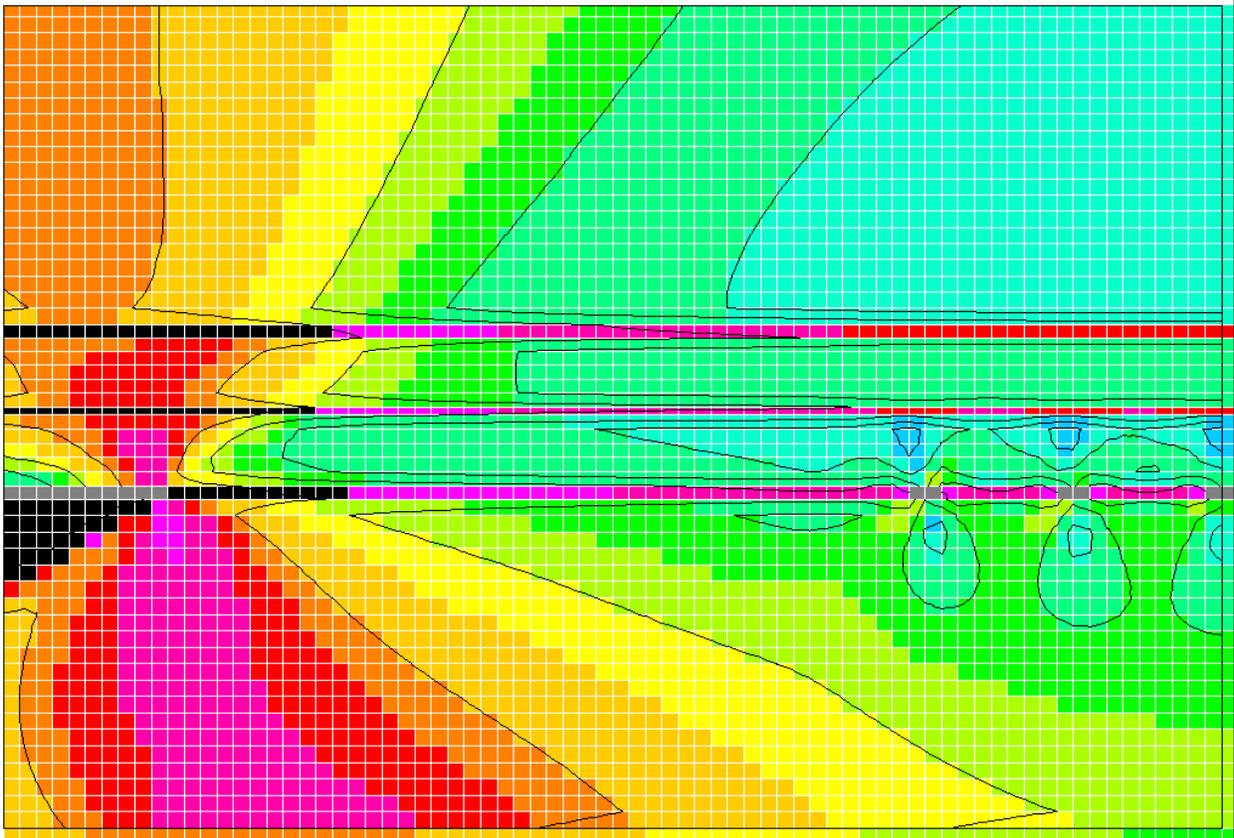
Yielding under high compressive stress penetrates the barrier pillar from the panel side a distance of 110 ft (33 m). Thus, about 25% of the barrier yields after panel excavation. This penetration is accompanied graphically by large horizontal excursions of the safety factor contour lines in Figure 11 which shows details of the element safety factor distribution in the vicinity of a barrier pillar. Half of the main entries are included in Figure 11. The remainder of the barrier pillar while not yielding is highly stressed with element safety factors no greater than 1.34. Yielding in the two overlying coal seams is evident in a region above the barrier pillar.

Figure 11. Element safety factors about a barrier pillar after panel mining.

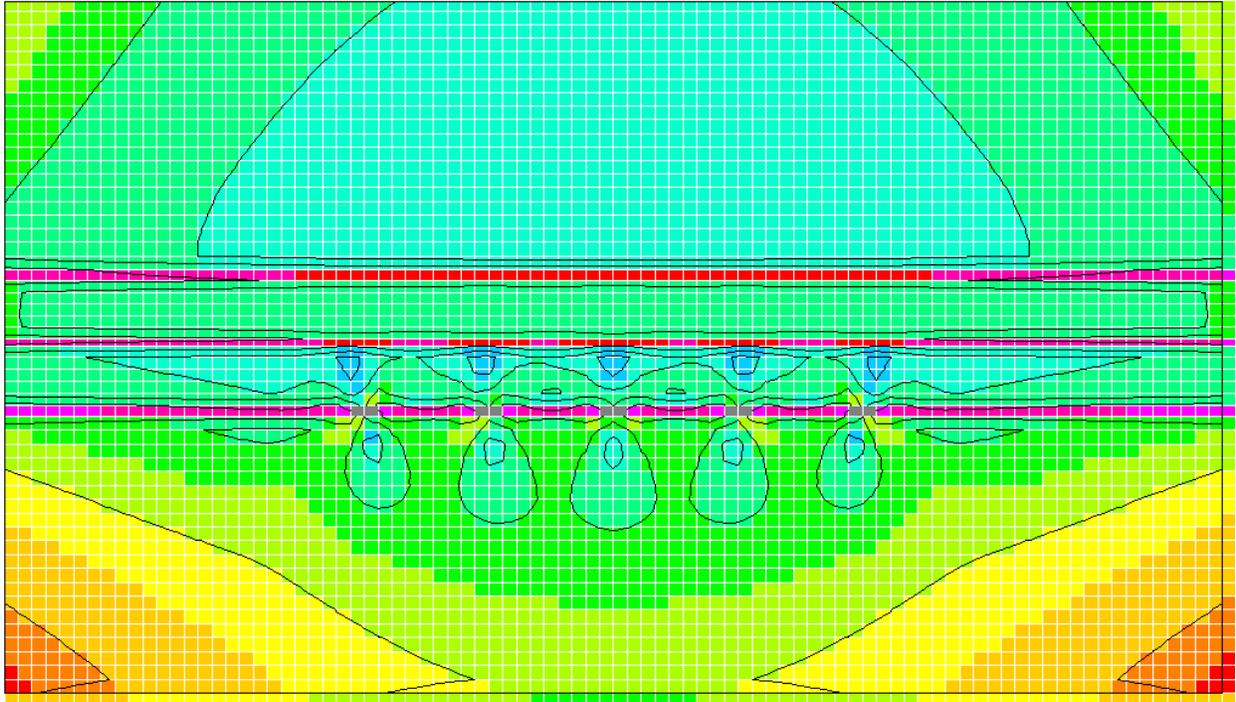
Details of the element safety factor distribution about the main entries is shown in Figure 12. The pink and red zones indicate relatively low safety factors. The highest safety factor in the main entry pillars is 1.34, the same peak value in the barrier pillars on either side of the main entries. Thus, all pillar element safety factors are less than the minimum of 2 recommended by Obert and Duvall (1967). Roof and floor safety factors are in the 4 to 5 range. Although mesh refinement would lead to lower safety factors at the roof and floor of an entry, there appears to be no significant threat to roof and floor safety at this stage of mining.

Figure 12. Distribution of element safety factors about the main entries after panel mining.

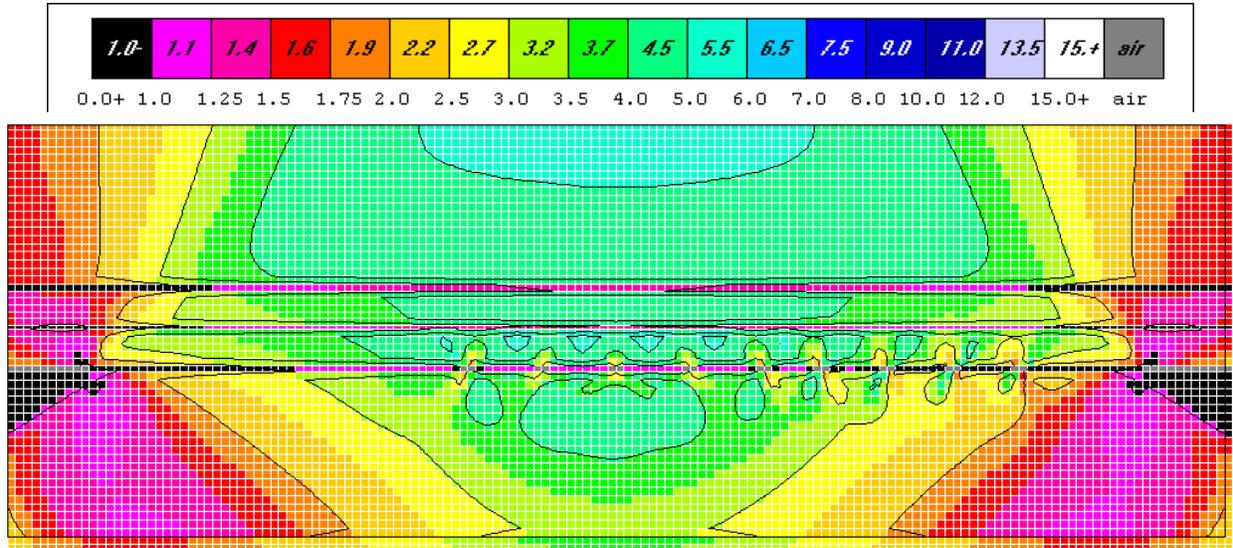
The distribution of element safety factors after entry development in the north barrier pillar is shown in Figure 14. Most elements in the north side barrier pillar are now at yield. Rib elements in pillars adjacent to the original main entries are also at yield. The outside entry of the original main entries shows ribs yielding in the pillar between it and the new north side barrier pillar entry. The south outside entry ribs shows yielding extending 10 ft (3 m) into the ribs. The highest safety factor in any pillar element in Figure 14 is 1.2.

Figure 14. Element safety distribution after entry development in the north barrier pillar.

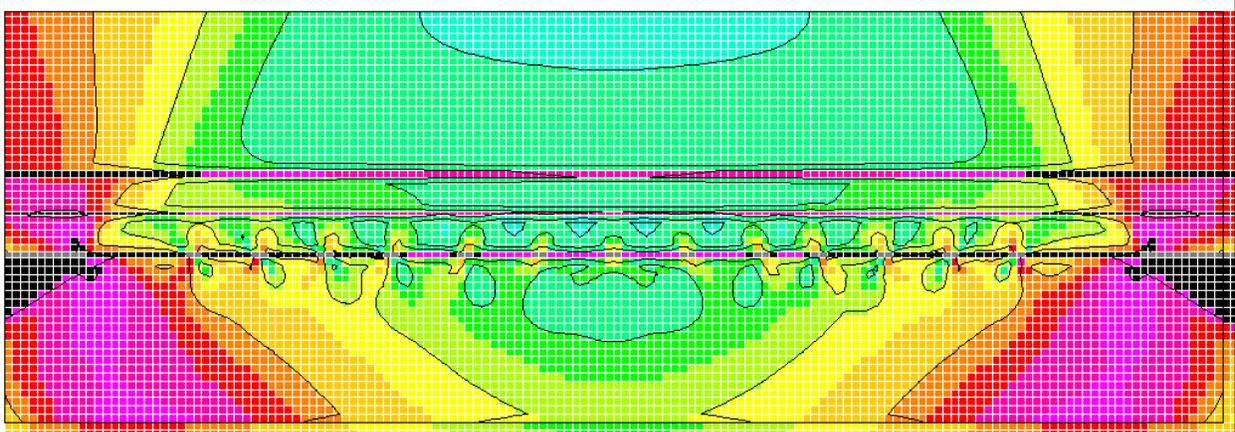
The distribution of element safety factors after entry development in the south barrier pillar is shown in Figure 16. Almost all elements in the south side barrier pillar are now at yield. Indeed all pillar elements across the mining horizon are close to yield. Peak vertical stress in the barrier pillars exceeds 38,400 psi (264.8 MPa), over 9 times the unconfined compressive strength of the coal. Horizontal stress exceeds 7,300 psi (50.3 MPa). Even so this high confining pressure is insufficient to prevent yielding. The lowest vertical pillar stress is about 6,000 psi (41.4 MPa), almost half again greater than the unconfined compressive strength of the coal; the lowest horizontal pillar stress is about 1,500 psi (10.3 MPa). Any release of horizontal confinement would likely result in rapid destruction of pillars. Additionally, entries nearest to the mined panels are showing reduced roof and floor safety factors. Yield zones extend to depth in the floor. Overlying coal seams are also yielding or are very close to yielding over portions of the barrier pillars, as seen in Figure 16.

Figure 16. Element safety distribution after entry development in the south barrier pillar.

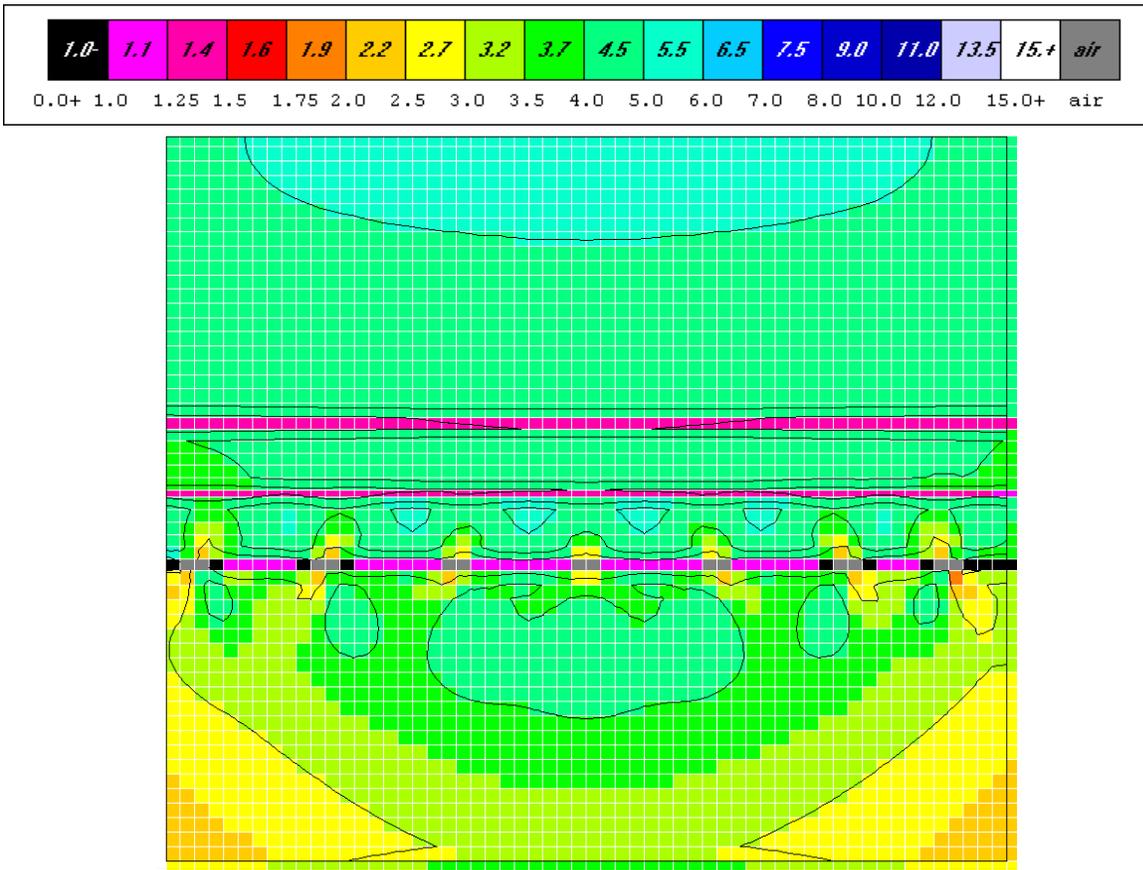
Figure 17 shows the distribution of element safety factors about the original main entries after entry mining in the north and south barrier pillars. Roof and floor element safety factors have decreased significantly from the original values obtained during development prior to longwall panel mining and range between 2 and 4, as seen in the color code. Roof and floor element safety factors about the new entries mined in the barrier pillars are lower, roughly in the range of 2 to 4 in Figure 17.

Figure 17. Distribution of element safety factors about the original main entries after development in the north and south barrier pillars.

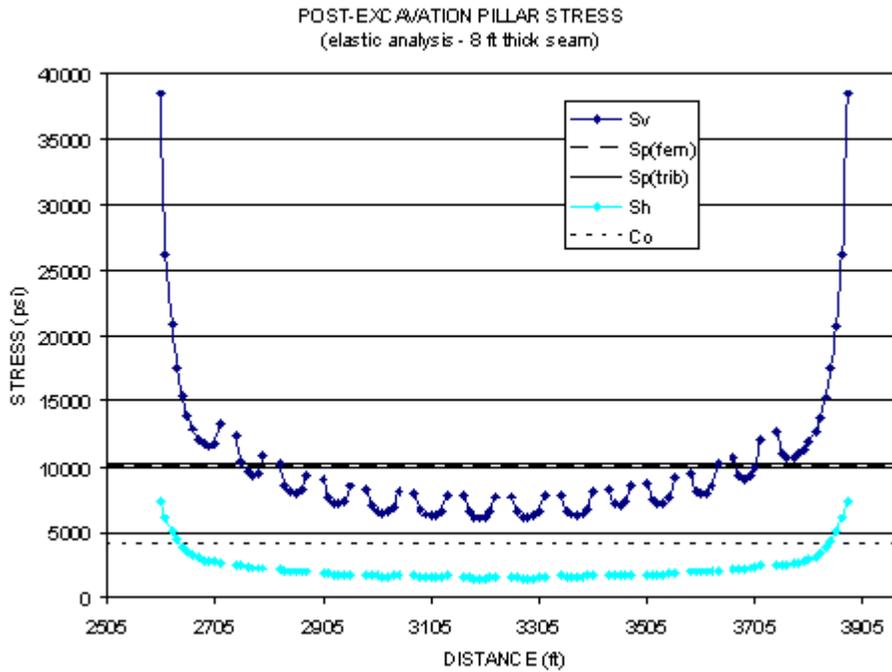
The distribution of horizontal and vertical element stresses after main entry development, panel mining, and entry development in the north and south barrier pillars is shown in Figure 18 where gaps are entry elements. The very high vertical stresses on the ribs of the barrier pillars

adjacent to the panels mined north and south of the barrier pillars is striking. Although these extreme peaks in vertical stress diminish rapidly across the pillars, they remain well above the unconfined compressive strength of the coal, also shown in Figure 18. Recall the analysis is elastic. If yielding were allowed as in an elastic-plastic analysis, these peaks would diminish and the extent of yielding would likely spread across regions of the pillars that have not yielded according to the elastic results. Horizontal confinement in rib elements at the ribs of the barrier pillars, where the vertical stress is high, is because of averaging over the width of rib elements. The actual horizontal stress at the rib must be zero. The high analysis value is associated with mesh refinement and the use of a 10 ft (3 m) wide element. A lower horizontal stress would enhance the spread of pillar yielding. Again, purely elastic behavior leads to an underestimate of the extent of yielding that is indicated by elements with a safety factor less than one.

Figure 18. Post-excavation pillar stress distribution. Sv=premining vertical stress. Sp=average pillar stress, fem=finite element method, trib=tributary area, Co=unconfined compressive strength.

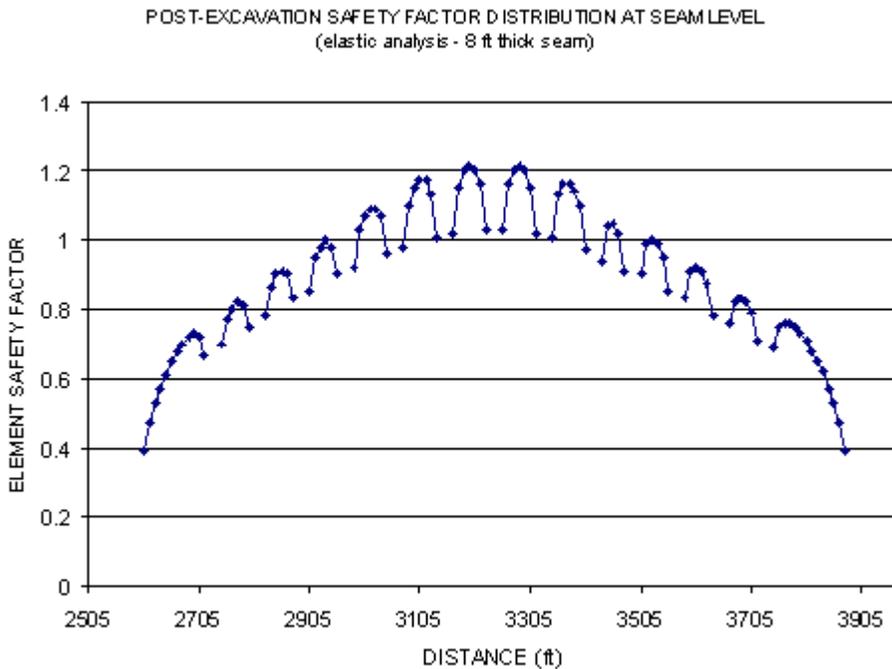
Figure 19 shows the distribution of element safety factors at seam level. Safety factors less than one are a consequence of a purely elastic calculation. Safety factors less than one indicate a potential for shedding stress to adjacent elements.

Figure 19. Post-excavation element safety factor distribution.
