REPORT OF INVESTIGATION

Fatal Underground Coal Burst Accidents
August 6 and 16, 2007

Crandall Canyon Mine
Genwal Resources Inc
Huntington, Emery County, Utah
ID No. 42-01715

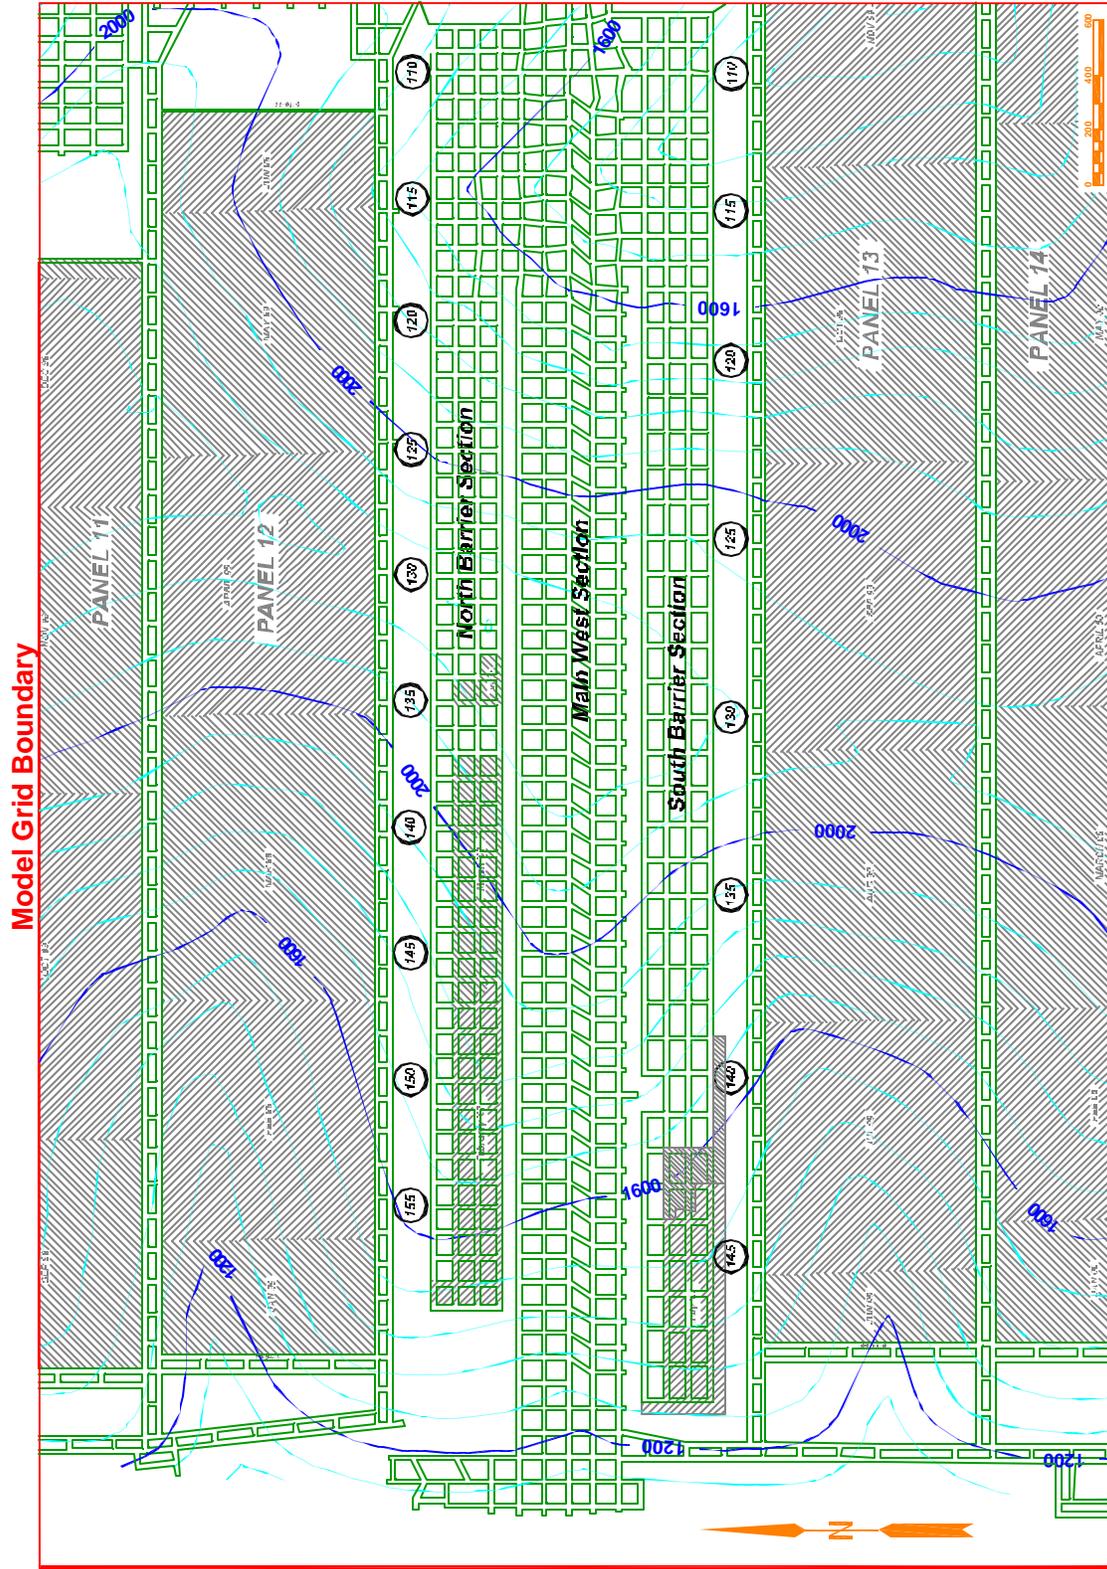
Figure 3.1 Map of the Main West area.

During the initial mining of the Main West section, the pillars were assumed to be stable, although some difficulties were encountered in this area and the safety factor under the deepest cover was probably not very high (see Figure 3.1). When longwall Panel 12 to the north and Panel 13 to the South were being mined, the abutment stress effects were seen in the outside entries of Main West and additional support was installed. When the Main West section was eventually sealed, some of the intersections had fallen and the pillars were in poor shape.

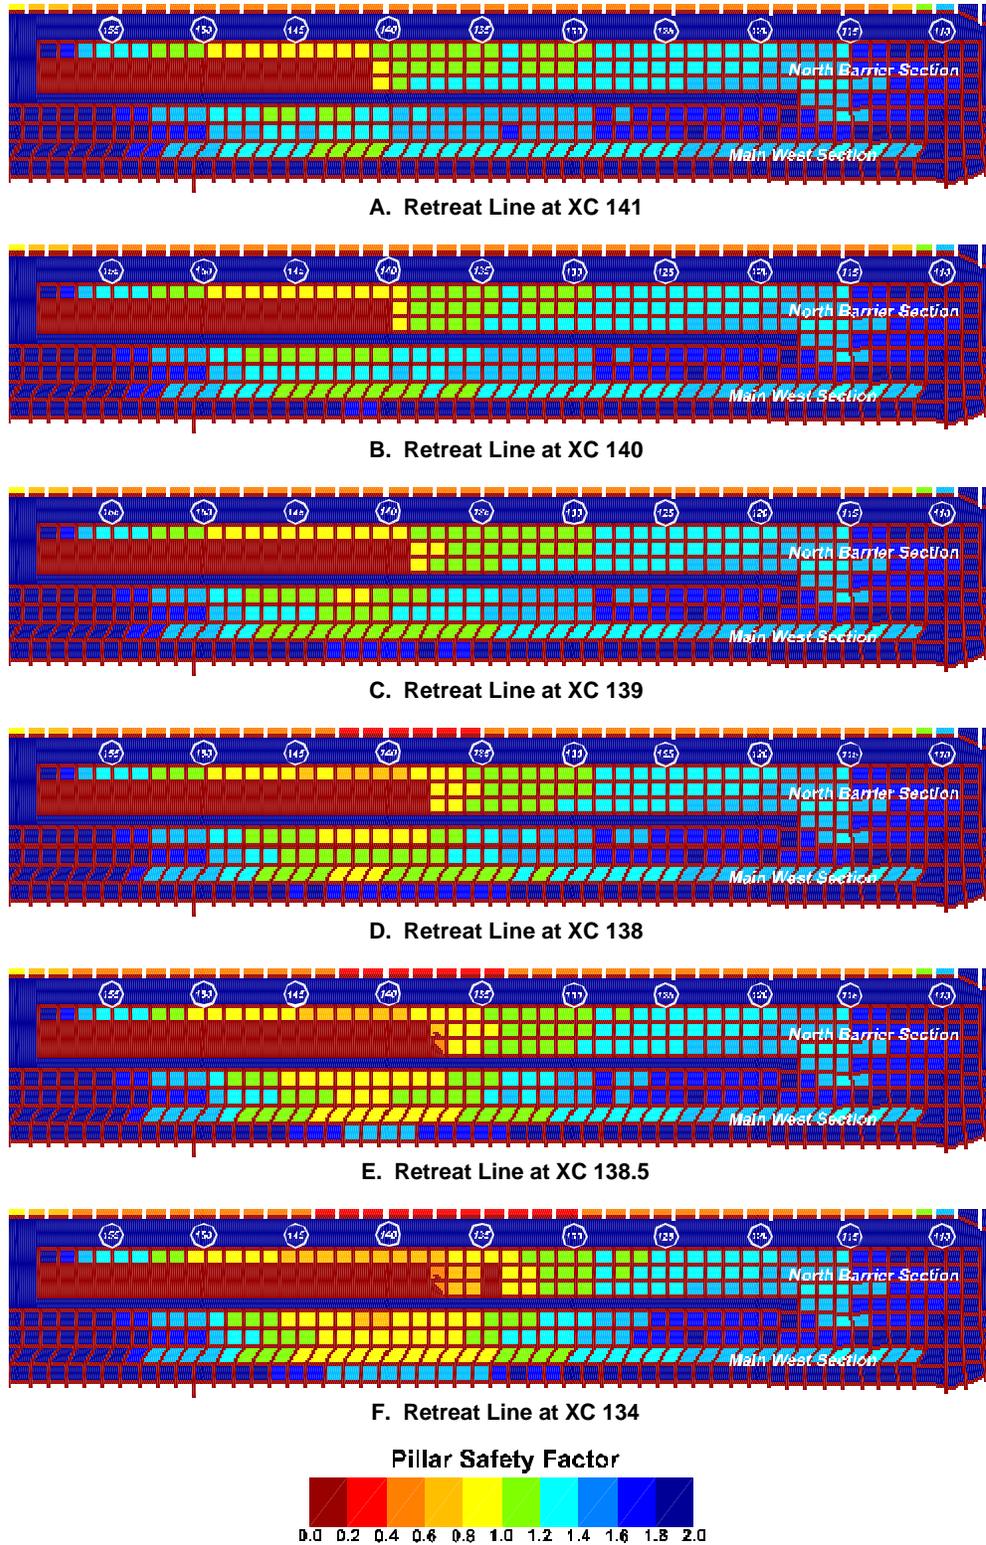
Figure 3.5 Analysis of North Barrier bump.

In the back-analysis of the North Barrier bump shown in Figure 3.5, the lamination thickness was set at 500 ft, the final modulus of the gob was set at 300,000 psi, and the coal strength was calibrated to an input value of 1325 psi (in the strain softening equations of 2.11 and 2.12). For the strain softening coal behavior, the residual stress was calculated using equation 2.11 with a factor of 0.188 (essentially a 30% reduction from the peak stress), and the residual strain was calculated with equation 2.12 using a peak stress multiplication factor of 2. The resultant pillar strength correlates to a Mark-Bieniawski pillar strength with an insitu coal strength of 927 psi.

The model results illustrated in Figure 3.5 agree reasonably well with the observed behavior. When the retreat line is at crosscut 141 (see Figure 3.5A), the model shows that two pillars on the retreat line have safety factors slightly less than one. This is a pretty typical response of a room-and-pillar retreat section. These pillars on the retreat line (although the model shows failure) may not fail in the short amount of time that they are under this stress condition, and often can be safely extracted. (However, if the section is allowed to sit idle for a length of time, these pillars may indeed fail.) As the North Barrier Section continues to retreat under deeper cover (the deepest cover is essentially crosscuts 131-132, see Figure 3.1), safety factors on the retreat line decrease. When the retreat line is at crosscut 138 (see Figure 3.5D & E), the model now shows that two full rows of pillars on the retreat line have safety factors less than one. It was at this point that deteriorating ground conditions prompted mine personnel to stop recovering pillars, move the section a couple rows outby, and continue retreating. The mine then extracted two pillars between crosscut 134 and 135 and the bump occurred. In the calibrated model, the extraction of the two pillars between crosscut 134 and 135 caused 4 pillars to fail outby, 2 pillars to fail to the north and the 4 pillars inby to fail more, or soften considerably. These calibrated pillar conditions appear to match the observed conditions in Figure 3.2 fairly well. Also, this response in the model, where a small mining step causes a large amount of failure, is certainly indicative of a dynamic event, such as the bump in this case.

It should also be noted in Figure 3.5, that as the North Barrier Section is retreated, considerable failure also occurs in the Main West Section. This response was seen in all of the calibrated models indicating that if the coal strength is adjusted to fail at the pillar geometry of the bump, then pillars in the Main West will also fail. This reaction seems entirely reasonable considering that: 1) the pillars in the Main West are only about 2% stronger than the pillars in the North Barrier Section, 2) the overburden stress is a little greater over the Main West than either the North or South Barrier sections, and 3) the abutment loading from the North Barrier gob can easily transfer over the intervening 50 ft wide barrier just as it transfers further inby in the North Barrier section. It is not believed that this amount of failure in the Main West section actually occurred at this time. Some adjustments to the model to correct this apparent inconsistency in the sequence of observed failure are discussed later in section 3.5.1.

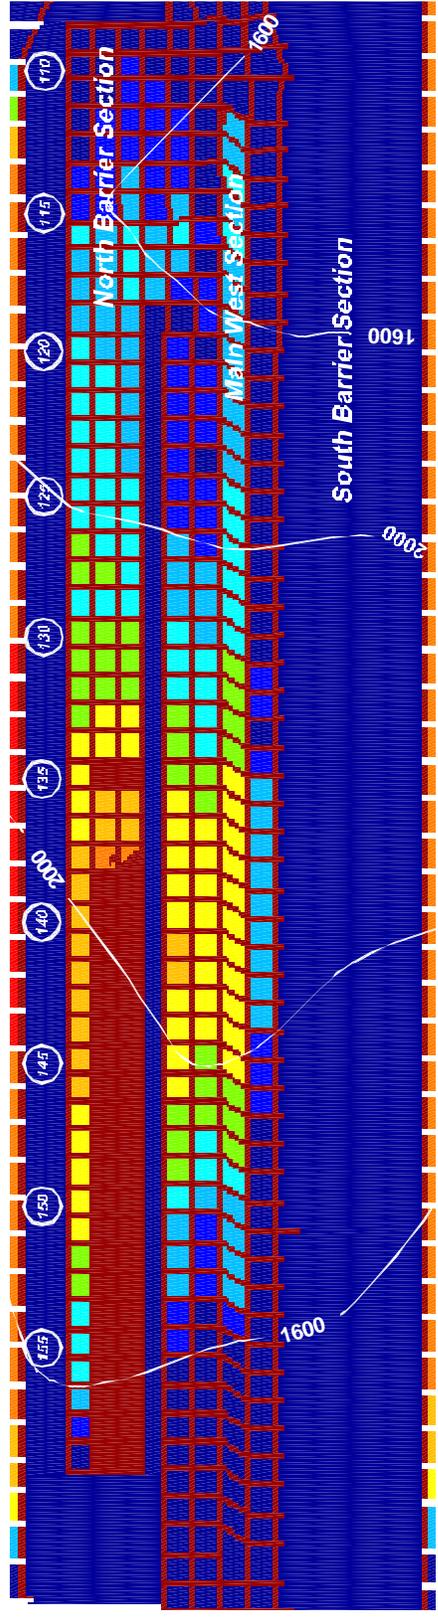
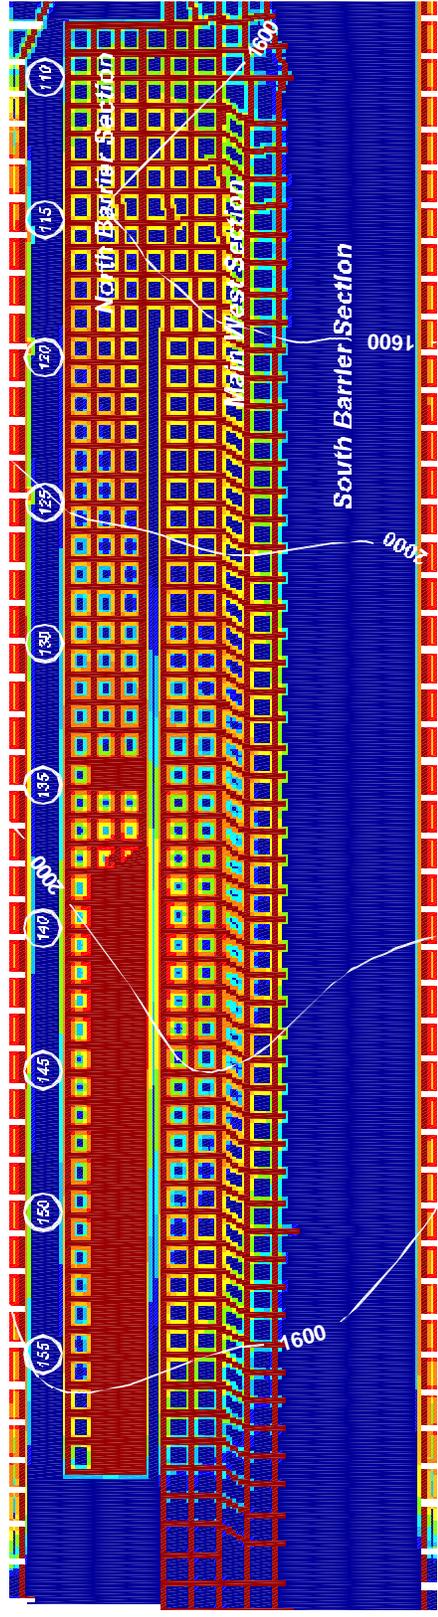
Figure 3.6 Plot of pillar and element safety factors for step 3.

The primary results of the initial back-analysis model for the Crandall Canyon Mine are shown in Figures 3.6-3.8. Figure 3.6 show the average pillar and individual element safety factors for step 3 which is the March 2007 bump geometry. Figure 3.6a is identical to Figure 3.5f and pillar failure in this plot was discussed above. Figure 3.6b shows the individual element safety factors calculated in the model for the bump geometry (step 3). By examining the element safety factors, it can be seen that the 50 ft wide barrier between the Main West and the North Barrier sections is indicating substantial failure between crosscut 137 and crosscut 144. Figure 3.6 also clearly shows the effect of the depth of cover on the pillar safety factors which increase rapidly as the cover drops below 2000 ft west of crosscut 145 and east of crosscut 125. Similarly, under the deepest cover between crosscuts 129 and 134, many pillars have not yet failed but they have very low safety factors and are close to failure. Finally, this figure indicates that the abutment stress from the active retreat gob is one of the primary factors driving the bump and the pillar failure; and therefore, the pillar failure radiates out from the active gob area. In addition, the deep cover stress is seen as a significant factor in propagating the pillar failure to the east.

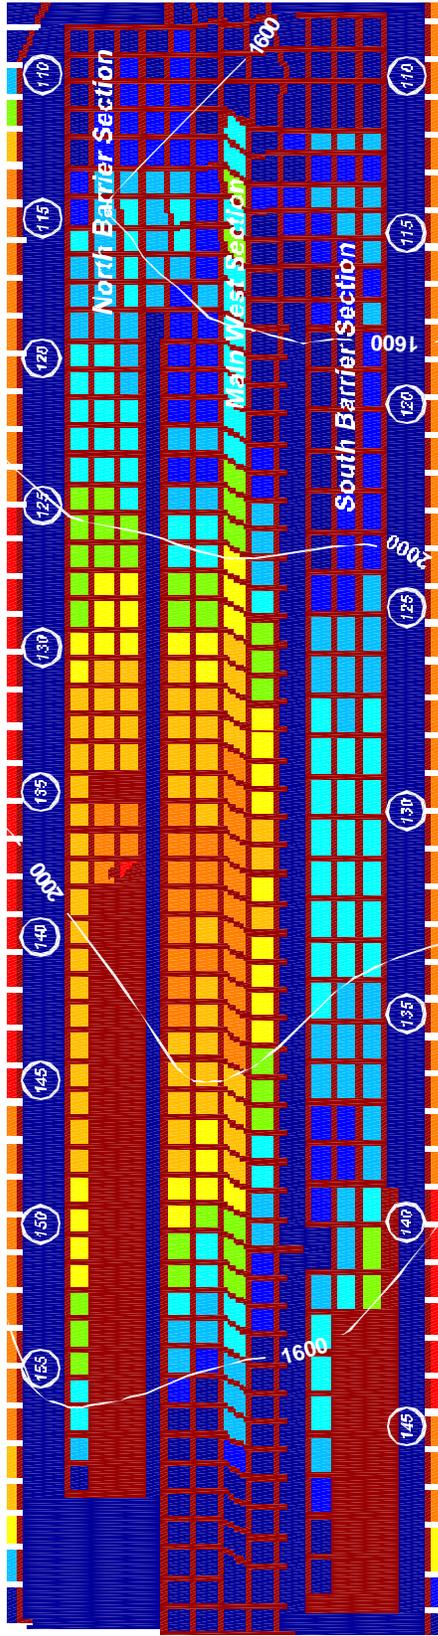
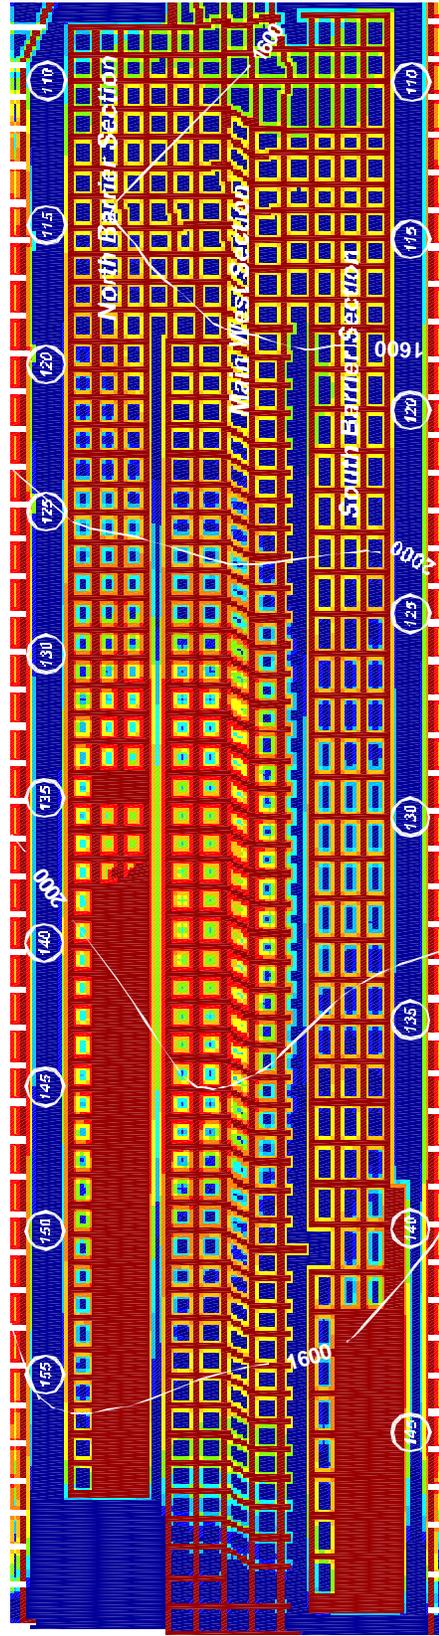
Figure 3.7 Plot of pillar and element safety factors for step 5.

Figure 3.7 shows the average pillar and individual element safety factors calculated by the model after the South Barrier section was developed and retreated to its final configuration. Several important observations can be made from this figure. First, on development and partial retreat, the pillars in the central portion of the South Barrier section (crosscuts 120–138) are shown to be fairly stable with the lowest safety factors.

Finally, it can be seen by comparing Figure 3.7 with the previous Figure 3.6 that the small increase in stress from the development of the South Barrier section has caused considerable additional pillar failure in the Main West and North Barrier sections. Fourteen additional pillars have failed in the North Barrier section and 46 additional pillars have failed in the Main West section. There is no evidence to support whether this degree of failure actually did or did not occur. It does not seem reasonable that a failure of this magnitude could have gone unnoticed during development of the South Barrier section. However, the failure may have been very gradual. More likely, the difference in Main West pillar failure between Figure 3.6 and 3.7 was part of the collapse on August 6th. Regardless, this model response certainly indicates how sensitive the Main West and North Barrier geometries are to any slight change in loading condition.

It can be seen in Figure 3.7a, that when the pillars in the Main West do start to fail, there is reluctance for the failure to propagate south past the barrier pillar and into the South Barrier Section. However, we know that this failure did occur on August 6th. To investigate what possible conditions may have triggered the collapse, or what conditions or parameter

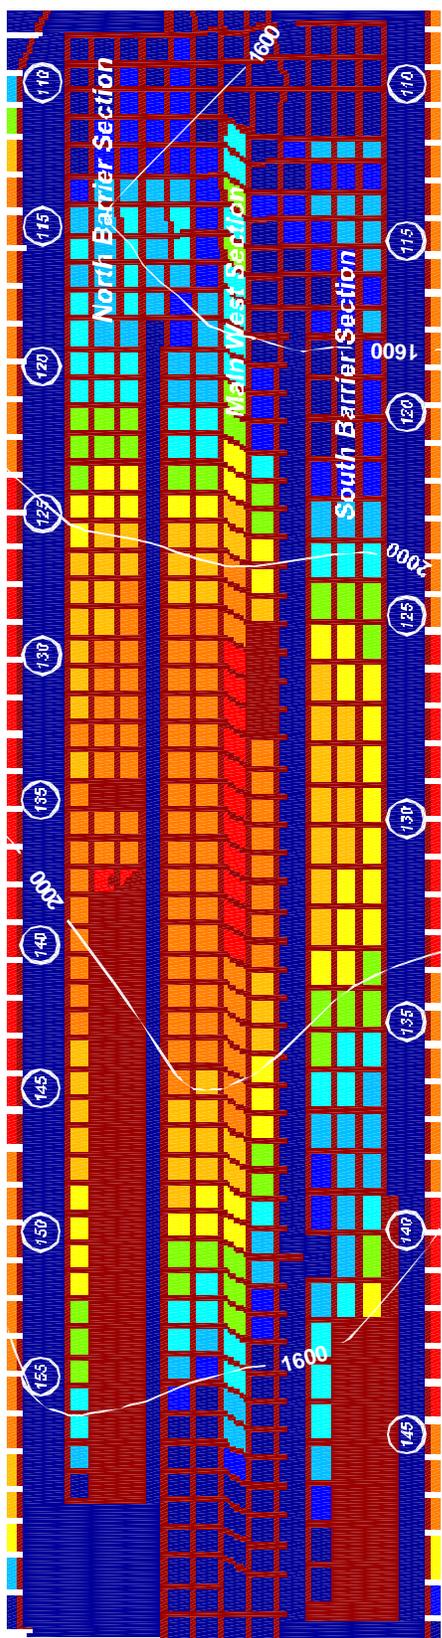
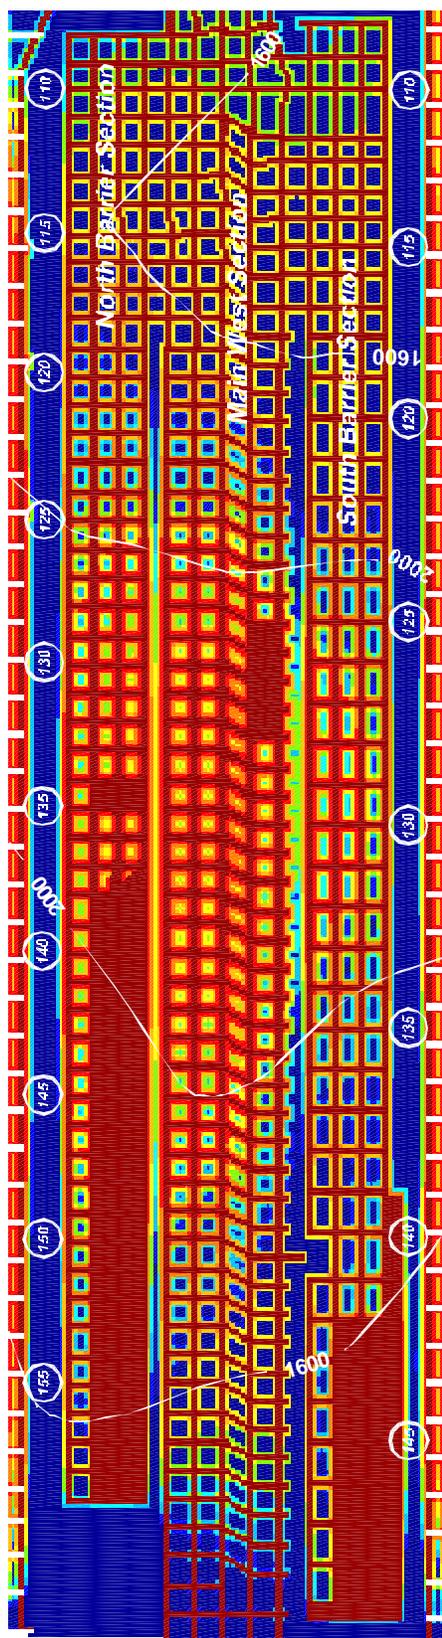
Figure 3.9 Plot of pillar and element safety factors for step 6 with 4 pillars removed.

A classic boundary-element technique used to check the stability of a potentially unstable mining plan is to simulate the extraction of a few pillars in the model (i.e., cause a small stress increase) and observe the magnitude of the resultant changes. In the optimized Crandall Canyon Mine model, four pillars (with a safety factor around 1) were removed between crosscut 128 and 132 on the south side of the Main West. The results of this perturbation are shown in Figure 3.9; it can be observed that the removal of the pillars has indeed caused 25 pillars to fail in the South Barrier section between crosscuts 125 and 134. Comparing this figure with Figure 3.7, it can also be observed that additional pillars in the Main West have failed between crosscut 124 and 129, and that the stability of the barrier between the sections has greatly decreased. The final pillar failure results shown in the South Barrier section of Figure 3.9 are not quite as extensive as observed in the field, but it does demonstrate that a relatively small change in the model conditions can cause the pillar failure to continue into the South Barrier section.

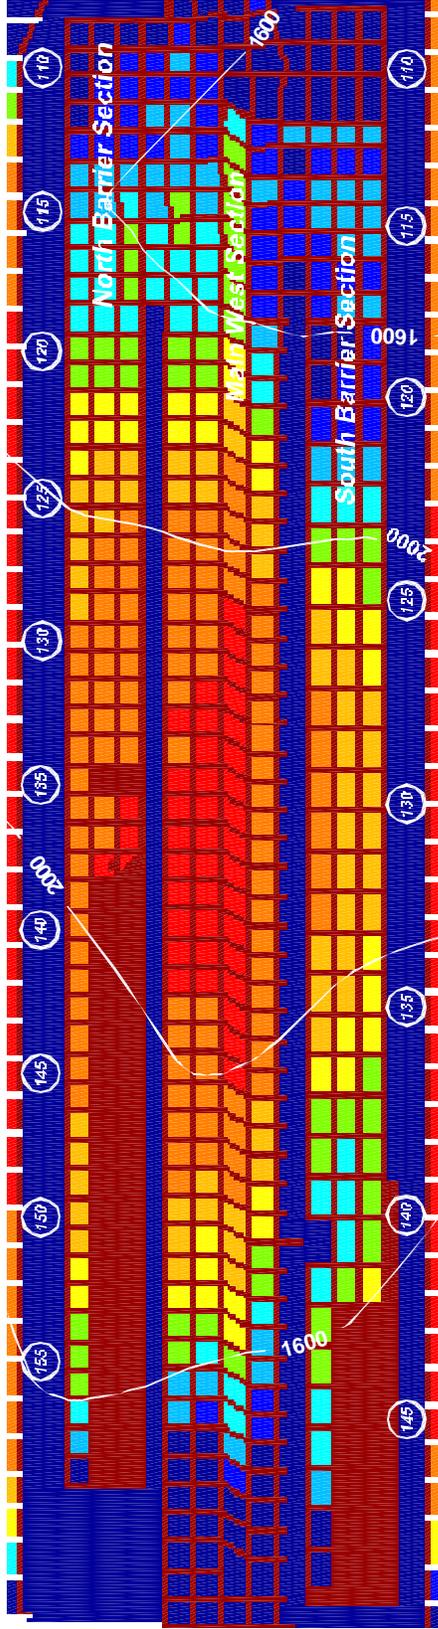
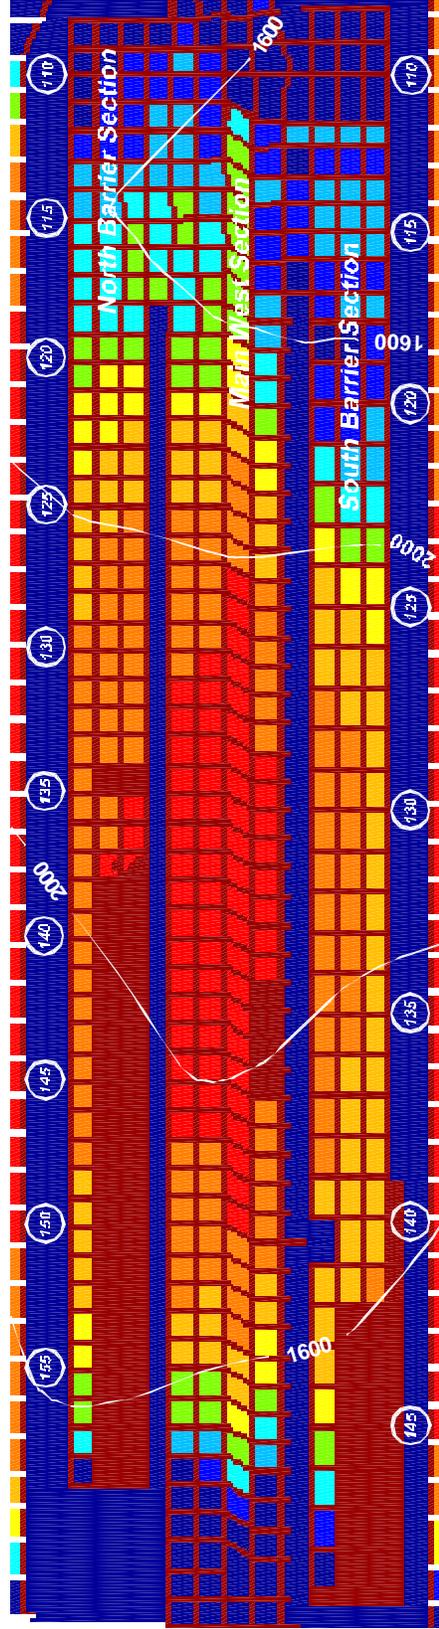
Figure 3.10 Plot of pillar safety factors for weakened coal in the Main West.

3.5.2.1 Reduced Coal Strength: The next triggering technique was to reduce the coal strength in the Main West by 50 psi or 3.8%. The results of this investigation are shown in Figure 3.10. Figure 3.10a shows that the small strength reduction has caused 37 pillars to fail in the South Barrier section between crosscuts 124 and 137, also many more pillars have failed in the Main West section. Figure 3.10b includes the removal of four pillars in the Main West and shows that the failure in the South Barrier section has encompassed the face area (crosscuts 137 to 139) and several pillars in the bleeder area (crosscuts 141 to 143). If Figures 3.8a and 3.10a are compared, it can be seen that a 7.7% reduction in the coal strength of the Main West pillars will cause 37 pillars to fail in the South Barrier section and 94 additional pillars to fail in the Main West. This large number of pillar failures in the model due to a relatively small decrease in coal strength effectively simulates the observed August 6th collapse. Seeing these model results, it certainly seems reasonable and plausible that the strength of the Main West pillars may have degraded from the effects of time and the northern abutment stresses, and a massive pillar collapse initiated which swept through the Main West pillars and down through the South Barrier section.

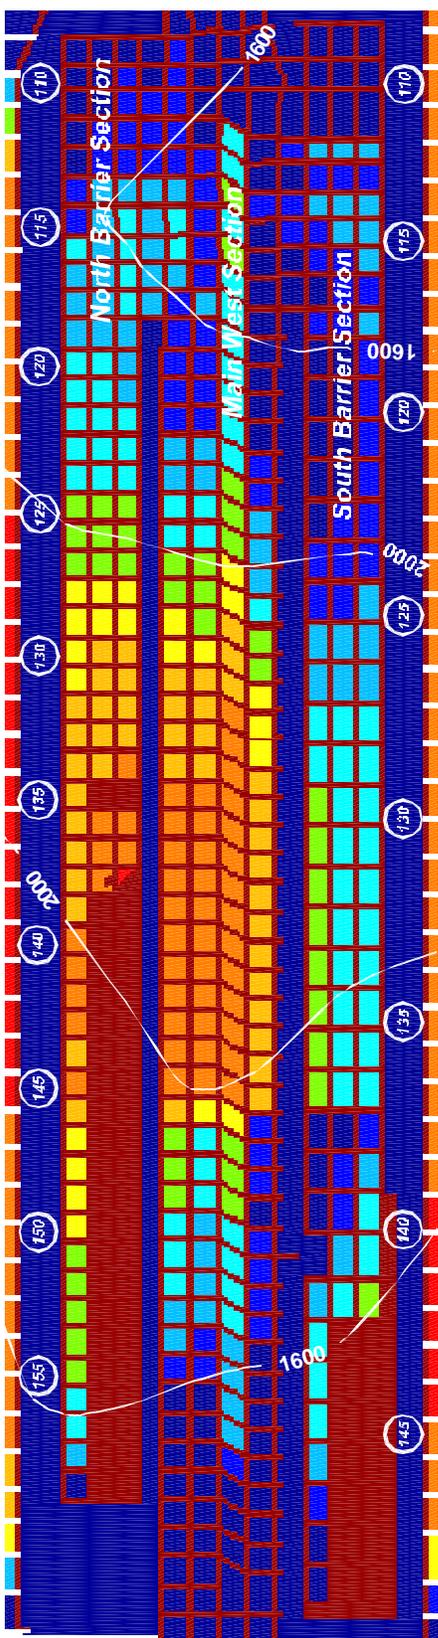
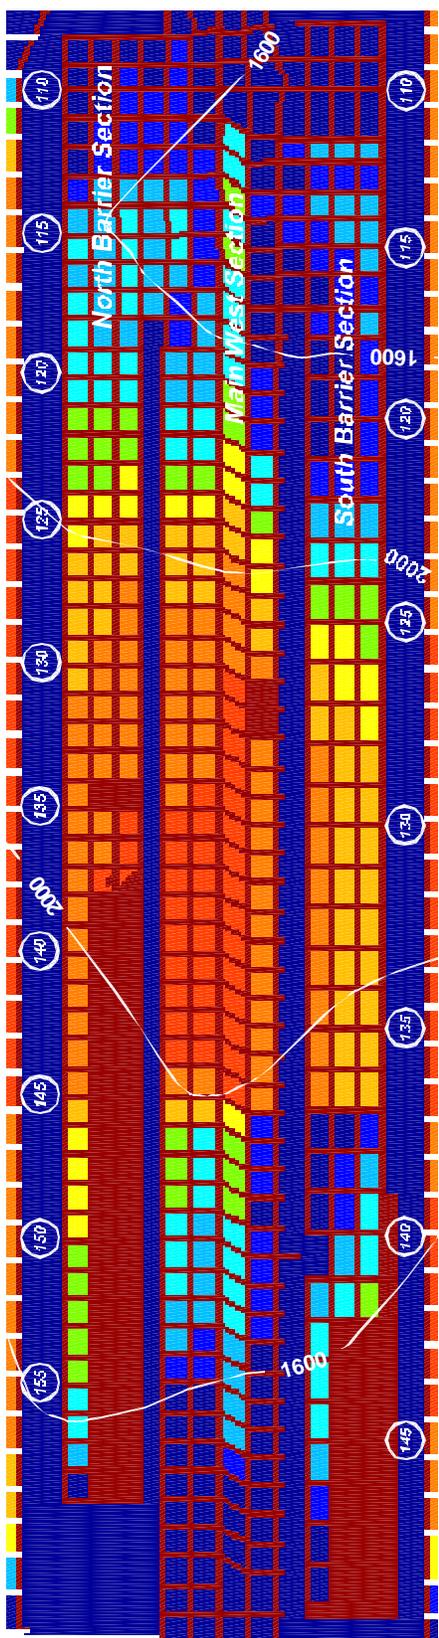
Figure 3.11 Plot of pillar safety factors for the model with a joint at crosscut 137.

For the analysis of a possible fault trigger, the joint was placed at crosscut 137 of the South Barrier section and oriented in a north-south direction between the columns of the LaModel grid. The results of this joint analysis are shown in Figure 3.11. Figure 3.11a indicates that the addition of the joint by itself does not cause any failure in the South Barrier section, but the joint with a couple pillars removed in the Main West causes 35 pillars to fail in the South Barrier section. This analysis indicates that a sudden change in stresses due to slip along a joint in the roof certainly could have been a factor in triggering the collapse seen on August 6th.

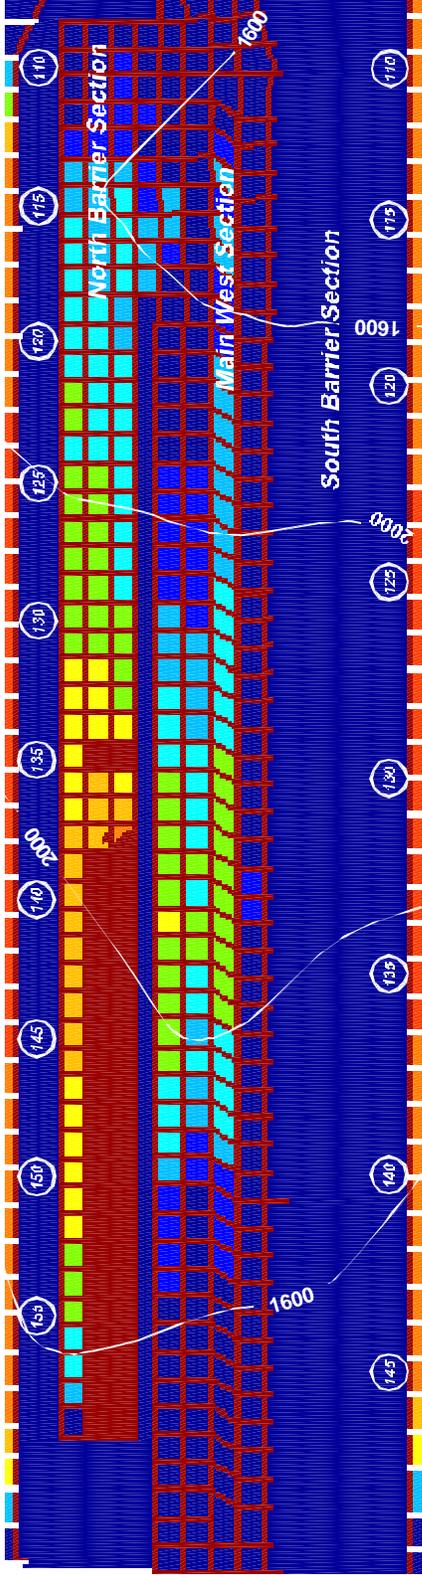
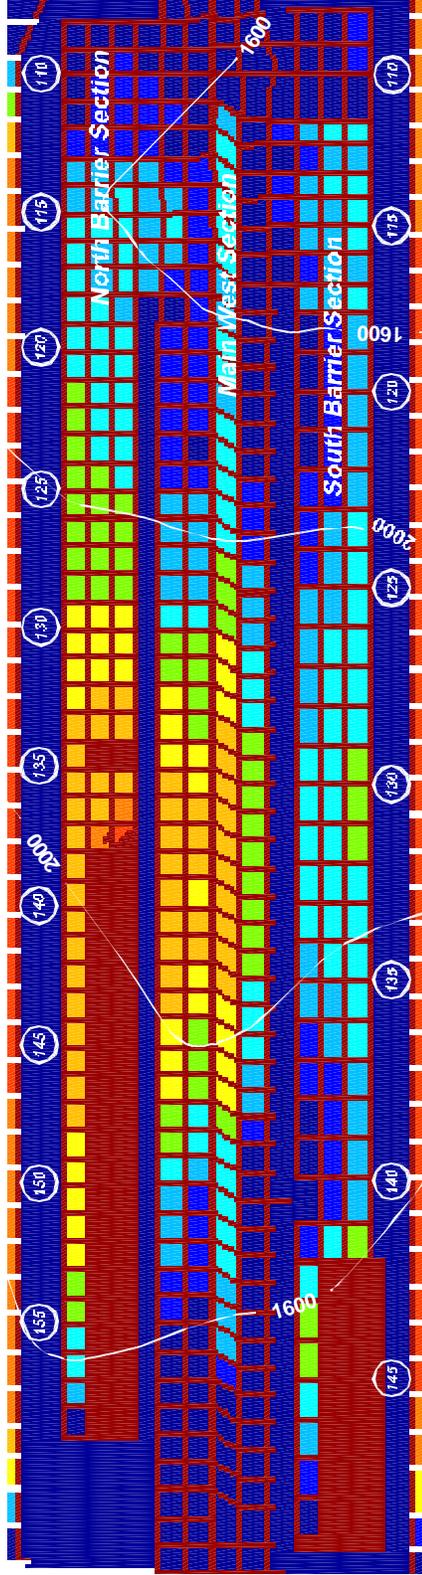
Figure 3.13 Final model of Crandall Canyon Mine – steps 3 & 5.

The results from this final back analysis model are shown in Figure 3.13 and 3.14. In Figure 3.13a, the March 2007 bump is simulated with fairly good correlation to the observed results in Figure 3.2. In this final model, only one pillar has failed in the Main West at the time of the bump. Figure 3.13b shows the development and retreat of the South Barrier section. In this final model, the pillars in the South Barrier section have fairly good stability, although some 42 pillars have failed in the Main West. Then, in Figure 3.14 after perturbing the model by removing 6 pillars, the August 6th collapse is simulated. The removal of the six trigger pillars has caused 106 additional pillars to fail in the Main West and 59 pillars to fail in the South Barrier section. The failure runs from crosscut 123 in the South Barrier section

in to crosscut 146 in the bleeder area. This final model does a fairly good job of simulating most of the critical observation of the geo-mechanical behavior at the Crandall Canyon Mine.
