**UNITED STATES
DEPARTMENT OF LABOR
MINE SAFETY AND HEALTH ADMINISTRATION
Metal and Nonmetal Mine Safety and Health**

REPORT OF INVESTIGATION

**Fatal Fall of Person Accident
February 21, 2014**

**Personal Touch Inc.
Contractor ID No. F223
at
Cemex Inc.
Kosmos Cement Co.
Louisville, Jefferson County, Kentucky
Mine ID No. 15-04469**

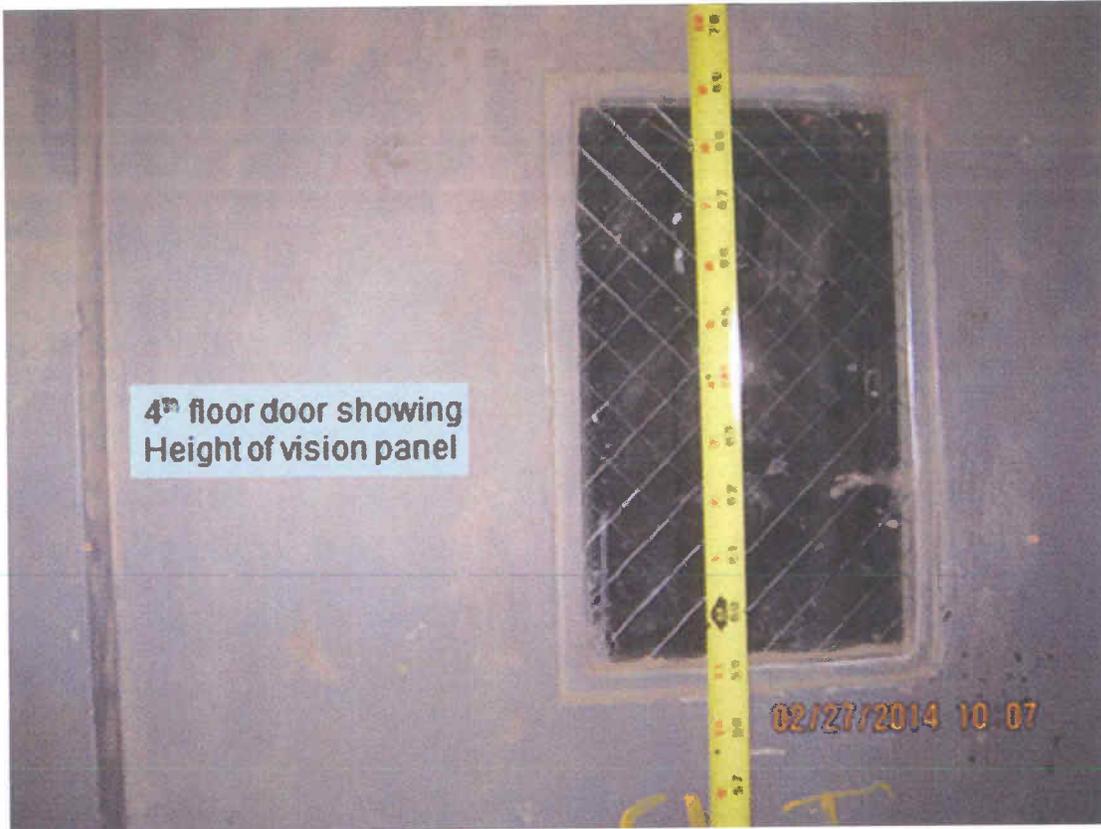
- The 4th floor landing door entrance hardware assembly was severely worn.
- The 4th floor landing door interlock did not function properly.
- The 4th floor landing door could be opened with minimal effort when the elevator car was away from the landing.
- The 4th floor in service light did not function

Locked 4th Floor landing door can be opened with a pull force of 30-40 Lbs.
