Coal Mine Fatal Accident 2006-13

Operator:	Maverick Mining Company, LLC
Mine:	Mine #1
Accident Date:	January 10, 2006
Classification:	Fall of Roof
Location:	Dist. 6, Pike County, Kentucky
Mine Type:	Underground Coal Mine
Employment:	9
Production:	140 Tons/Day

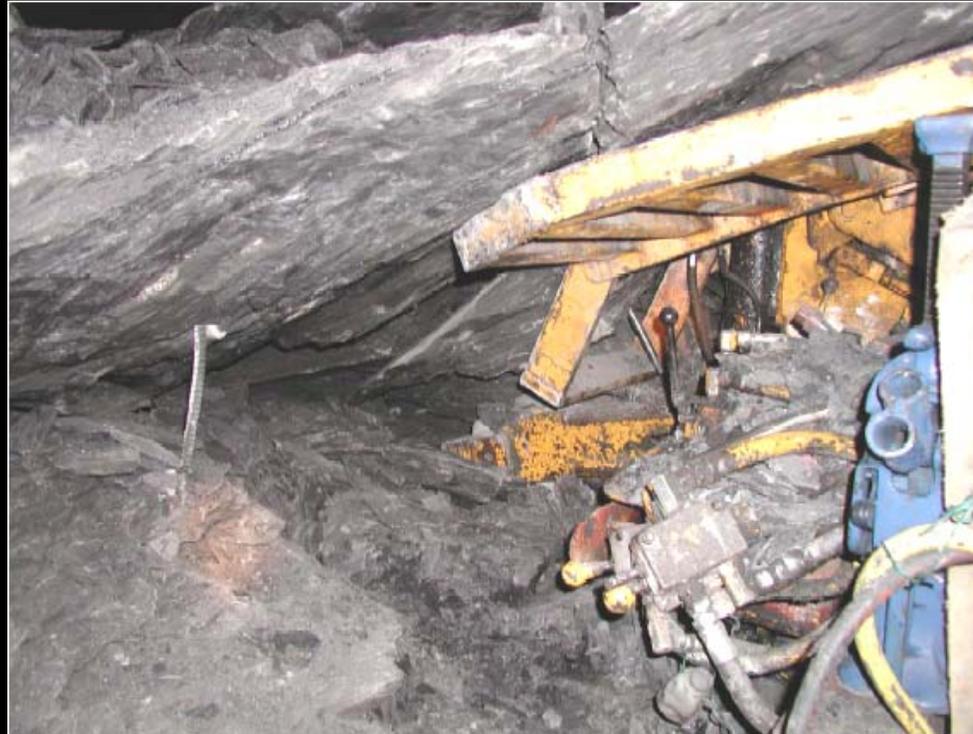
The accident occurred as the roof bolter operator was drilling a hole in the roof to install the third roof bolt of a row in the normal roof bolting cycle in the No. 1 heading. A section of unsupported roof rock measuring approximately 14 feet by 20 feet by 3 feet thick fell against the Automated Temporary Roof Support (ATRS) and operator's canopy on the Model 320 Galis Roof Bolting Machine. The ATRS and canopy collapsed under the weight of the rock pinning the victim underneath resulting in fatal crushing injuries.

Obvious adverse roof conditions were encountered on the MMU 002 working section in the face of the No. 1 heading. Unconsolidated draw rock approximately 3 feet thick was present from the last row of permanent roof support to the face, a distance of approximately 20 feet in depth and 18 feet wide. This draw rock subsequently fell in the process of installing the third roof bolt in the normal roof bolting cycle causing fatal injuries to the operator of the roof bolting machine.

A 20 feet deep cut, 18 feet wide had been mined from the face of the No. 1 heading and approximately 3 feet of draw rock **had not been taken** as the cut was mined. The 3 feet of unconsolidated draw rock had fallen in the cut prior to the cut in which the fatal accident occurred. Mine management did not take additional measures to protect persons when the unusual hazard associated with the unconsolidated draw rock was encountered. Reasonable care was not taken to cut the draw rock during the extraction of coal or to reduce the depth of cut from 20 feet to a more suitable depth to control the hanging draw rock that was left as the cut was mined. The unconsolidated draw rock subsequently fell and struck the victim while he was installing the permanent supports, resulting in fatal injuries.

Corrective Action: The roof control plan was revised to show 3 feet of draw rock taken during coal extraction, limit the depth of cuts to 12 feet, use 8" by 8" bearing plates, and use a dual boom roof bolting machine equipped with a t-bar type ATRS.
