DAILY COVER SHEET

EVENT NO. 4118295

Traveled to Performance Coal Co, UBB 46-08436
EOP inspection

Upon arrival to closed AN EOP inspection
I was informed by Bill Harless, mine foreman
that a roof fall had occurred on NW1 Section
in the face of NW1 entry, an EOP inspection was
started. A 103(R) order was issued
at verbally at 0950..

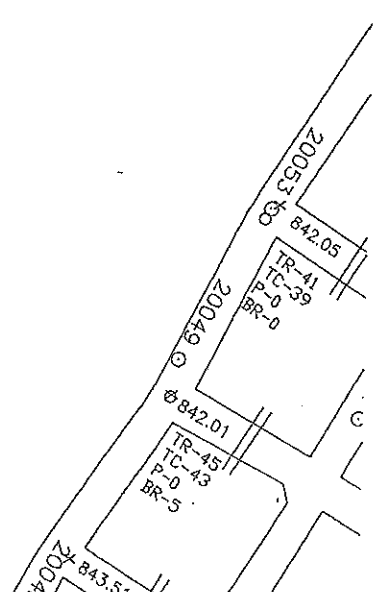
At approximately 6:00 AM on 09-30-08 on
the m.e.-night shift the fall occurred
the Fall beginning app. 50 feet in by Survey
Station # 22702 and extended in by for an
undetermined distance the Fall broke off
at the point where the cable bolt installation
had stopped

The Area had been supported with 6 steel
forged tension rod bolts the fall fell
above the anchorages of the bolts and was
approximately 8' in length the area had been
timbered off using SAND jacks, on the
Fall area there were some visible cracks present,
the Fall is laminated sandstone.

INSTALLING CABLE BOLTS
APPEARS THE
OPERATOR IS COMPLYING
W/ REVISED R.C. PLAN
THEREFORE RECOMMEND
THAT THE K ORDER
BE TERMINATED.
