## Coal Mine Fatal Accident 2003-25-26

| Operator: | Progress Coal (Massey Energy Company) |
| Mine: | Twilight MTR Surface Mine |
| Accident Date: | September 17, 2003 |

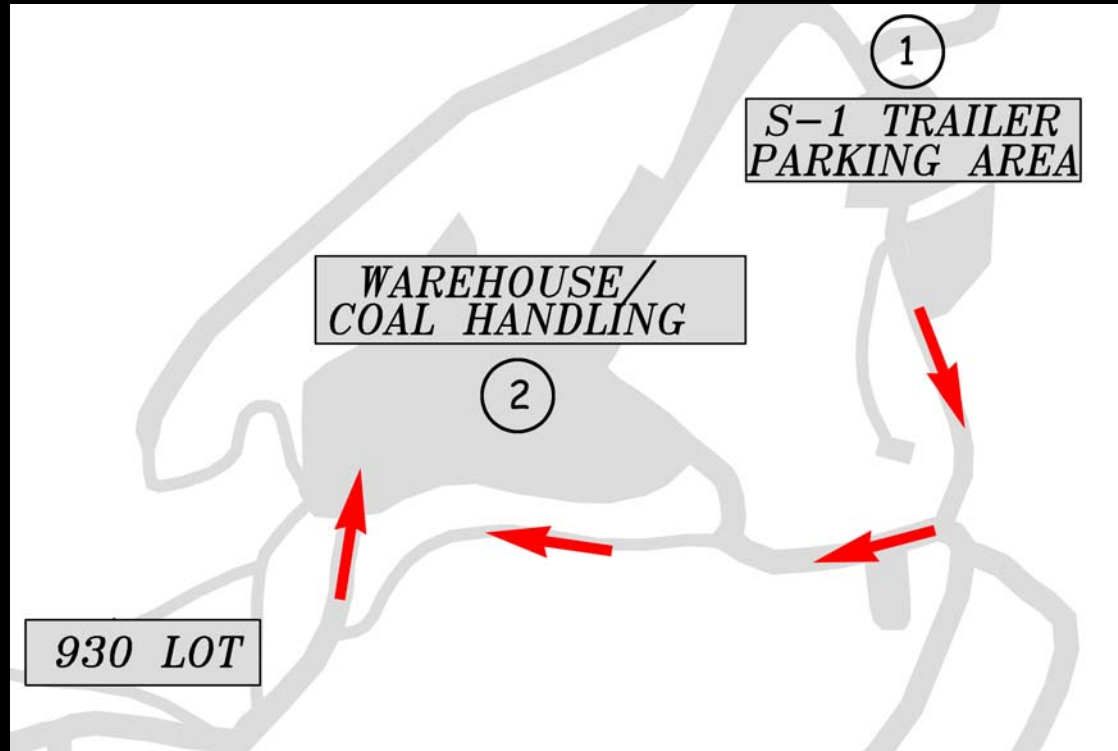
1. At ~5:30 a.m., members of the day shift crew arrived in the mine parking lot. Two dozer operators, a highwall drill operator, and a rock truck driver boarded a Ford E-350, Portal Van driven by a track-hoe operator. Prior to leaving the parking lot, a rock truck driver, asked the van driver to obtain toilet paper supplies for him.
2. The portal van traveled approximately one mile to the warehouse to obtain the supplies.

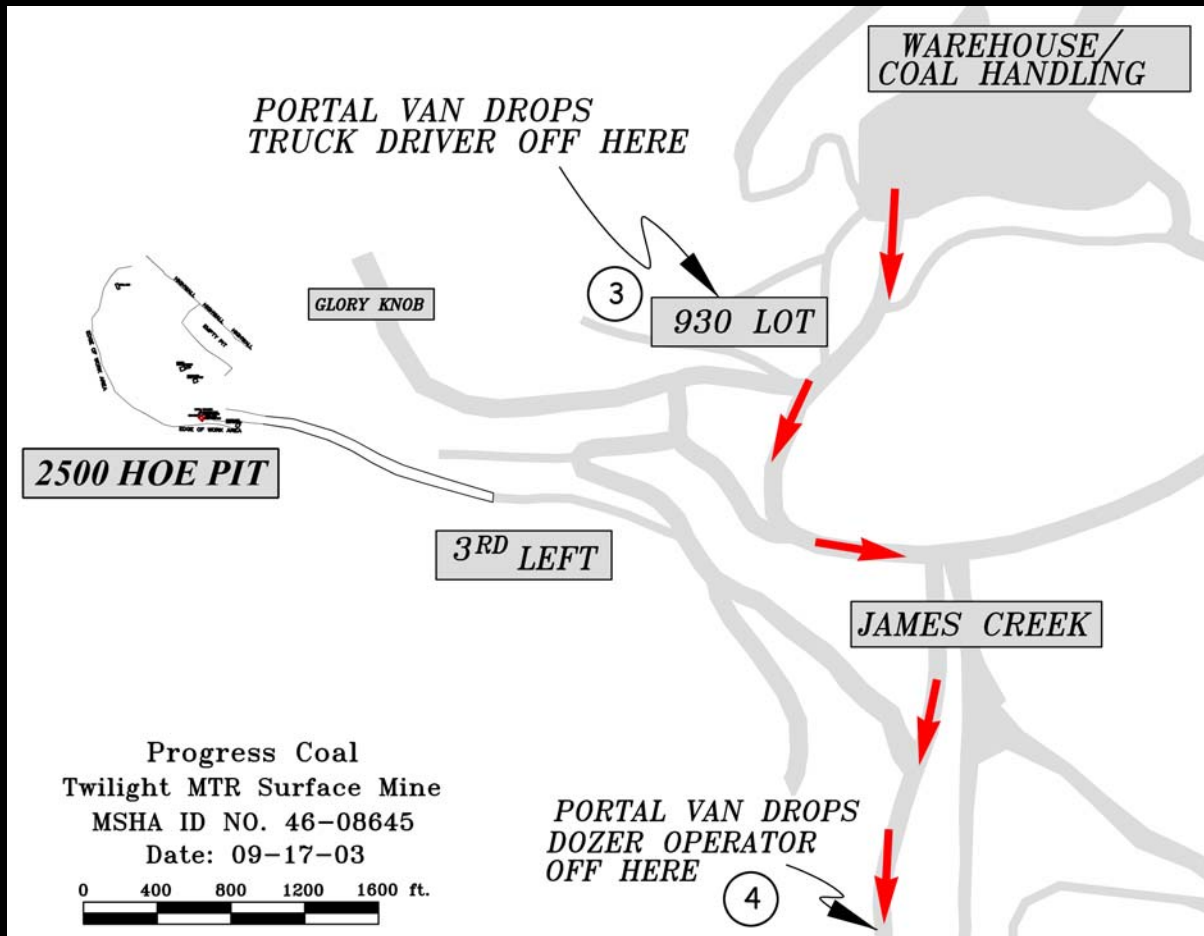
3. The back-hoe operator then drove the portal van ~400-500 feet from the warehouse, where he dropped off the rock truck driver at his truck.
4. Next, they dropped off one of the dozer operators on James Creek Road.

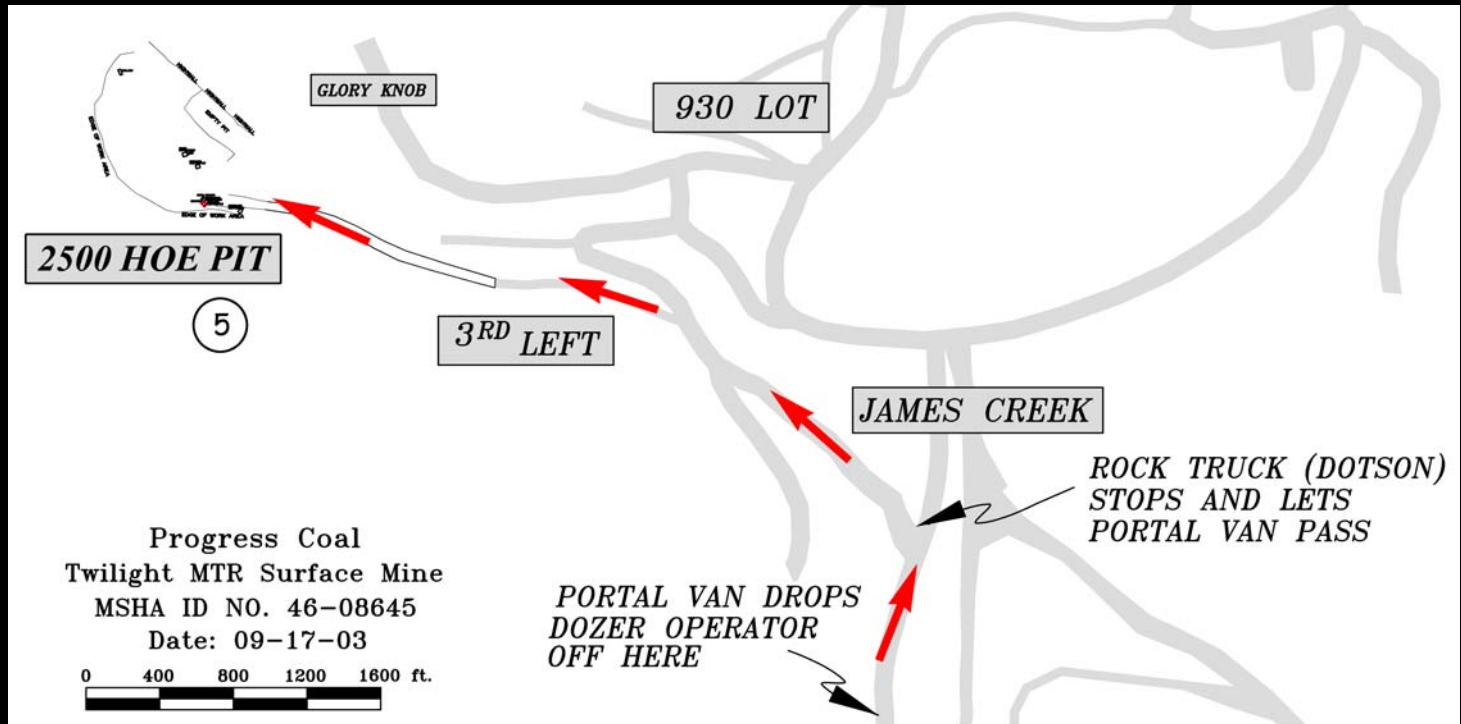
5. The 3 remaining miners then traveled to the 2500 Hoe Pit. Another rock truck driver, observed the portal van approaching the intersection of the 2500 Hoe Pit access road. He stopped and allowed the van to cross in front of him. The van then proceeded into the pit ahead of the rock truck.

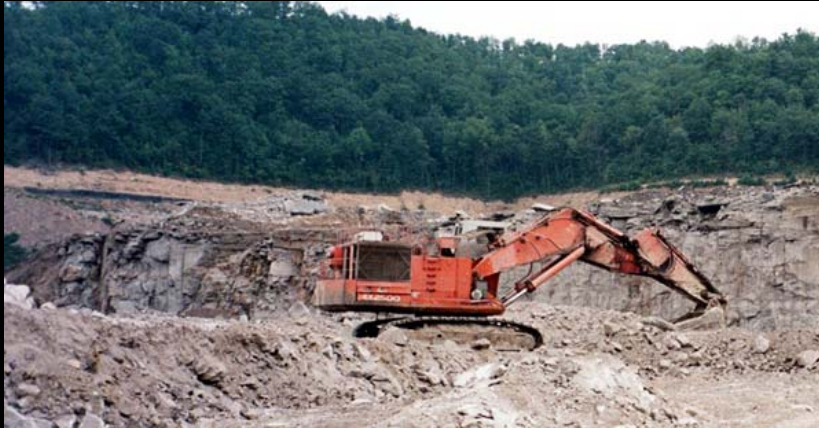
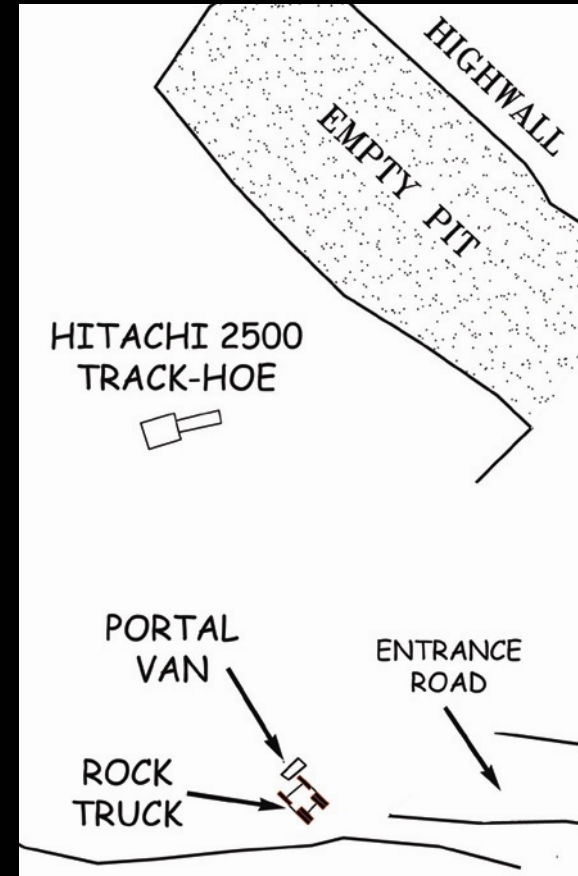
- Meanwhile, the rock truck driver who requested the supplies had left the parking area and traveled to the 2500 Hoe Pit, stopping approximately 270 feet away from the Hitachi Model 2500 Track-hoe.
- Also at this time, a mechanic finished servicing the track-hoe and left its dome lights and small entrance lights illuminated as he left the pit.

- As the portal van approached to within ~50-60 yards of the truck, the van driver radioed a message for the truck driver to get his supplies.

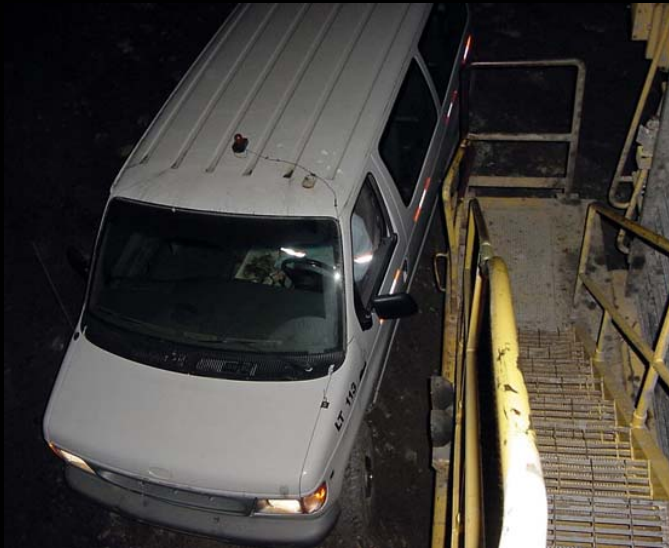
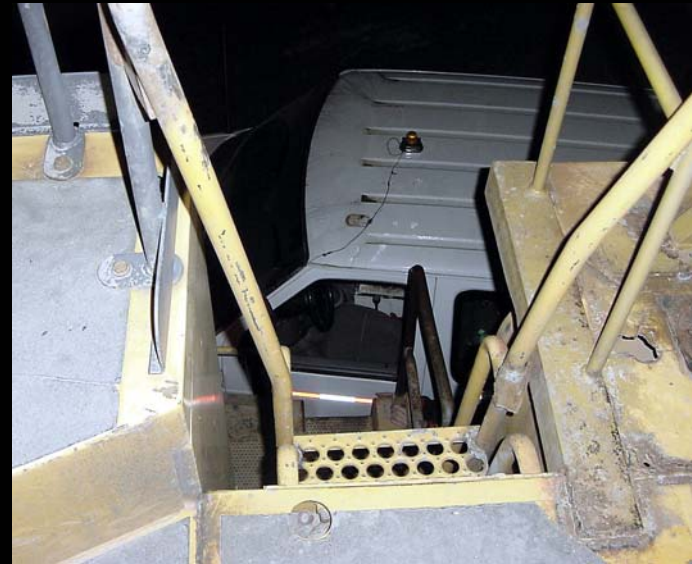
- The rock truck driver following the van stopped his rock truck ~300' behind the parked rock truck and he started cleaning the interior of his truck.
- The van driver intended for the rock truck driver to climb down from the cab to meet him. To facilitate transfer of supplies, he parked the van in front of the rock truck bumper, with the driver-side door of the van aligned with the access ladder on the off-side of the truck.
- The rock truck driver was leaning down, getting ear plugs out of his dinner bucket, and did not see the headlights on the approaching portal van when he heard the radio transmission.
