Coal Mine Fatal Accident 2004-06

Operator:	Brooks Run Mining Company, LLC
Mine:	Brooks Run Processing Plant No. 1
Accident Date:	March 2, 2004
Classification:	Sliding Material
Location:	District 4, Webster County, WV
Mine Type:	Surface
Employment:	51

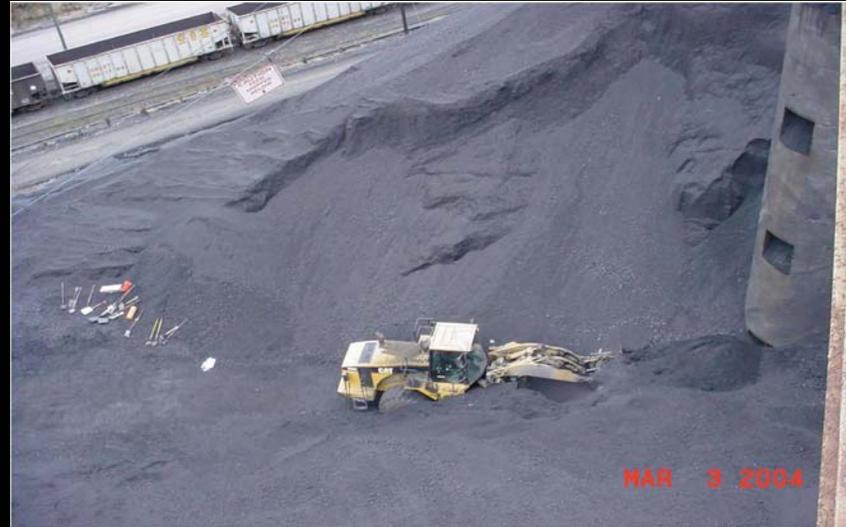
- At approximately 4:00 p.m. on Tuesday, March 2, 2004, a 50-year old Maintenance Foreman with 31 years of mining experience was fatally injured while he was directing the placement of a steel plate over the chute of an underground reclaim feeder near the toe of a coal stockpile.
- Reclaiming operations to open up the stockpile for access to the feeder caused the coal bank near the feeder to be unstable. The coal bank became unstable due to the height of the stockpile and the steepness of its slopes.
- Immediately after the plate was placed over the feeder, part of the coal bank collapsed. The victim was knocked to the ground and covered with approximately three feet of coal. It took about 30 minutes for nearby workers to uncover the victim. He was found in a face down position under the boom of the end loader but could not be revived.
