Coal Mine Fatal Accident 2004-16

Operator:	McElroy Coal Company
Mine:	McElroy Mine
Accident Date:	August 17, 2004
Classification:	Fall of Rib
Location:	District 3, Marshall County, WV
Mine Type:	Underground
Employment:	639
Production	6.7 Million Tons/Year

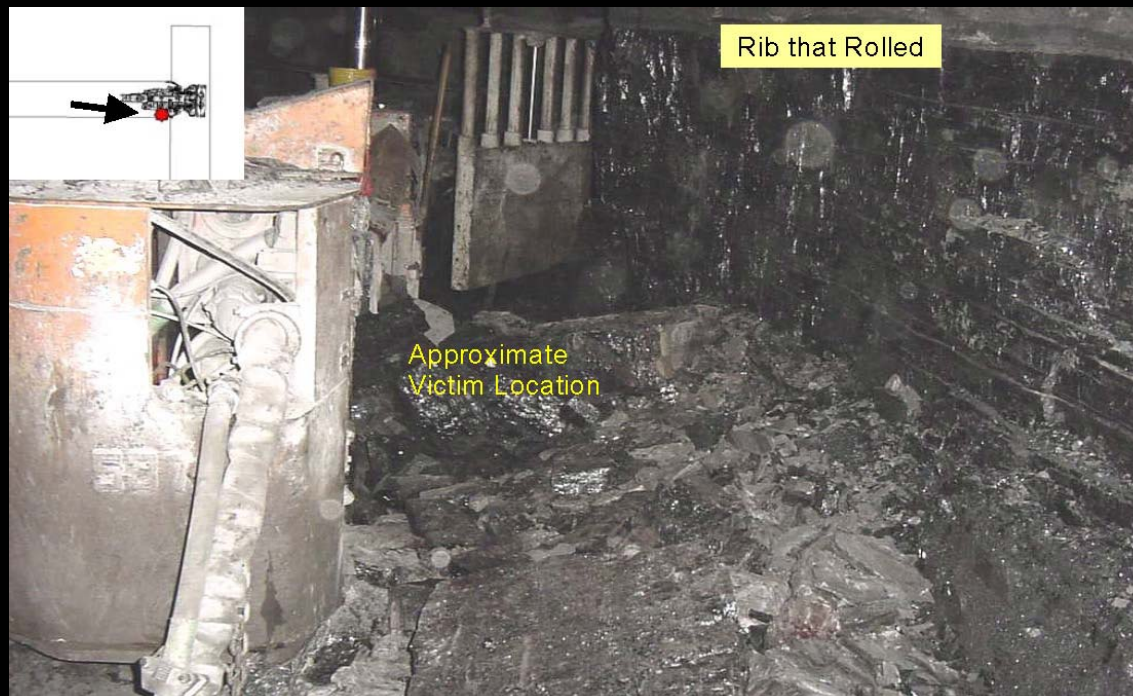
A 57-year old Continuous Mining Machine Roof Bolter Operator was fatally injured in a rib roll accident on the right side of the 5-North Mains section. The crew had mined through the No. 30 crosscut between the No. 5 and No. 6 entries when the roof bolters started to install the last strap. The miner operator warned the victim that the rib was beginning to work. The victim withdrew approximately 3 feet toward the No. 5 entry (rear of the mining machine) when he stopped and placed his hand on the rib. The coal and rock rib (~20' long by 5' wide and up to 10" thick) collapsed and pinned the victim against the continuous mining machine causing fatal injuries.

The accident was caused by failure to effectively control the rib at the work area which exposed the victim to a hazardous condition. The hazardous condition was a result from what appeared to be mining induced loading in the No. 30 crosscut between the No. 5 and No. 6 entries. Stress redistribution resulting from the completion of the crosscut shed an additional load on the surrounding pillar ribs. The additional load caused the pillar block to expand and the rib line adjacent to the right side of the continuous mining machine to fracture. Contributing to the accident was equipment incapable of installing rib support, an insufficient roof control plan, and failure to reevaluate changing conditions relative to equipment, mining procedures and practices.

Corrective Actions: The approved roof control plan was revised to include rib bolting as mining advanced.
