Coal Mine Fatal Accident 2004-25

Operator:	Endurance Mining
Mine:	Red Cedar Surface Mine
Accident Date:	November 20, 2004
Classification:	Fall of Highwall
Location:	District 4, Boone County, WV
Mine Type:	Surface
Production	6,000 Tons/Day

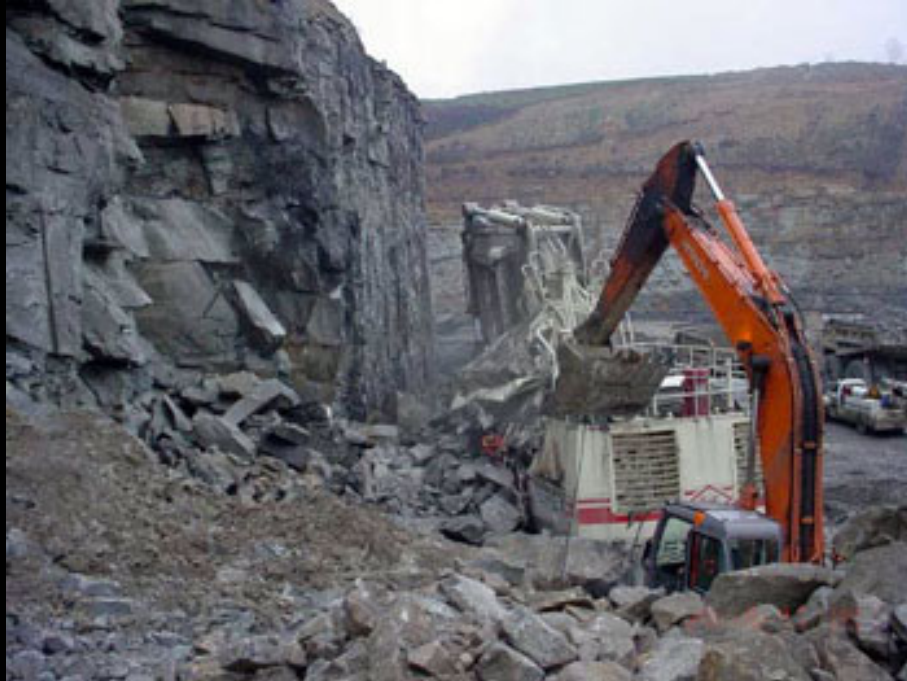
A 41-year old equipment operator with seven months of mining experience was fatally injured while operating an excavator near the highwall, loading spoil into trucks. The excavator was positioned with the cab on the highwall side. The highwall collapsed causing rocks to cover the operator's cab.

Causal Factor: Surface mining was developed into abandoned, pillared, underground mine workings where subsidence had occurred, resulting in unstable highwall conditions.

The accident occurred because the ground control plan did not provide for safe control of the highwall and safe working conditions in areas near abandoned underground mine workings. Subsidence resulting from the second mining of the abandoned underground mine workings caused the highwall to be unstable. The unstable highwall collapsed crushing the machine operators cab and resulted in the death of the machine operator. At the time of the accident, the operator's cab was positioned immediately adjacent to the highwall while the pad was being excavated. This was the normal procedure for excavator positioning.

Corrective Actions: The mine operator revised the ground control plan to require drilling in advance of contour mining adjacent to old underground mine works. The revised plan also required a bench to be left above the pit floor, away from the outermost edge of old underground mine works. This resulted in highwall development away from the old mine workings to prevent subsidence from affecting the stability of the highwall.
