## Coal Mine Fatal Accident 2004-17

Operator:	Hobet Mining, Inc.
Mine:	Hobet 21 Surface Mine
Accident Date:	August 29, 2004
Classification:	Electrical
Location:	District 4, Boone County, WV
Mine Type:	Surface
Employment:	306
Production	14,000 Tons/Day

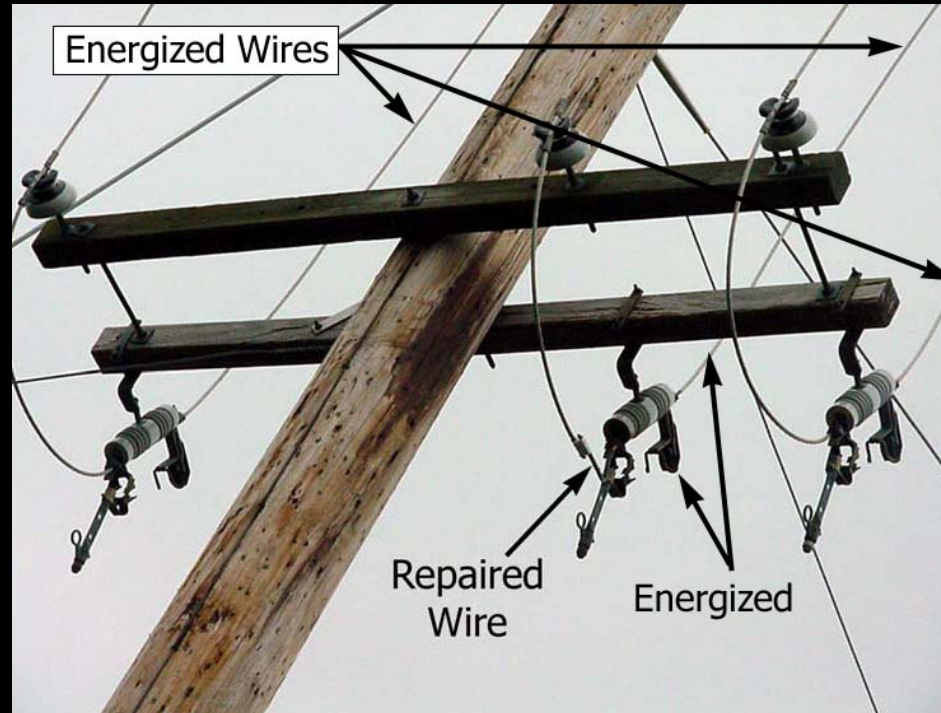
The mine operator discovered that a burned fuse link on a high voltage, pole-mounted, disconnect had resulted in a gap of 8-9" between the base of the middle phase knife switch and the load-side conductor.
