Coal Mine Fatal Accident 2006-20

Operator: Perry County Coal Corp.
Mine: HZ4-1
Accident Date: February 16, 2006
Classification: Fall of Roof
Location: Dist. 7, Perry County, KY
Mine Type: Underground Coal Mine
Employment: 40
Production: 1,600 Tons/Day

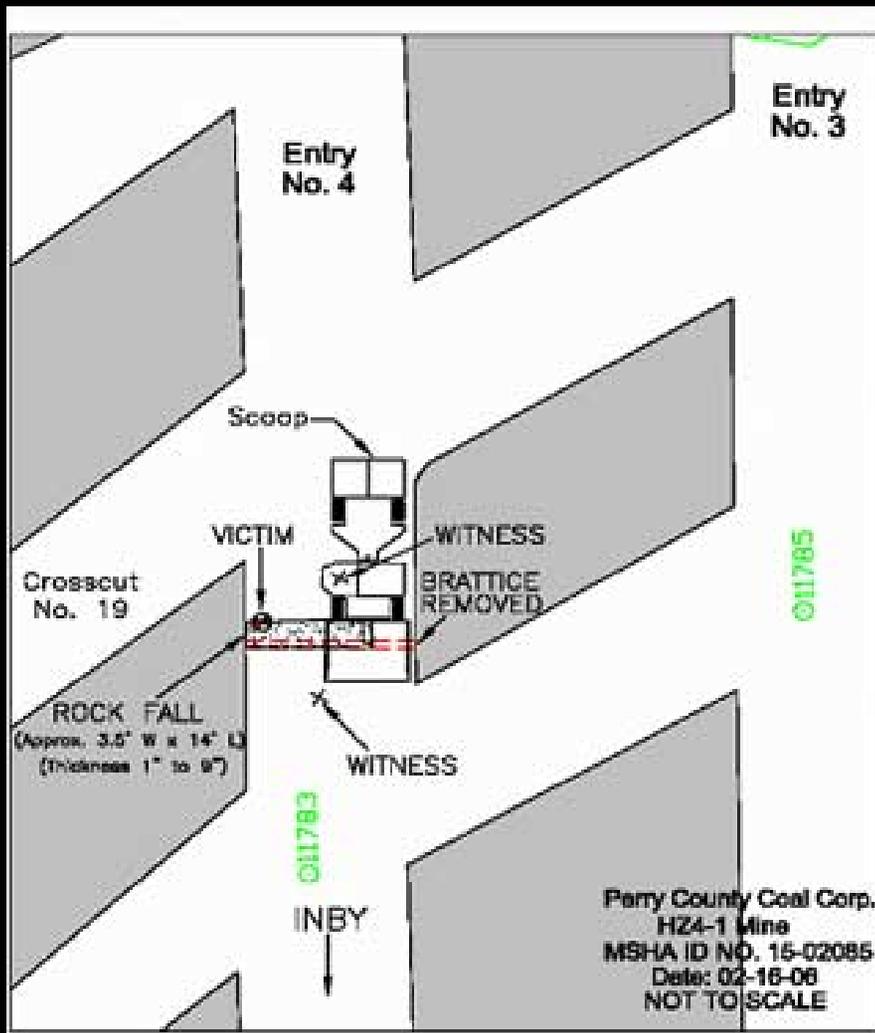
At 8:30 a.m. on Thursday, February 16, 2006, a 33-year old roof bolting machine operator was fatally injured at Perry County Coal Corporation's HZ4-1 mine. The accident occurred while the victim was assisting in the removal of a permanent stopping during a move of the working section to another panel. The accident occurred as a result of an area of inadequately supported roof, which fell, causing fatal crushing injuries.

Causal Factor: An effective procedure or Roof Control plan requirement was not in place and followed to ensure that roof irregularities would be adequately supported. The roof rock that fell was not adequately supported. The rock that fell had a brow present that resulted from the continuous mining machine cutting up into the mine roof and then over-correcting, leaving a protruding segment of rock projecting between the installed roof supports. The permanent stopping was constructed directly under the protruding segment of mine roof and held it in place. After this permanent stopping was removed, the roof fall occurred that caused the death of the victim.

An investigation of the fatal fall of roof accident which occurred on February 16, 2006, revealed that an area of inadequately supported roof (drawrock) was present between crosscuts 19 and 20 of the number four entry of the 012 working section sub-mains. The drawrock fell from the mine roof causing crushing fatal injuries. The rock that fell had a brow present which resulted from the continuous mining machine cutting up into the mine roof and then over correcting, leaving a protruding segment of rock projecting down between the installed roof supports. Contributing to this accident was an unsafe procedure whereby miners entered an area following the removal of a permanent stopping without an adequate inspection or without allowing sufficient time to ensure that the removal of the permanent stopping did not allow the mine roof to sag or fall.

Corrective Action: The operator's approved Roof Control plan was changed to address inadequately supported roof and brows. Task training was added to the training plan to require safe procedures to be followed when permanent stoppings are removed.
