## Coal Mine Fatal Accident 2006-43

Operator:	Double Bonus Coal Company
Mine:	No. 65
Accident Date:	October 30, 2006
Classification:	Machinery
Location:	Dist. 4, Wyoming County, West Virginia
Mine Type:	Underground Coal Mine
Employment:	40
Production:	4,000 Tons/Day

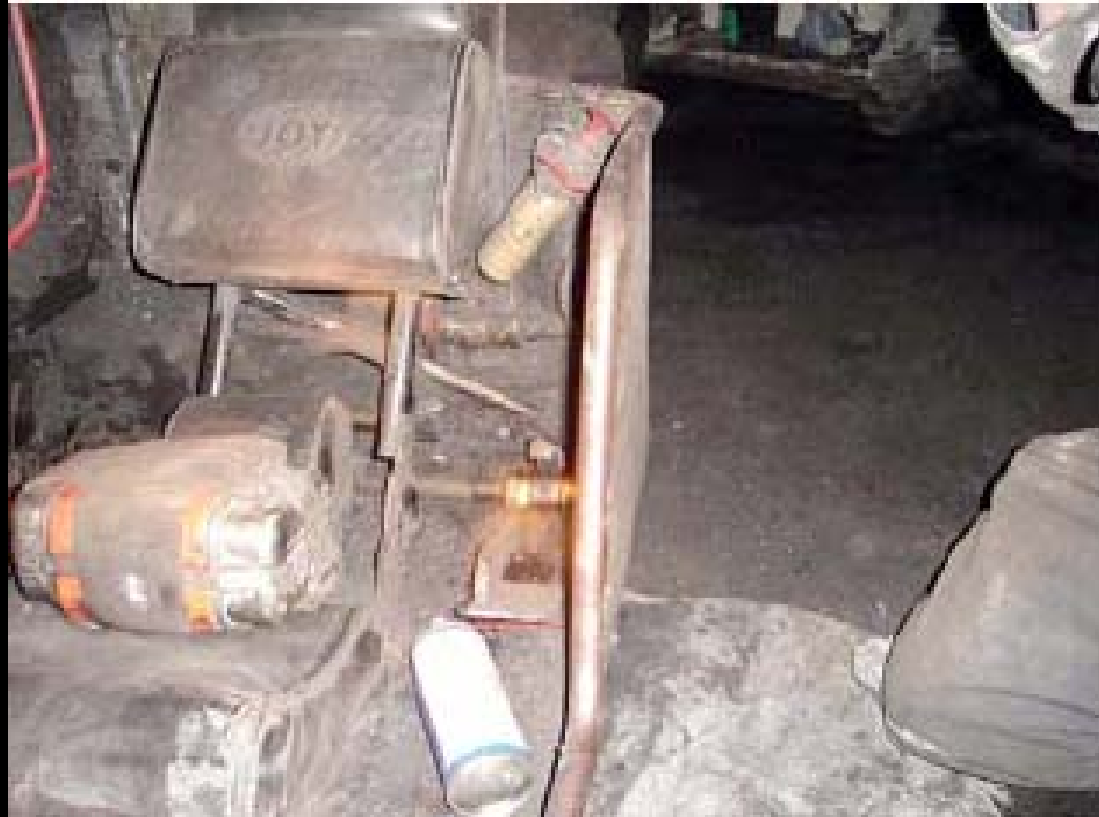
At approximately 7:05 a.m. on Monday, October 30, 2006, a 31-year-old shuttle car operator was fatally injured when he was crushed between a shuttle car and the coal rib. The accident occurred when the victim and a section mechanic were attempting to free-up a sticking tram pedal on the #2 shuttle car. Both miners were positioned between the shuttle car and the inby solid coal rib of the #4 to #5 crosscut. The shuttle car was energized, the park brake was not set and the controls were set to fast tram. The shuttle car trammed and struck both miners. The section mechanic received life-threatening injuries when he was rolled along the solid coal rib.

Root Cause: The operator's management systems and policies did not ensure that the #2 shuttle car's cross shafts and four journal bearings that support the two cross shafts were properly lubricated. Improper lubrication and fine coal particles caused the tram pedal to stick, causing an unsafe operating condition.

Corrective Action: The written mine training program was revised to include the following safety precaution under task training; "The operating decks on shuttle cars will be cleaned and properly greased prior to being placed into production on each shift." Management and miners were trained in the new safety precaution.

- De-energize, lock out, tag, and block mobile equipment when making repairs.
- Ensure that equipment decks are cleaned of accumulations of coal, mud and other extraneous materials, and mechanical components are greased and lubricated as necessary.
- Assume safe positions prior to conducting work.
