Coal Mine Fatal Accident 2007-04

Operator:	Double E Augering Inc.
Mine:	No. 3
Accident Date:	March 12, 2007
Classification:	Machinery
Location:	Dist. 6, Pike County, Kentucky
Mine Type:	Surface Coal Mine
Employment:	5
Production:	200 Tons/Day

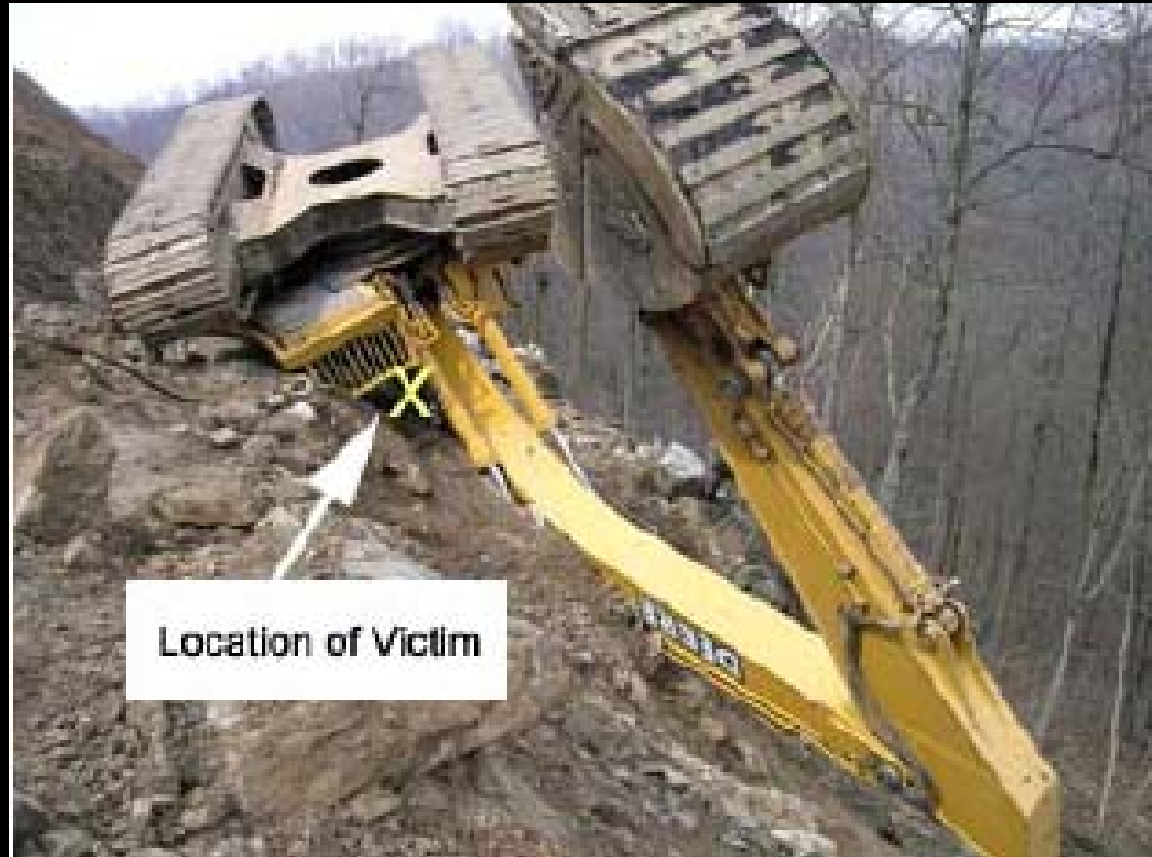
At approximately 4:00 p.m. on March 12, 2007 a 47-year old foreman/excavator operator with 29 years mining experience received fatal injuries when the track-mounted excavator which he had been operating overturned from an elevated mine bench. The victim had been loading and moving shot rock overburden while positioned on the narrow

bench, digging toward the excavator. The excavator was positioned with the left (operator's) side track on the edge of the upper bench, when he began trying to reposition the machine away from the edge by using the boom. When down pressure was applied to the boom, the rear portion of the track went over the edge of the bench and the excavator began to roll over onto the lower bench. As the excavator continued rolling over, the cab was crushed and the victim was fatally injured. The accident occurred because the width of the elevated mine bench was not sufficient to insure safe operation of the excavator.

Root Cause: The standards, policies and procedures used by the mine operator did not ensure that safe working conditions were provided for the employees at all times. The width of the elevated mine bench was not sufficient to provide safe working conditions for the equipment being used and the operation being performed.

Corrective Action: The mine operator developed a plan to prevent a similar occurrence of this accident. The ground control plan was revised to show when track-mounted equipment is being operated parallel to the outslope from an elevated bench on in-place shot material, the width of the bench will be a minimum of 1.5 times wider than the distance between the outside edges of the equipment tracks. The plan also requires training to be provided to the employees concerning the revised ground control plan and hazards associated with operating equipment from a mine bench.
